A STUDY OF METHODS TO IMPROVE  
THE PERFORMANCE OF DRAG BITS USED  
TO CUT HARD ROCK.

A Thesis Submitted to the Faculty of Engineering  
University of the Witwatersrand, Johannesburg  
for the Degree of Doctor of Philosophy.

Johannesburg 1977

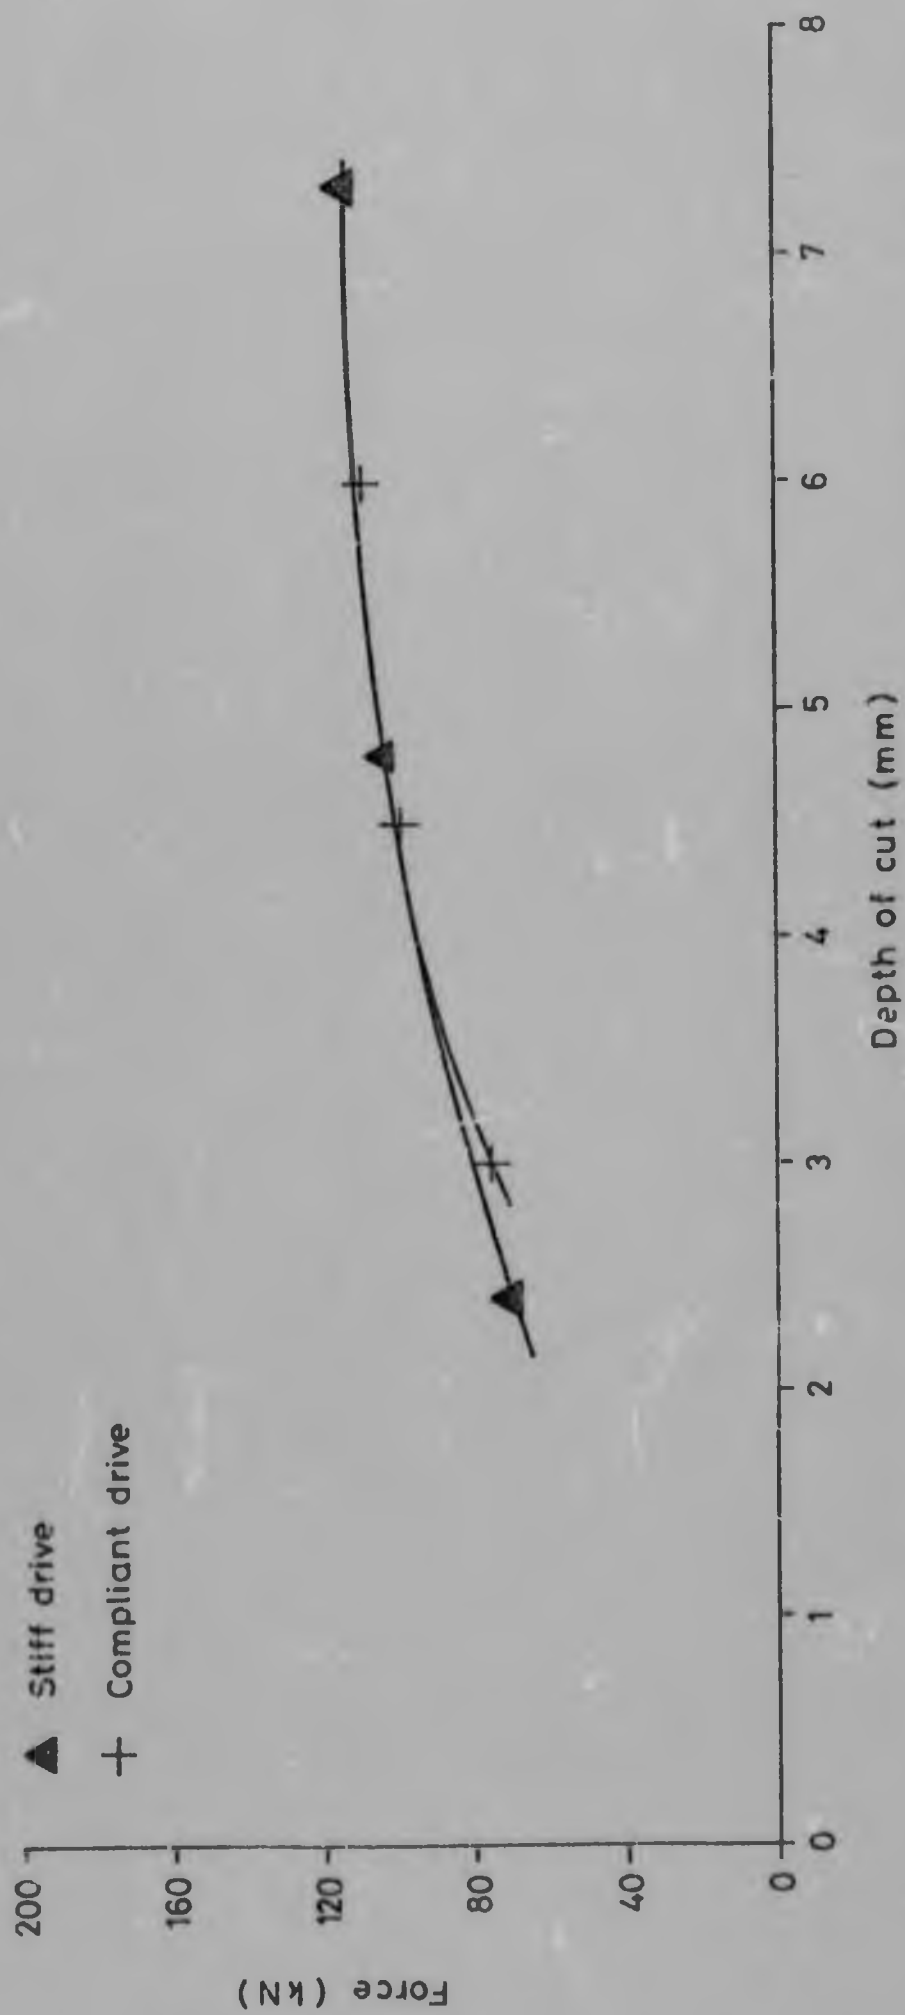
FIGURE 48 : Mean peak bit cutting force plotted against depth of cut, comparing a stiff hydraulic drive to the machine with a compliant hydraulic drive.

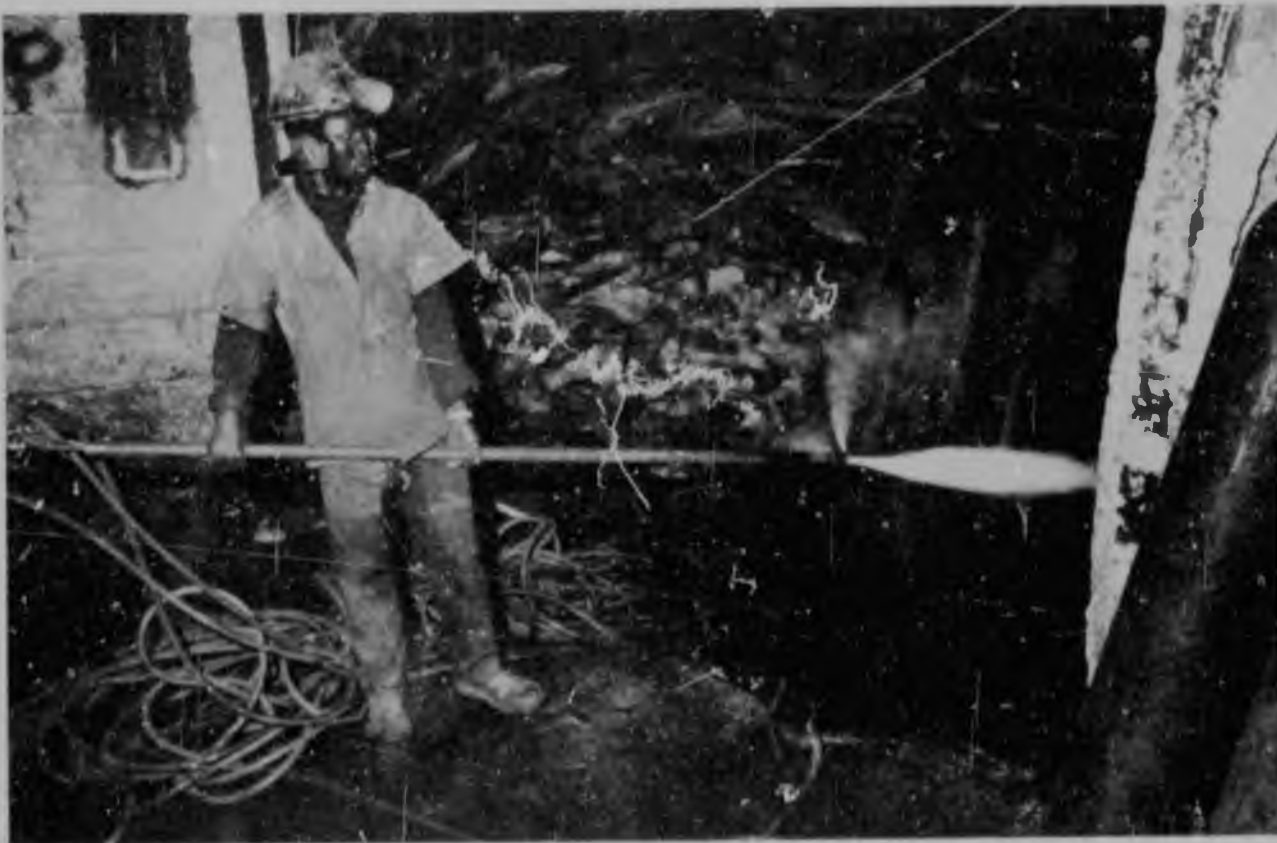
FIGURE 52. Igniting jet channeling torch.

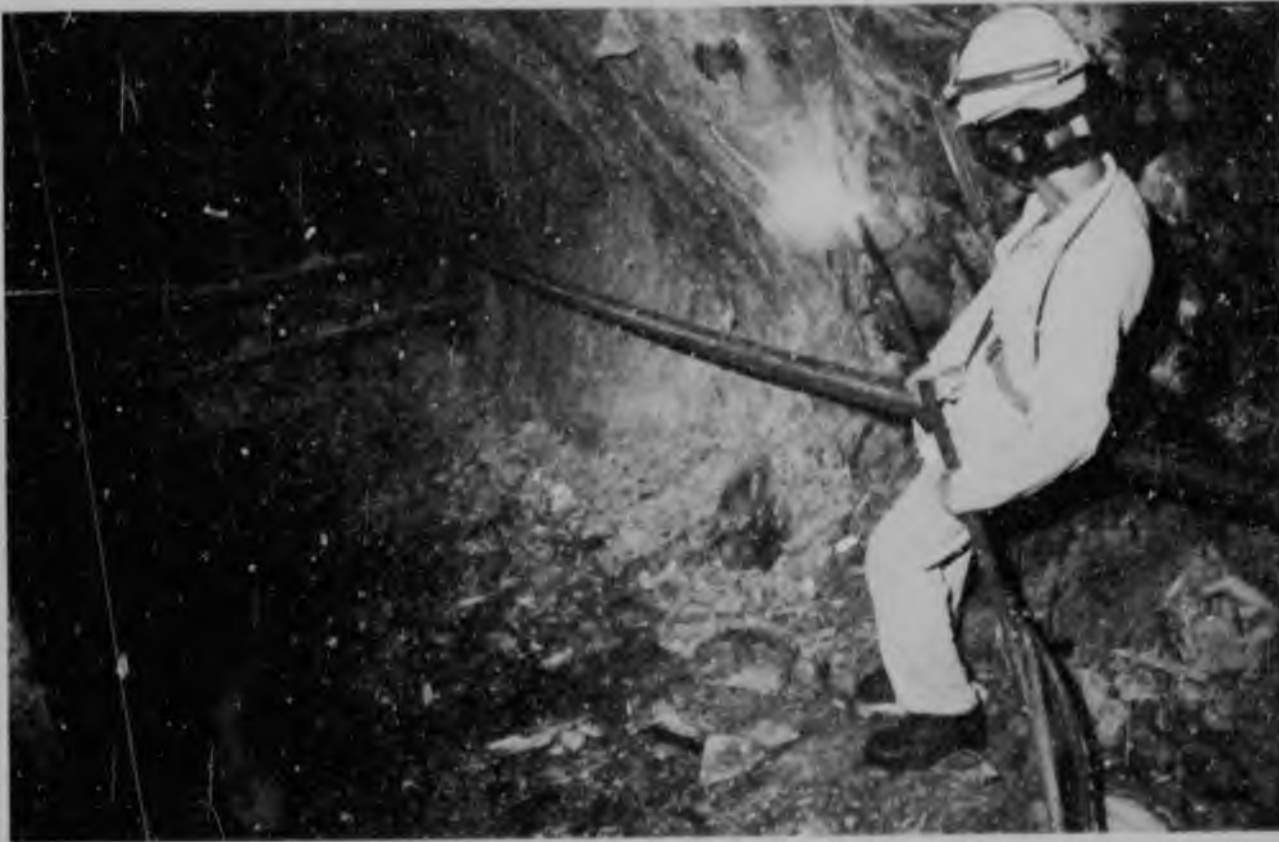
FIGURE 53. Weakening the rock using a jet channeling torch.

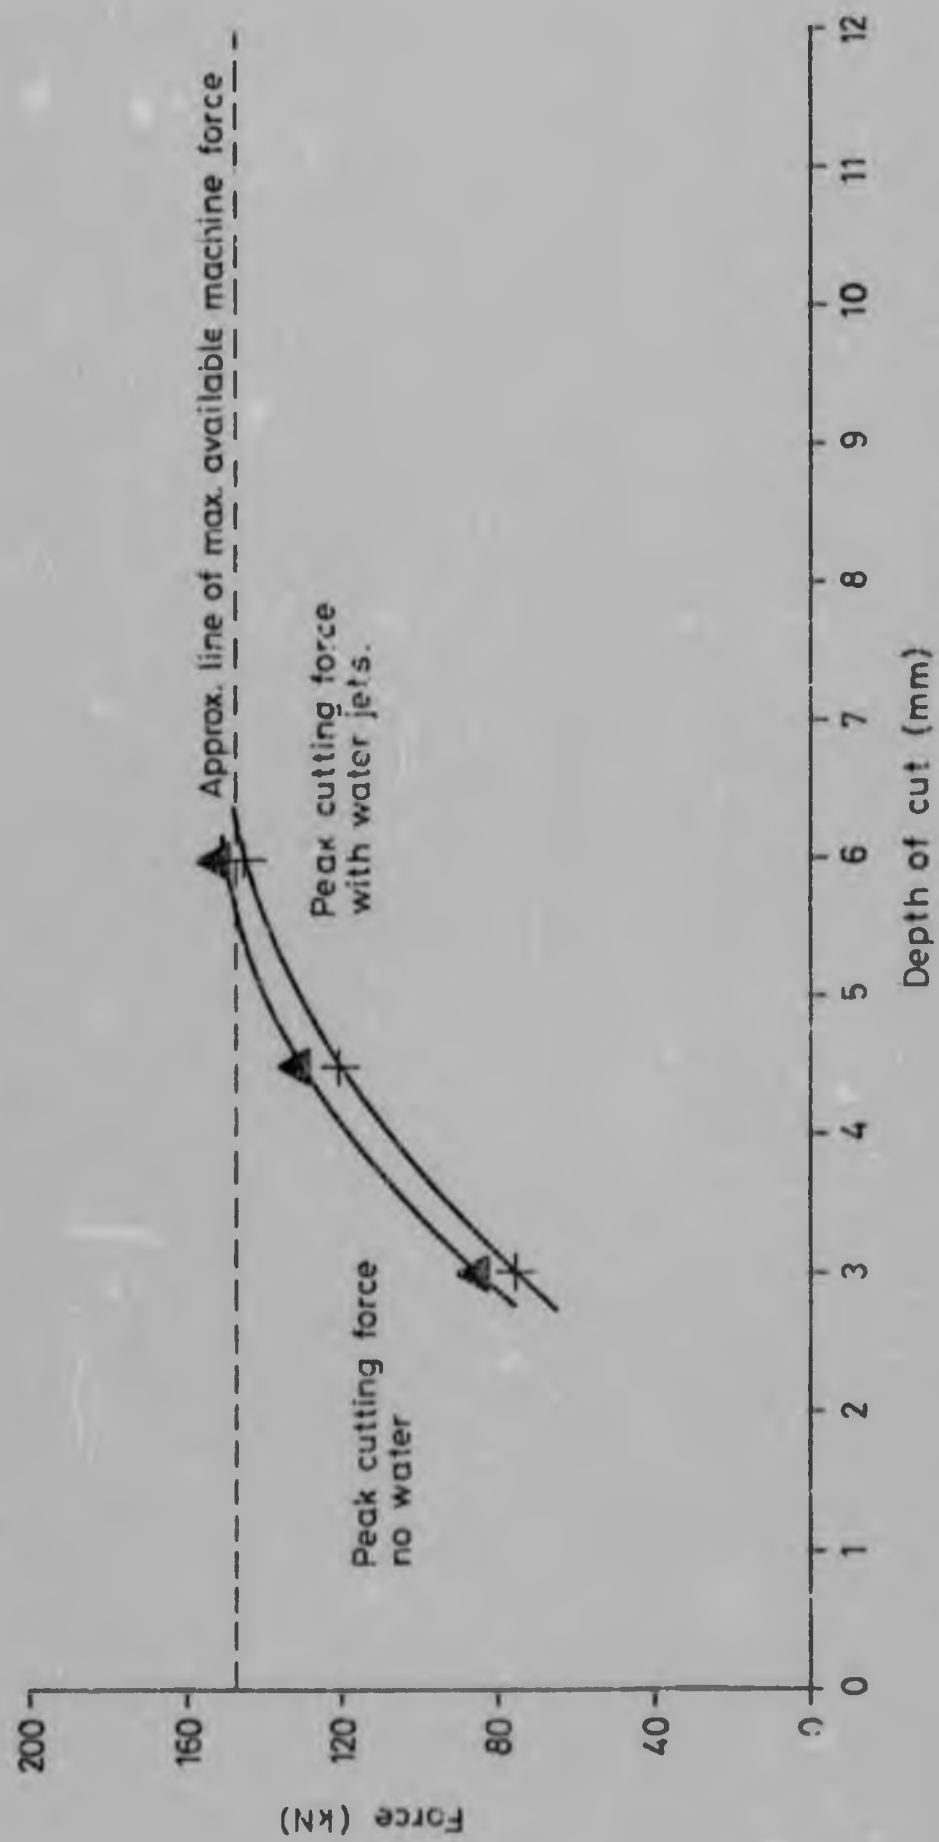
FIGURE 55 : Mean peak bit cutting force plotted against depth of cut, with a 'flat-fan' water jet and with no water jets.

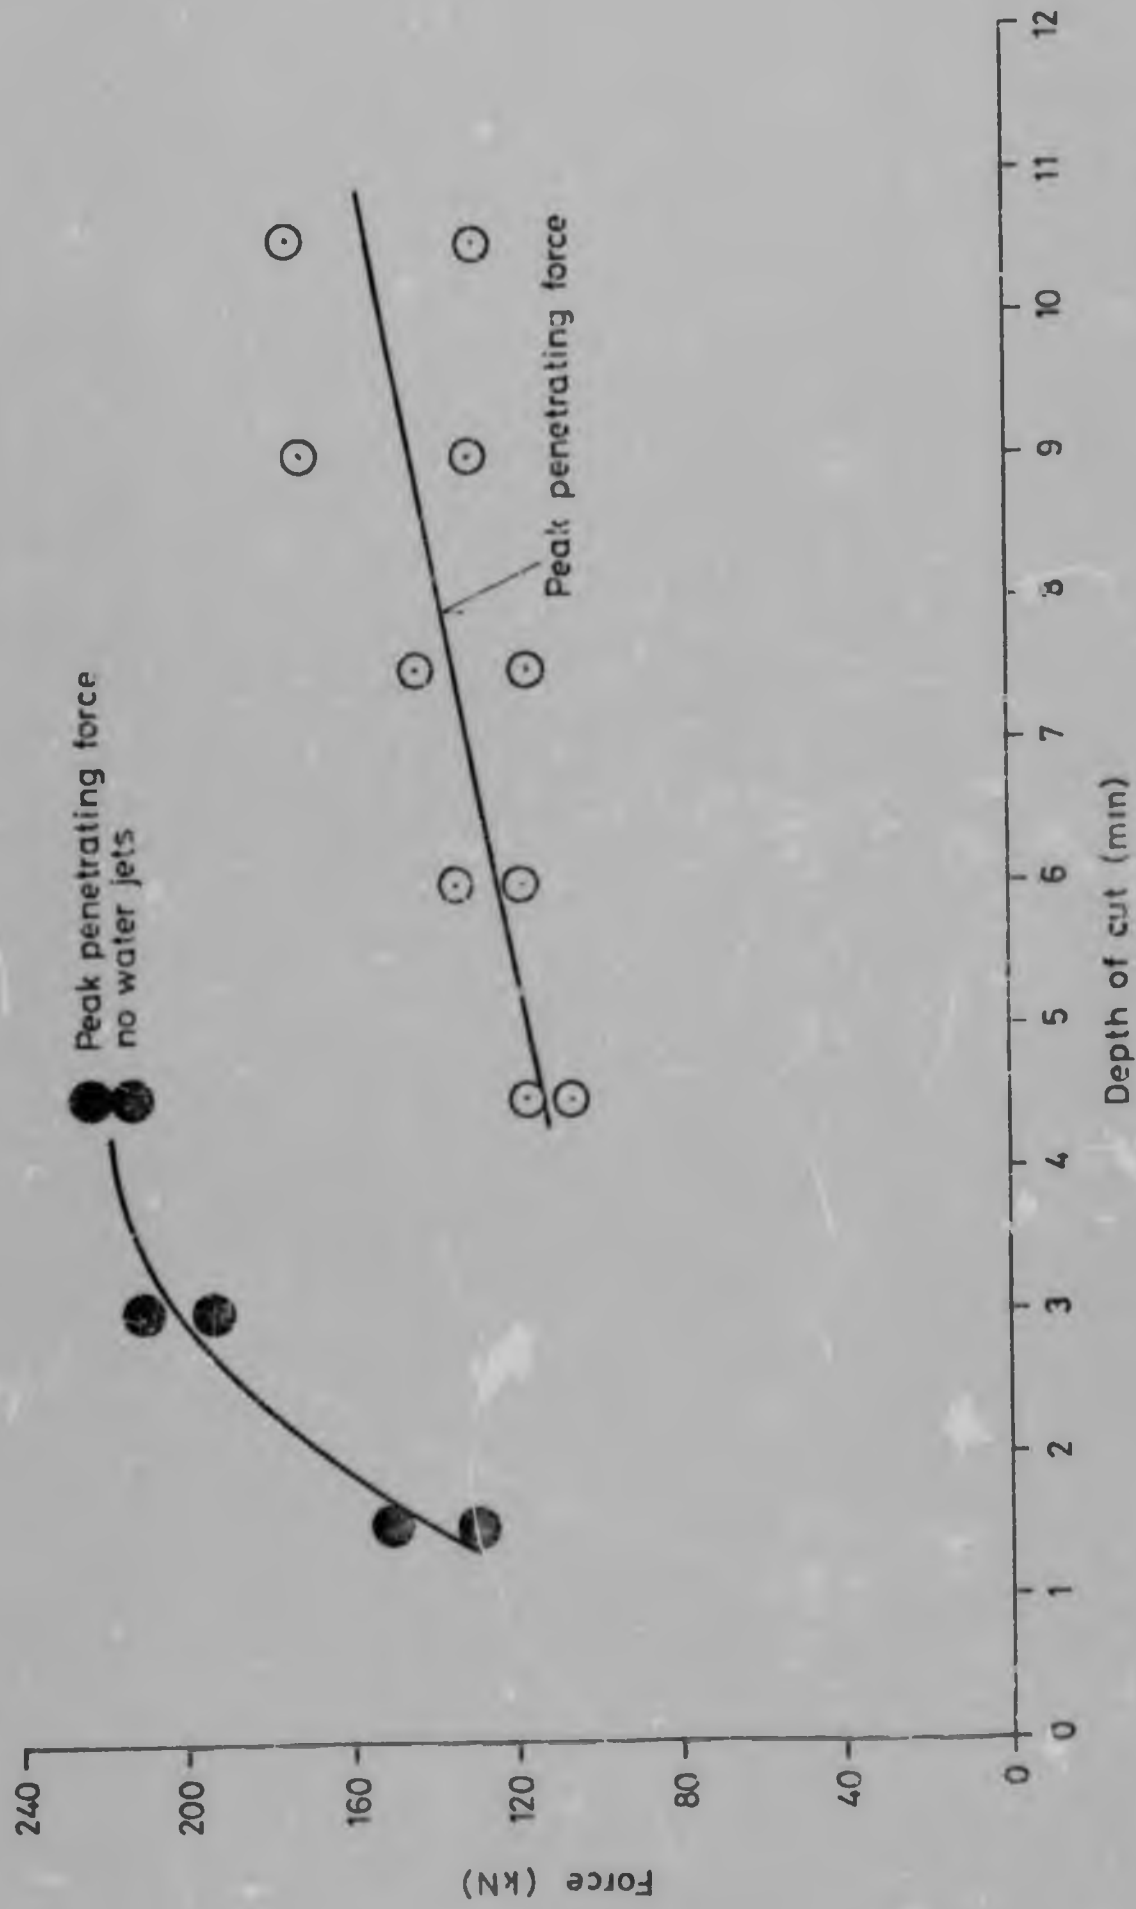
FIGURE 65 : Mean peak bit penetrating force plotted against depth of cut illustrating the reduction of the force required to cut the rock with 50 MPa water jets directed ahead of the bit.

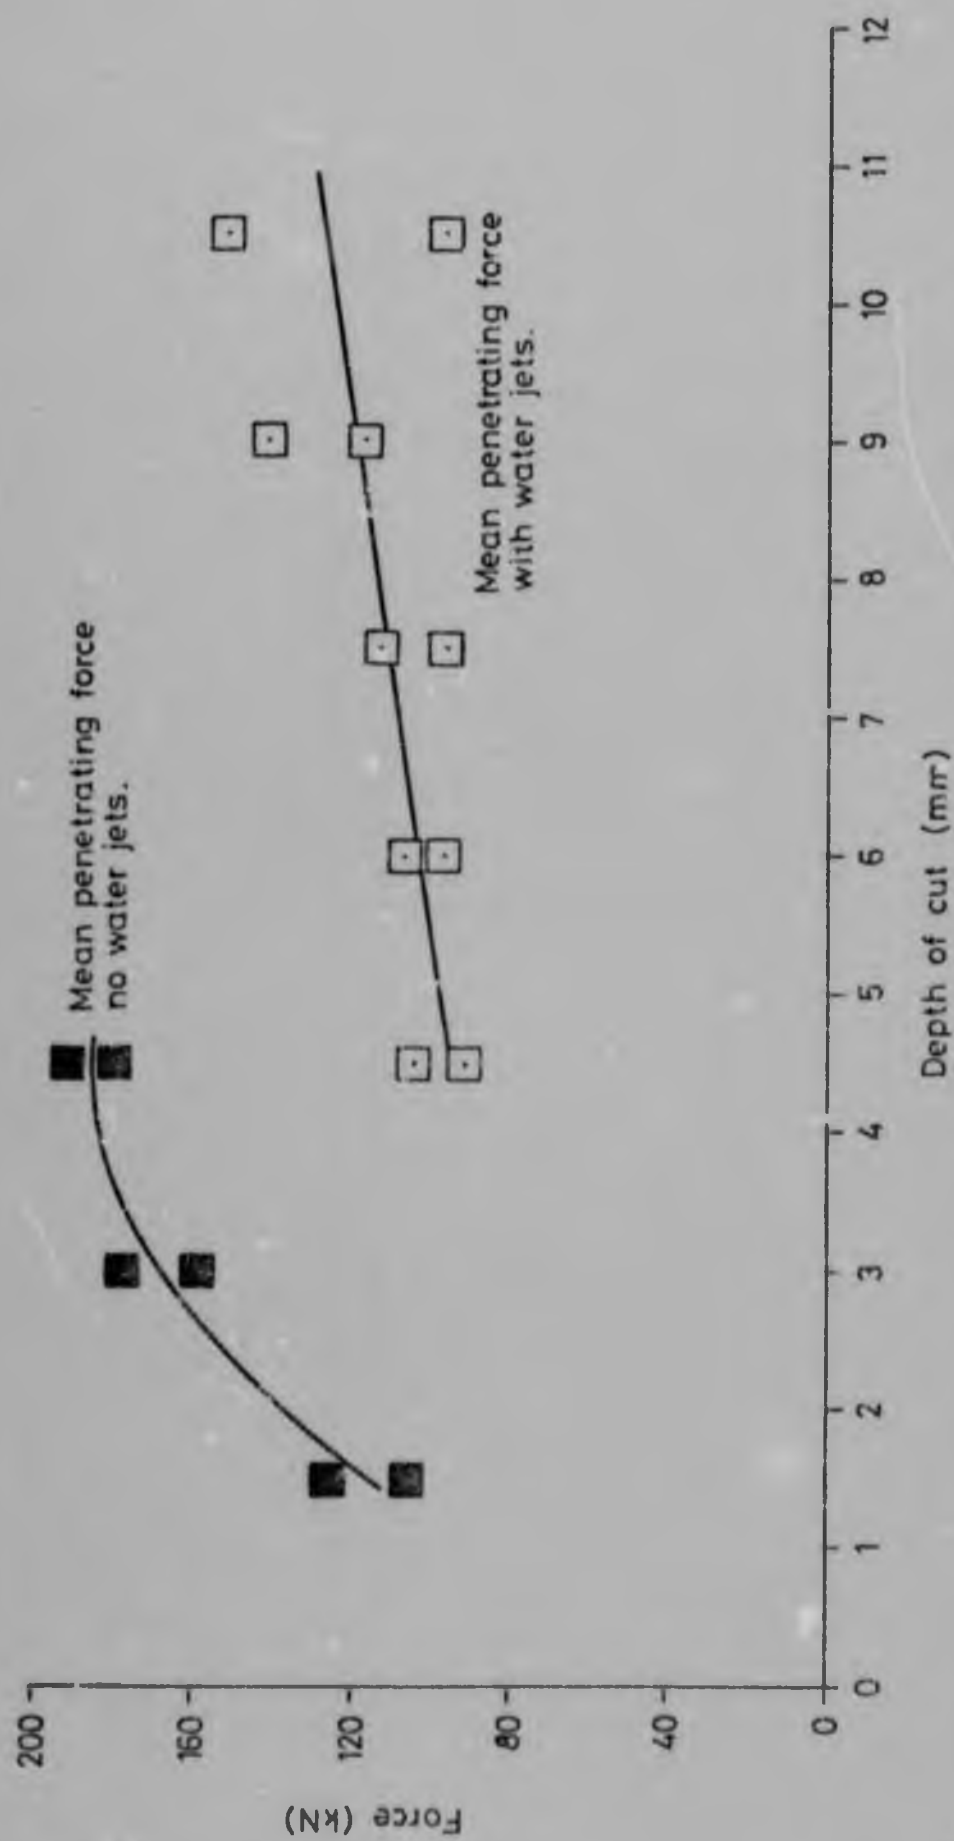
FIGURE 66 : Mean bit penetrating force plotted against depth of cut illustrating the reduction of the force required to cut the rock with 50 MPa water jets directed ahead of the bit.

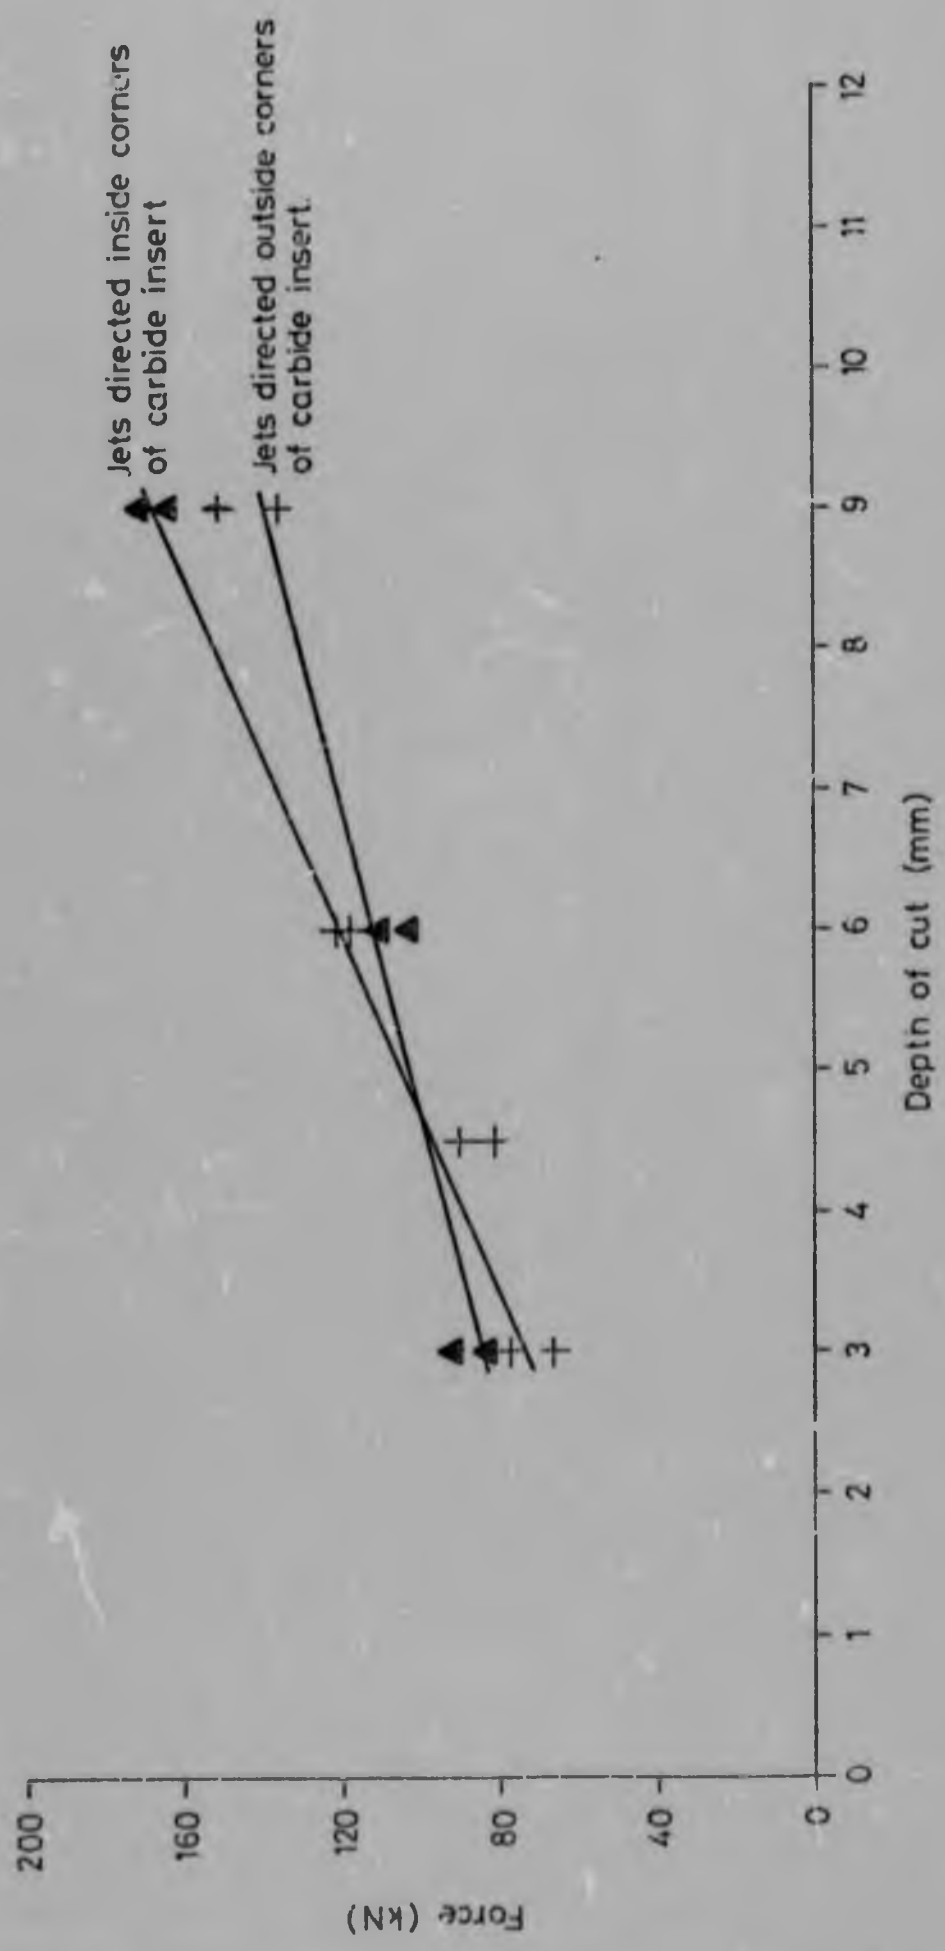
FIGURE 71 : Mean peak bit cutting force plotted against depth of cut with 10 MPa water jets directed adjacent to the corners of the tungsten carbide bit inserts.

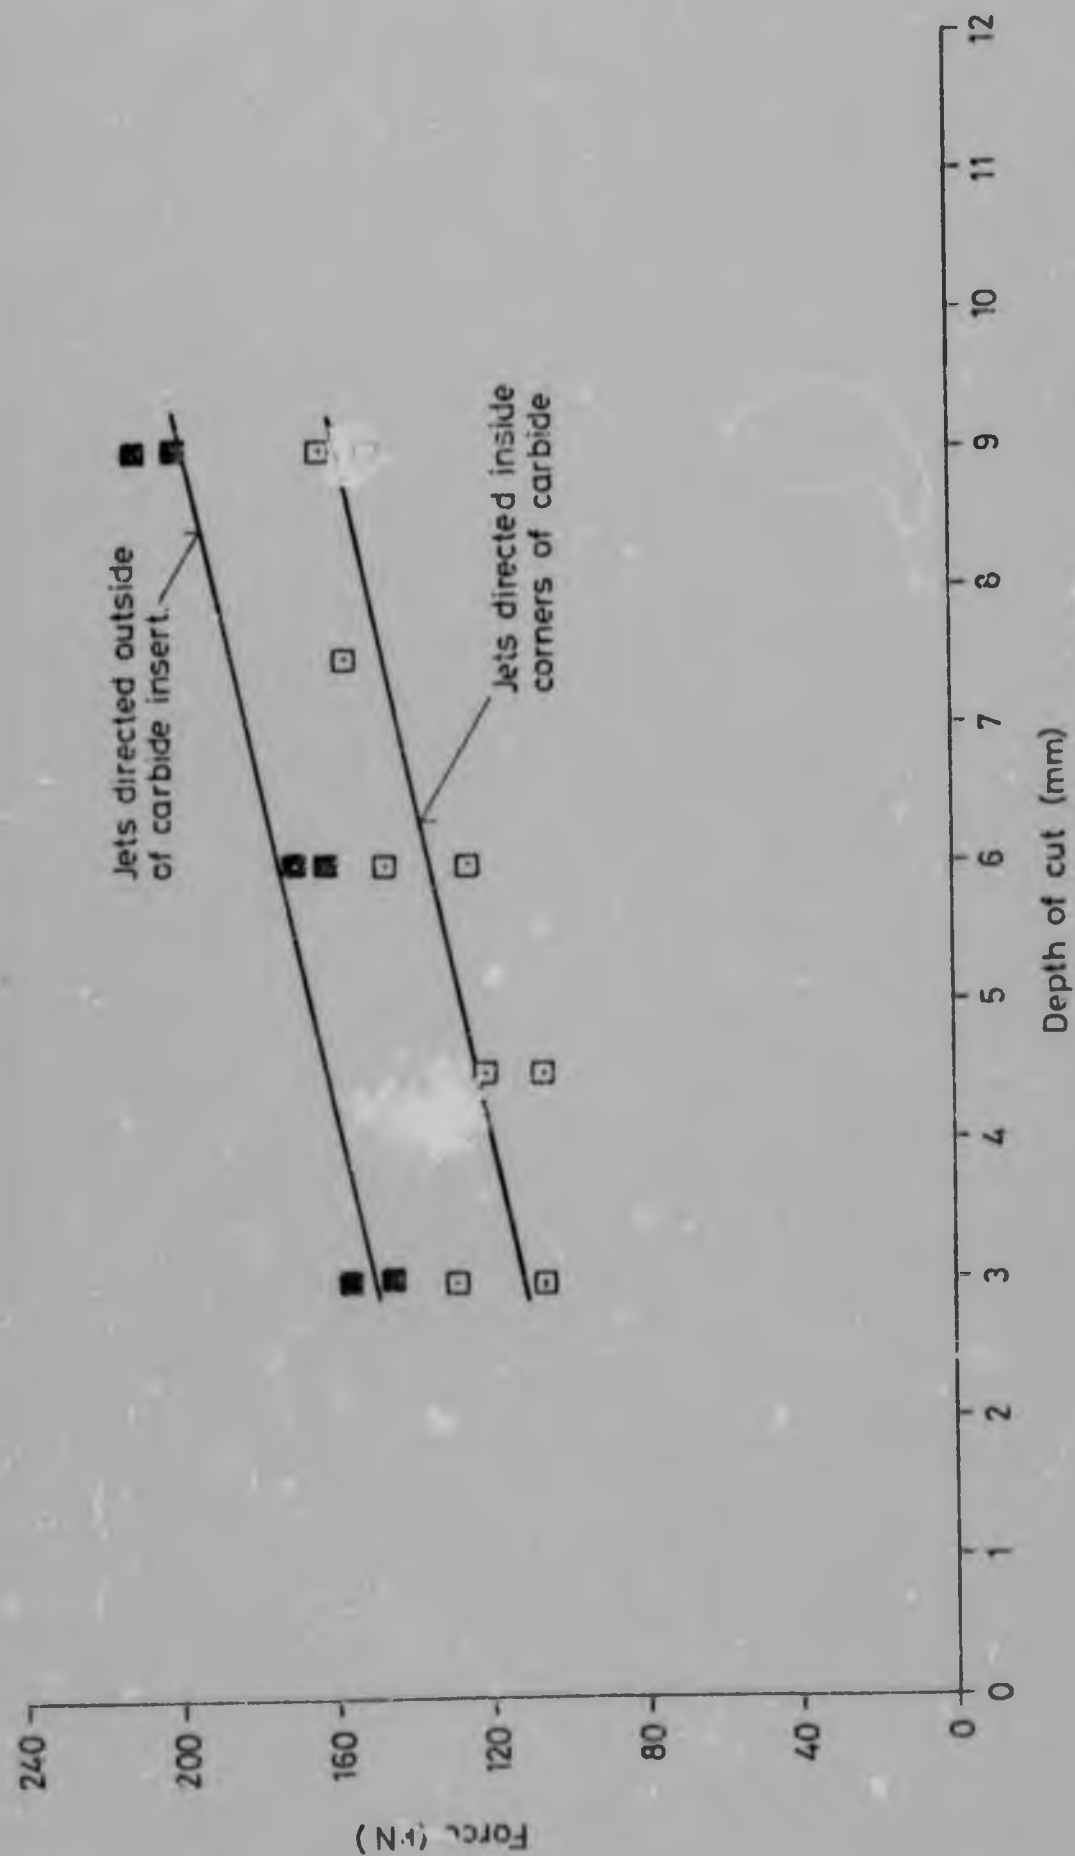
FIGURE 7a : Mean bit penetrating force plotted against depth of cut with 10 MPa water jets directed adjacent to the corners of the tungsten carbide bit inserts.

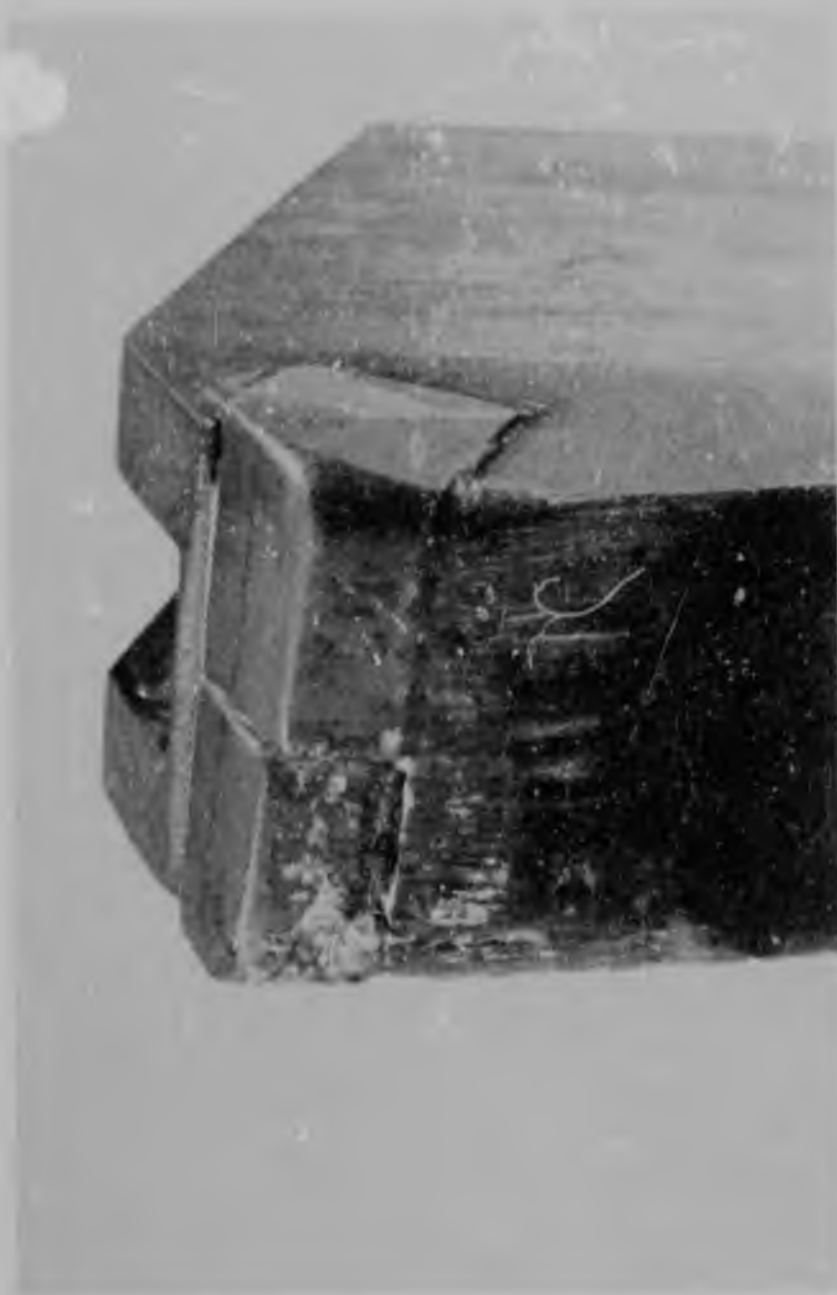
FIGURE 75. Photograph showing damage to a tungsten carbide bit insert when water jet was not directed towards the insert during the cutting operation.

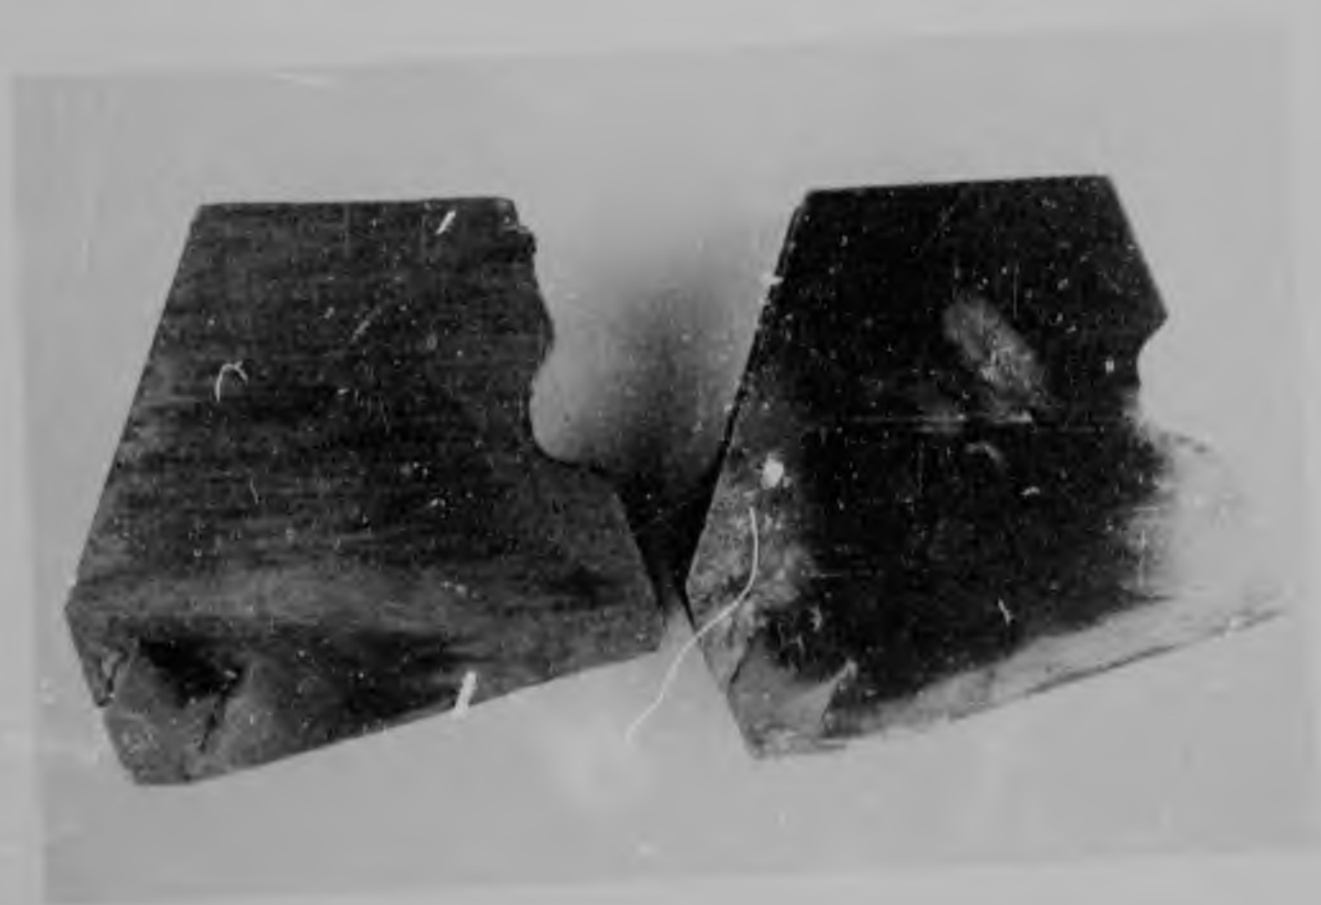
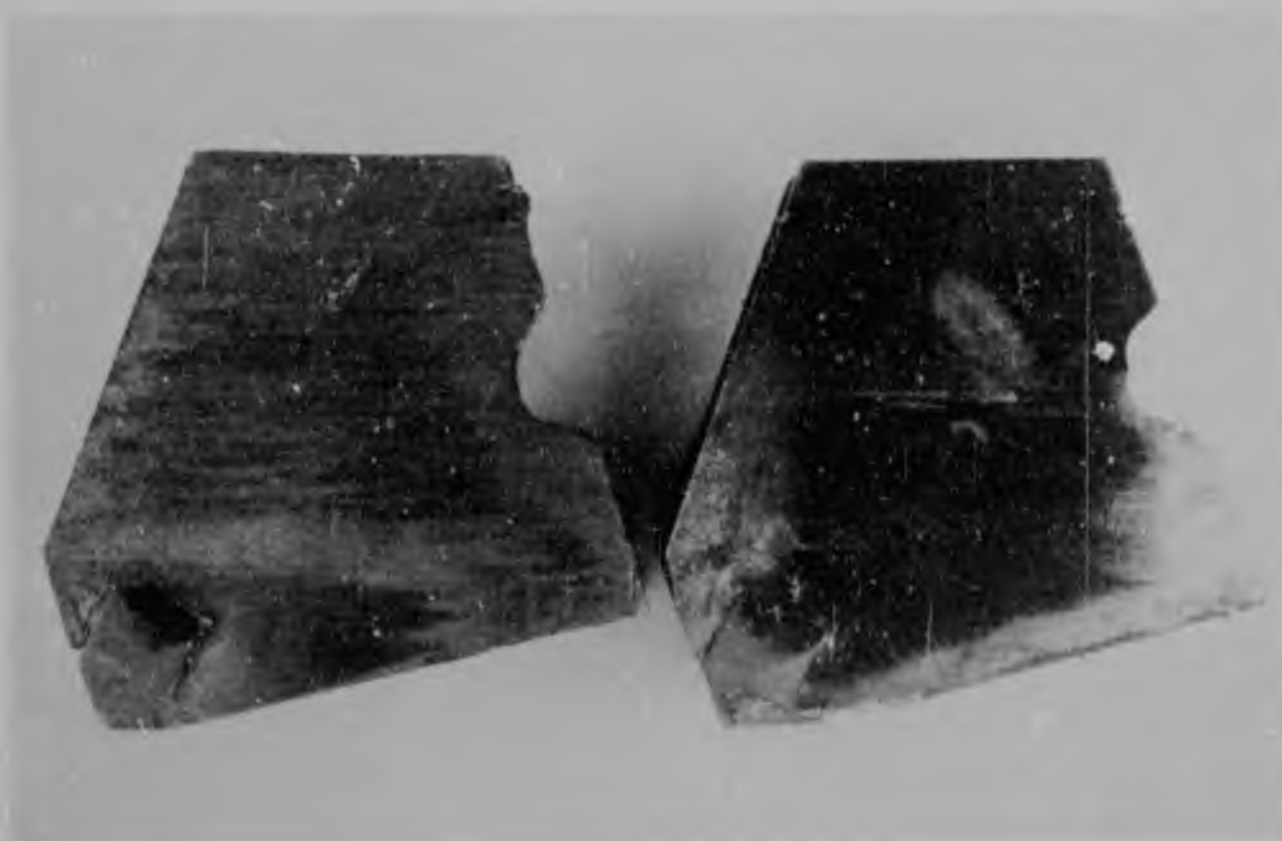
FIGURE 76. Photograph showing wear of steel bit body when a water jet was not used.

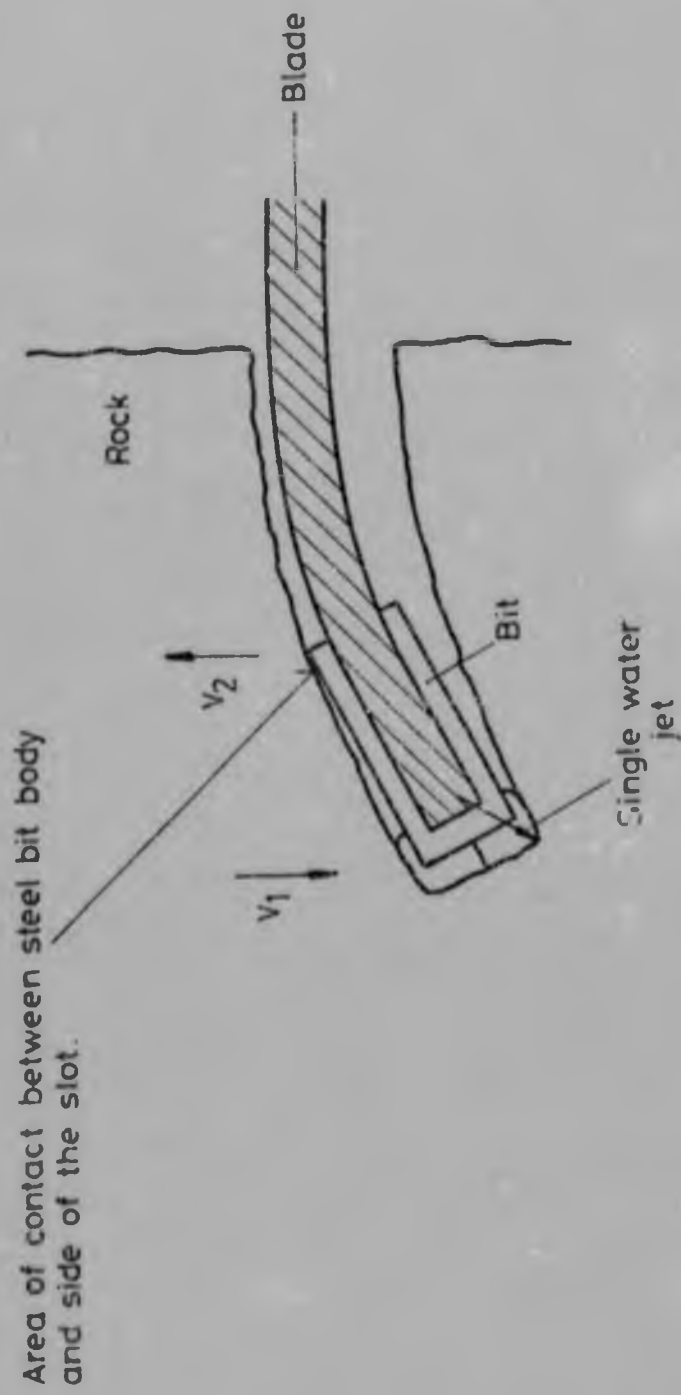
FIGURE 77 : Diagram illustrating the influence of water jets on the side force acting on the bit.

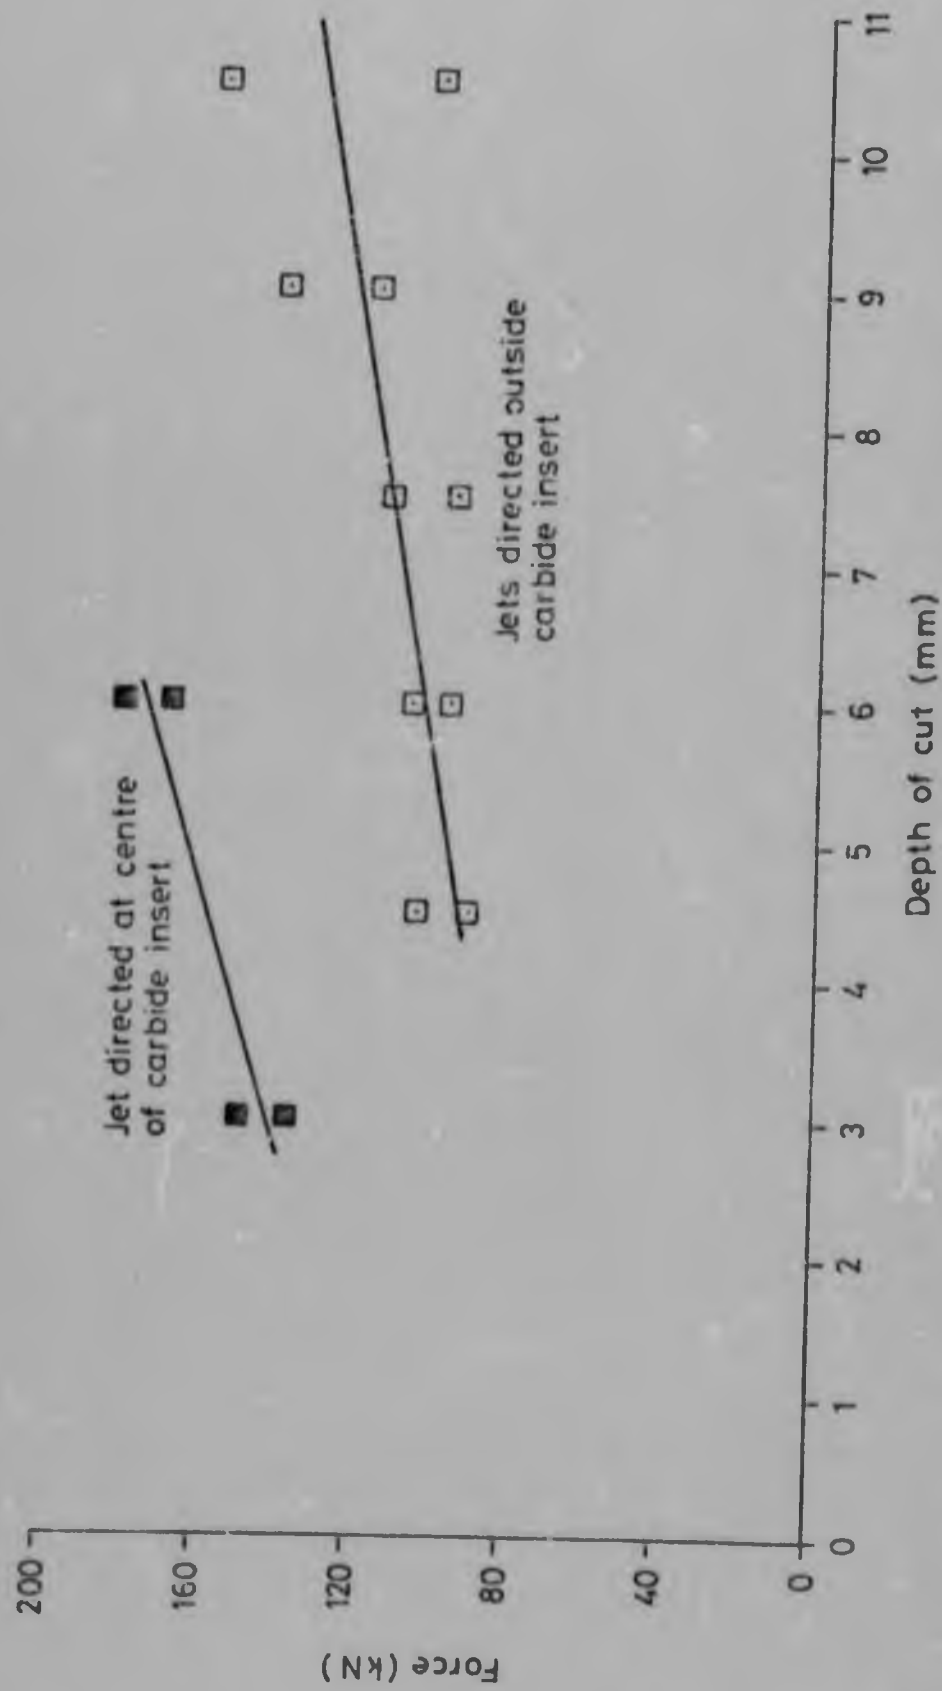
FIGURE 8.5 : Mean bit penetrating force plotted against depth of cut, comparing force measurements using two water jets directed towards the bit corners with a single jet directed along the centre of the leading face of the bit.

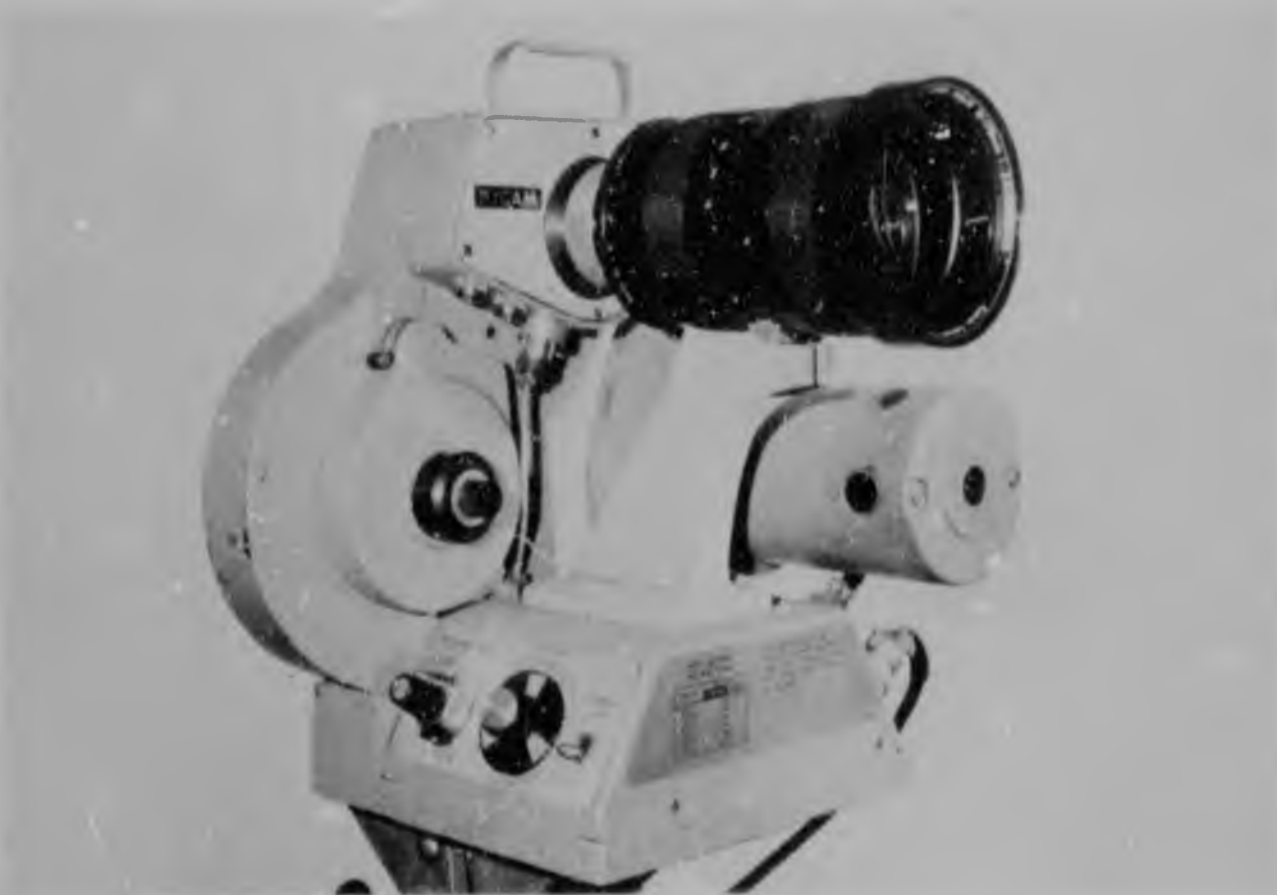
FIGURE 86 : High-speed camera.

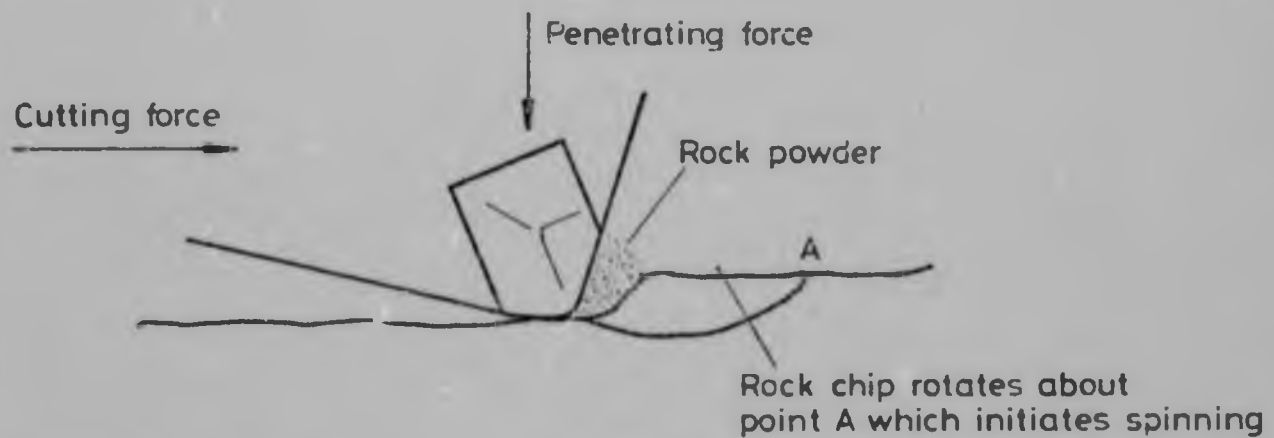
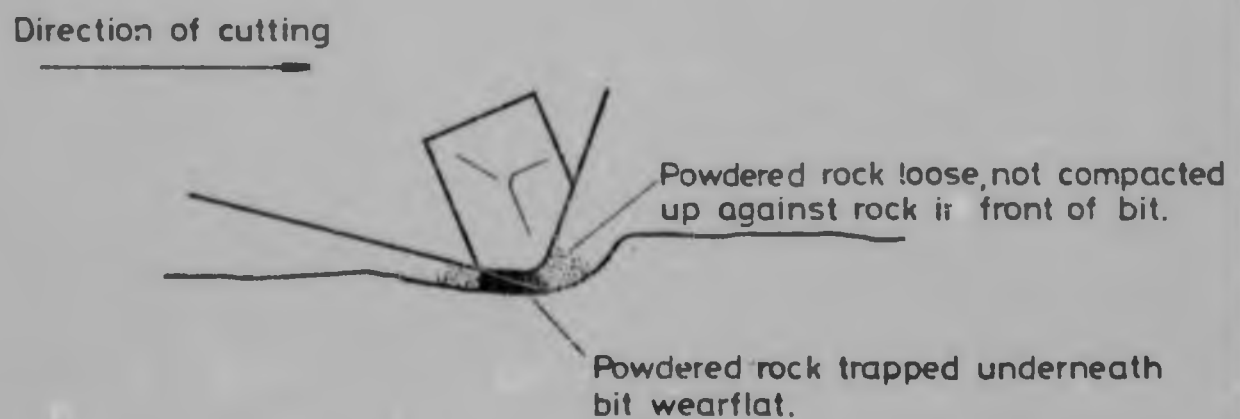
- a) A rock chip forms in front of the leading face of the bit with a minor explosion. Rock powder is observed ahead of the bit, and the rock chip is ejected in the direction of the applied cutting force, rotating about point A.

- b) As the bit advances through the rock, powdered rock is trapped underneath the wearflat.
- c) Cycle is then repeated and another chip forms ahead of the leading face of the bit.

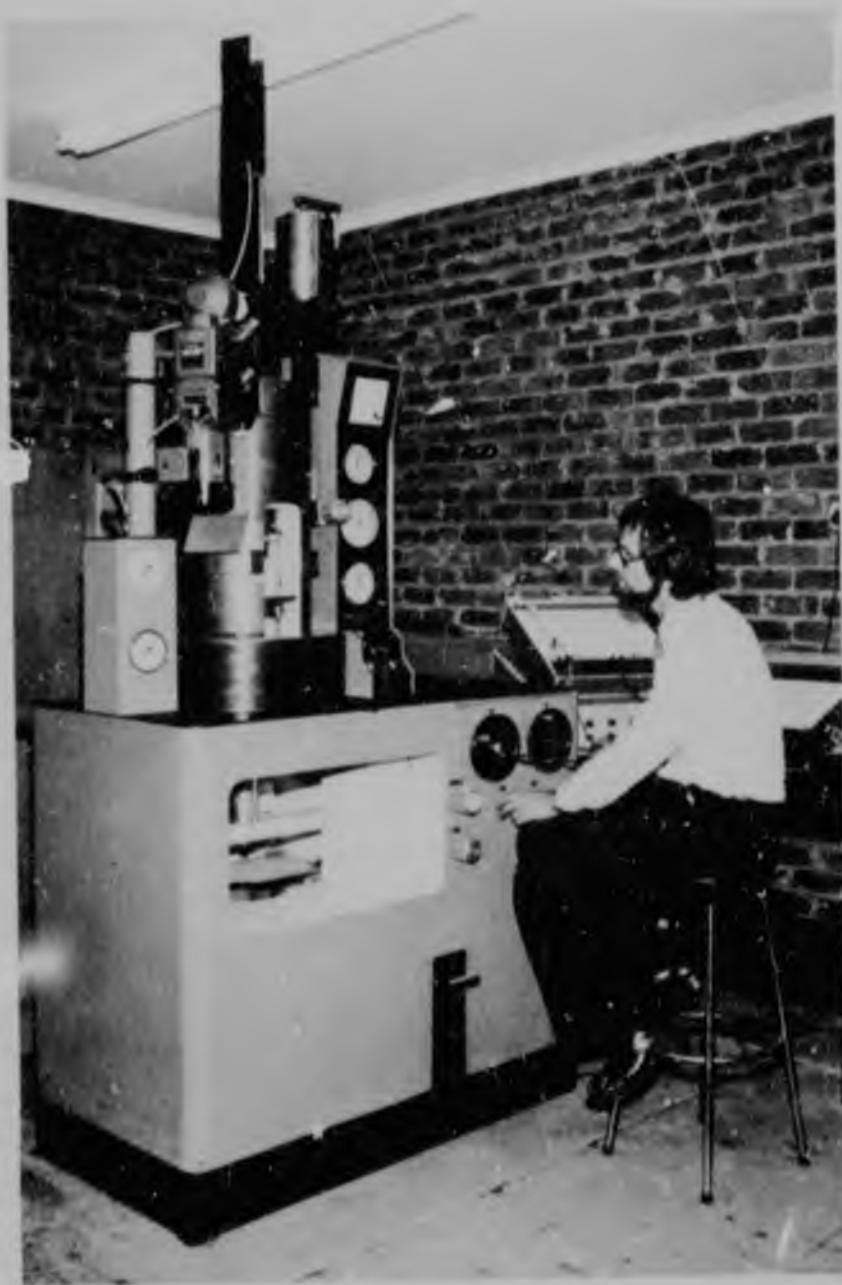
FIGURE 88 : Stiff compression testing machine.
