A STUDY OF METHODS TO IMPROVE  
THE PERFORMANCE OF DRAG BITS USED  
TO CUT HARD ROCK.

A Thesis Submitted to the Faculty of Engineering  
University of the Witwatersrand, Johannesburg  
for the Degree of Doctor of Philosophy.

Johannesburg 1977

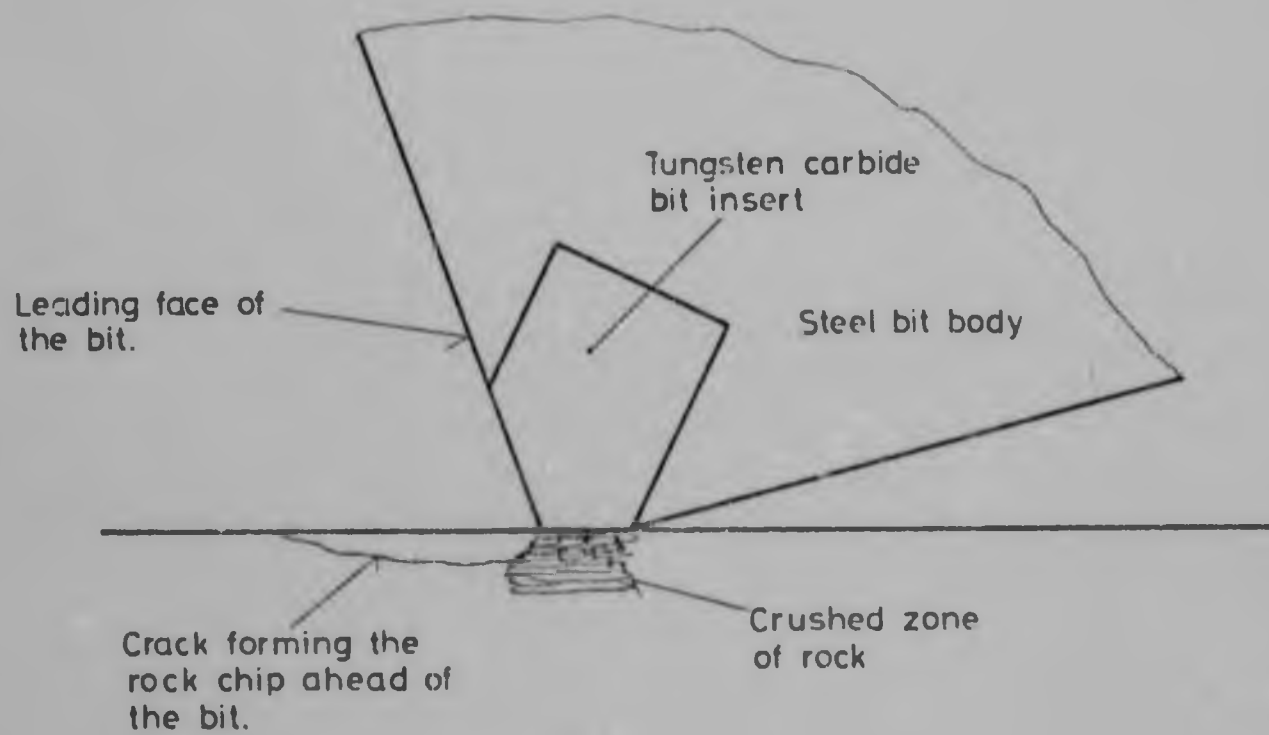
FIGURE 90 : Diagram illustrating formation of a rock chip during indentation tests.

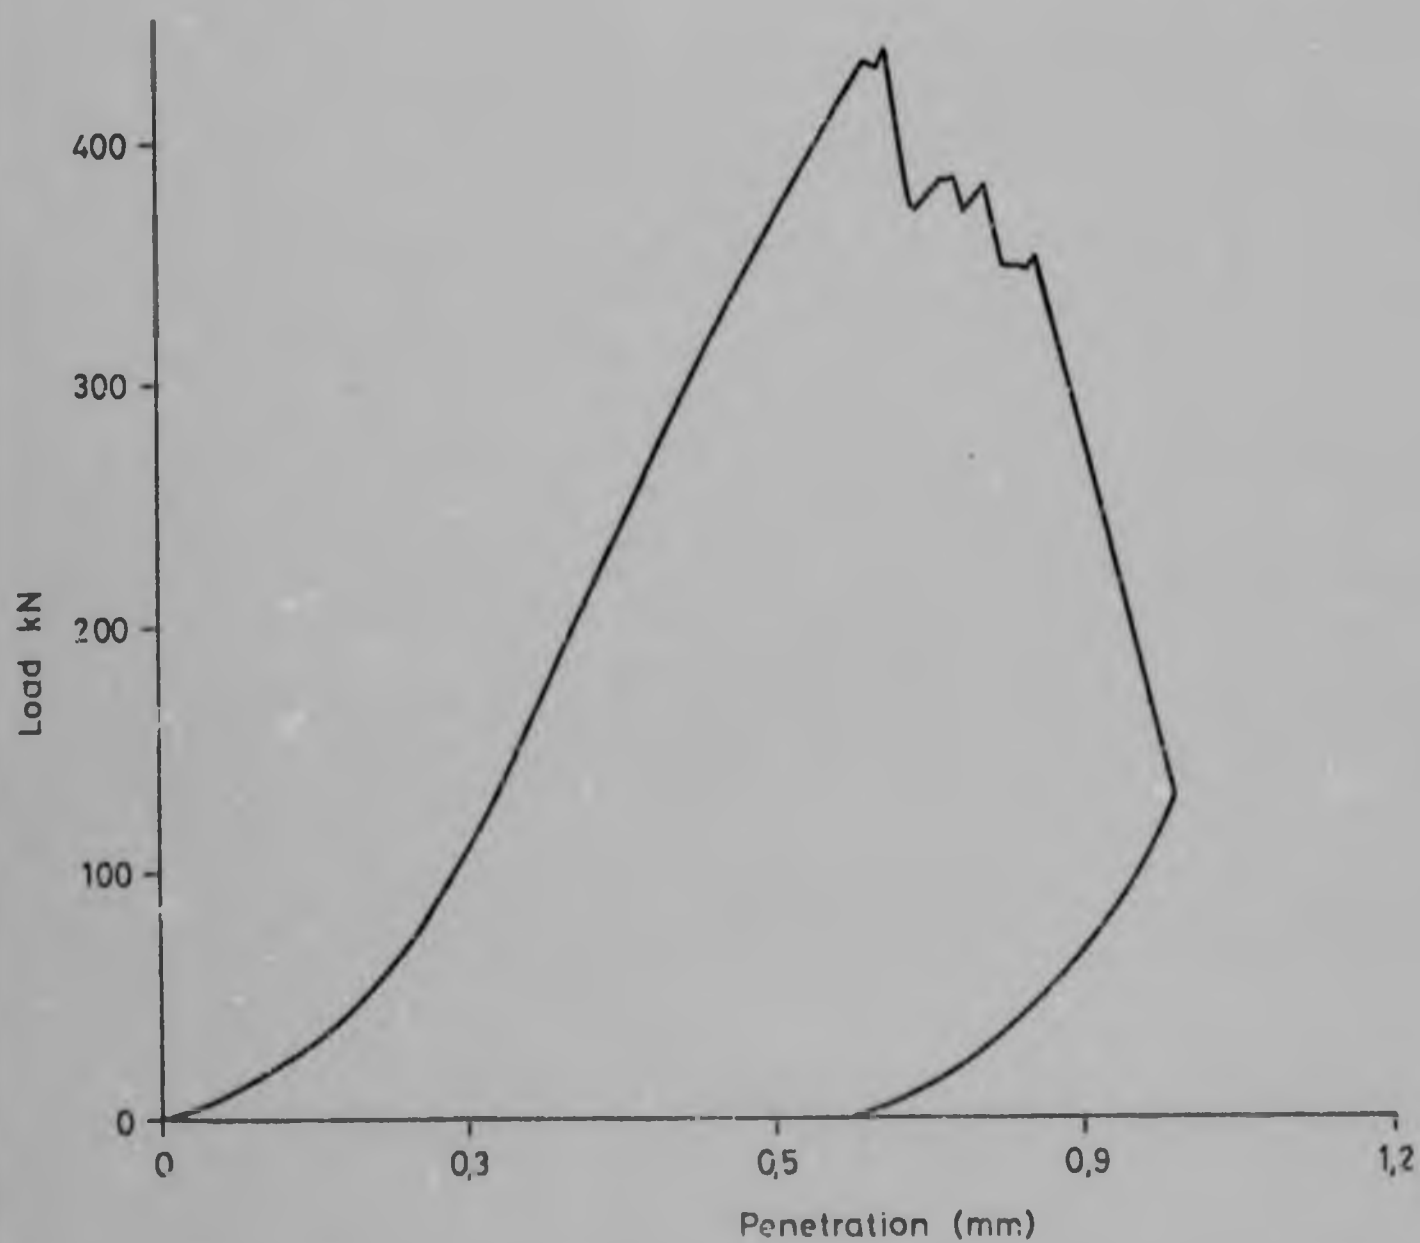
FIGURE 91 : Indentation force required to form a rock chip in norite, plotted against penetration of the bit.

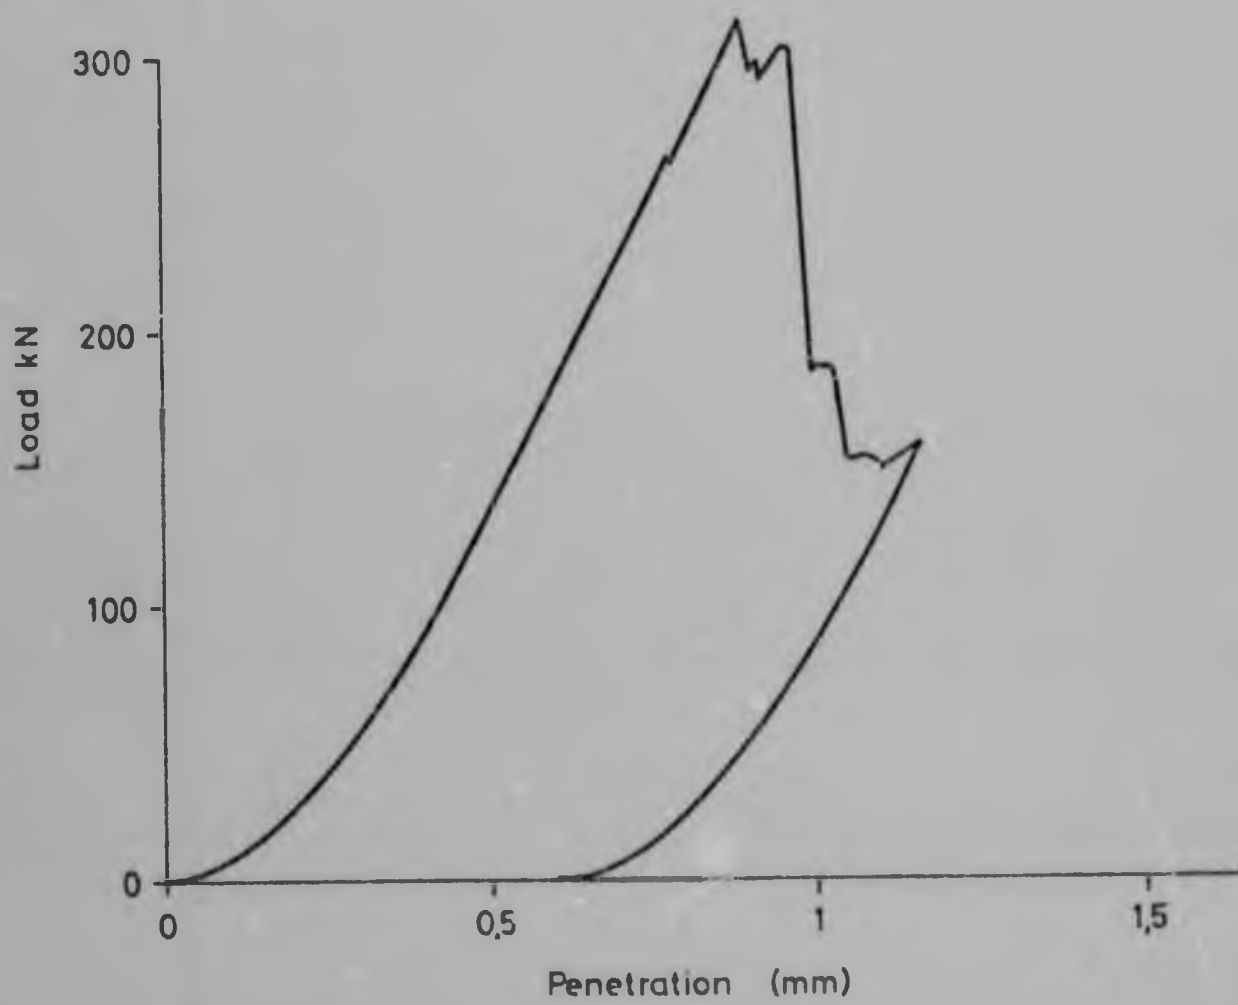
FIGURE 92 : Indentation force required to form rock chip in quartzite, plotted against penetration of the bit.

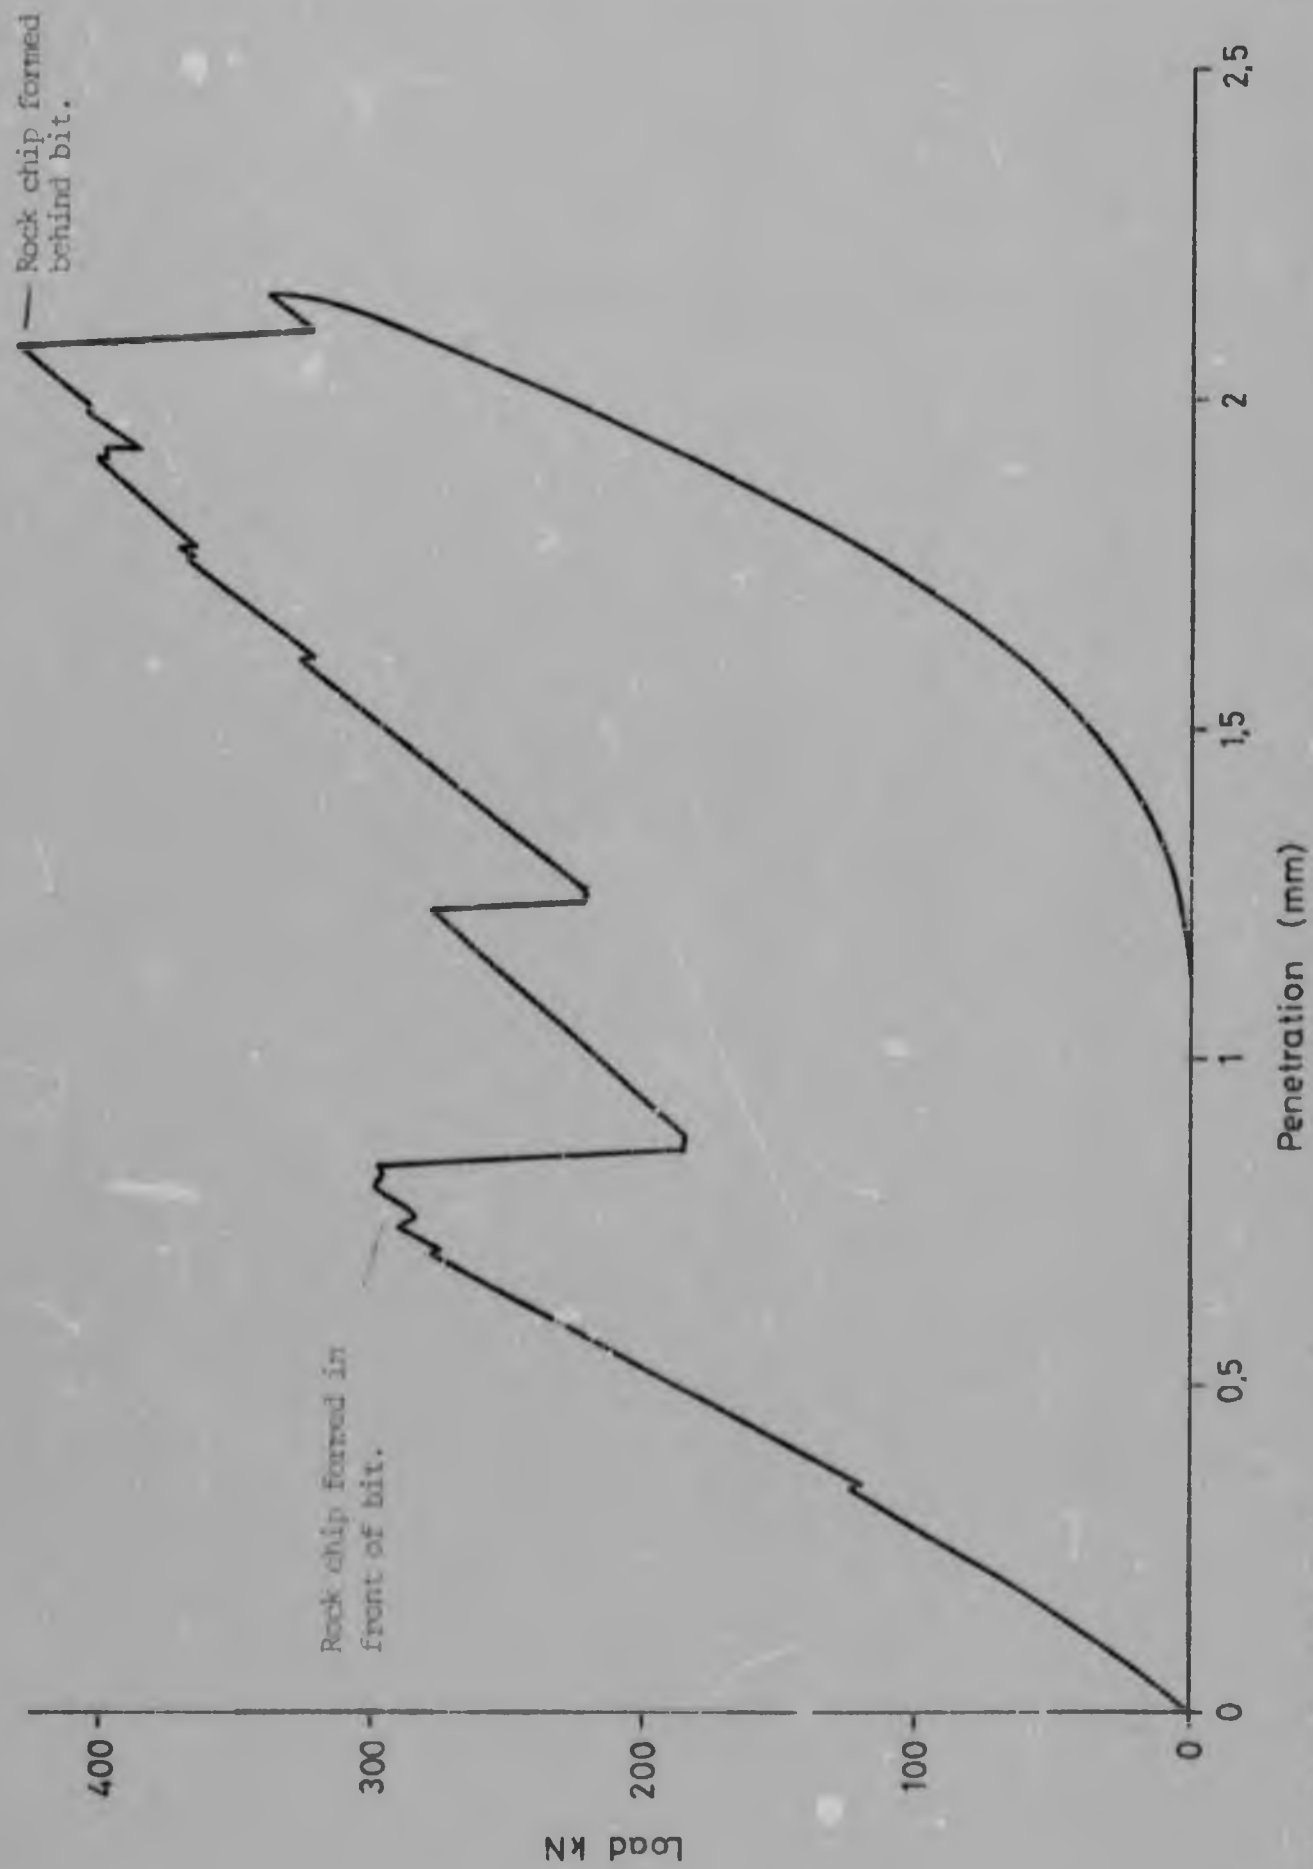
FIGURE 93 : Indentation force required to form a rock chip behind the bit plotted against bit penetration.

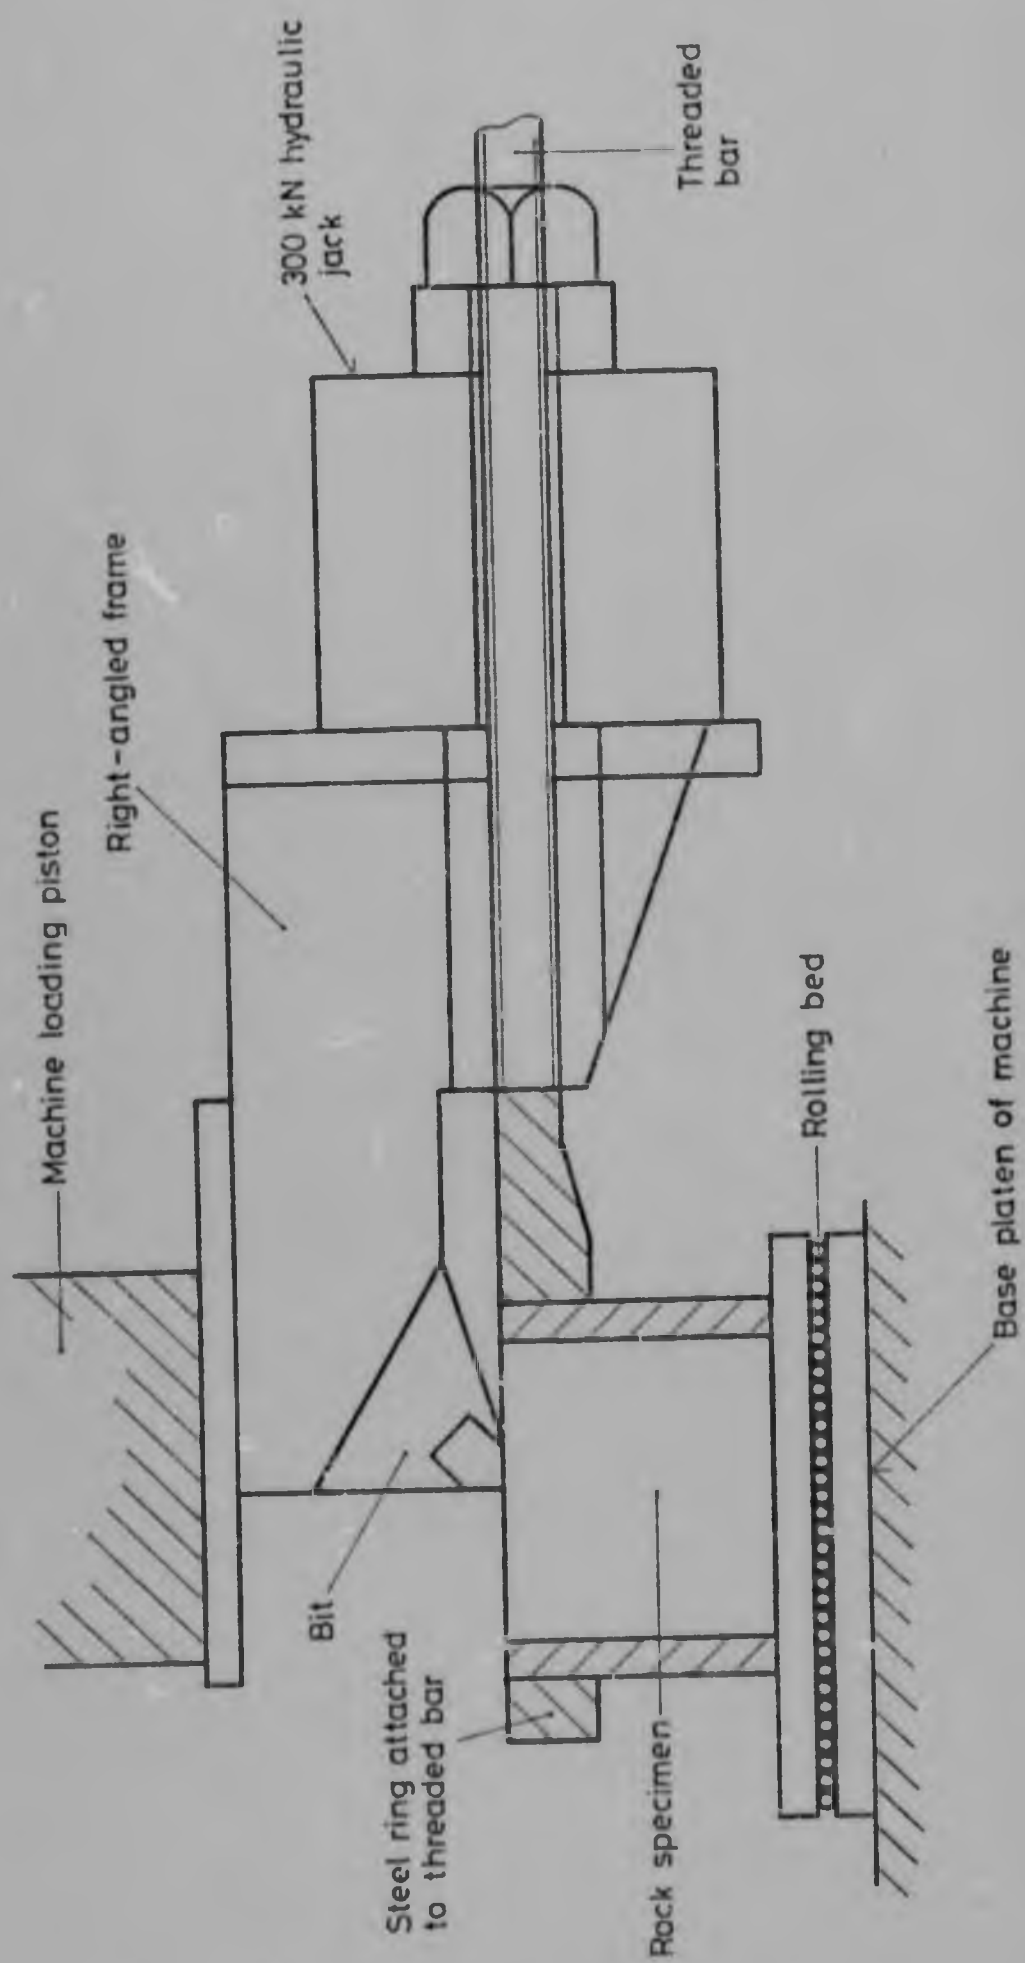
FIGURE 95 : Method by which a shear force was applied to the rock during indentation tests.

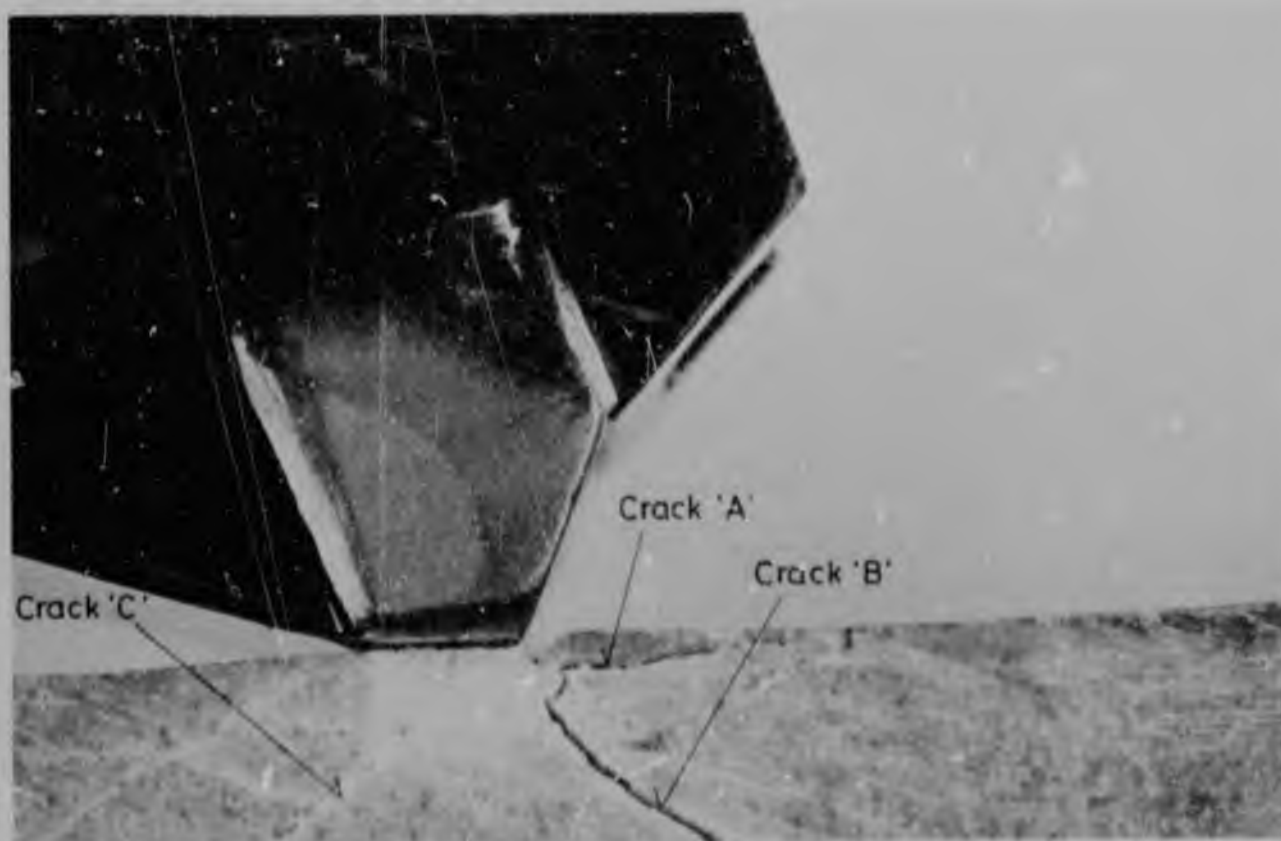
FIGURE 96 : Section through rock specimen, illustrating the position of a rock chip relative to the bit.

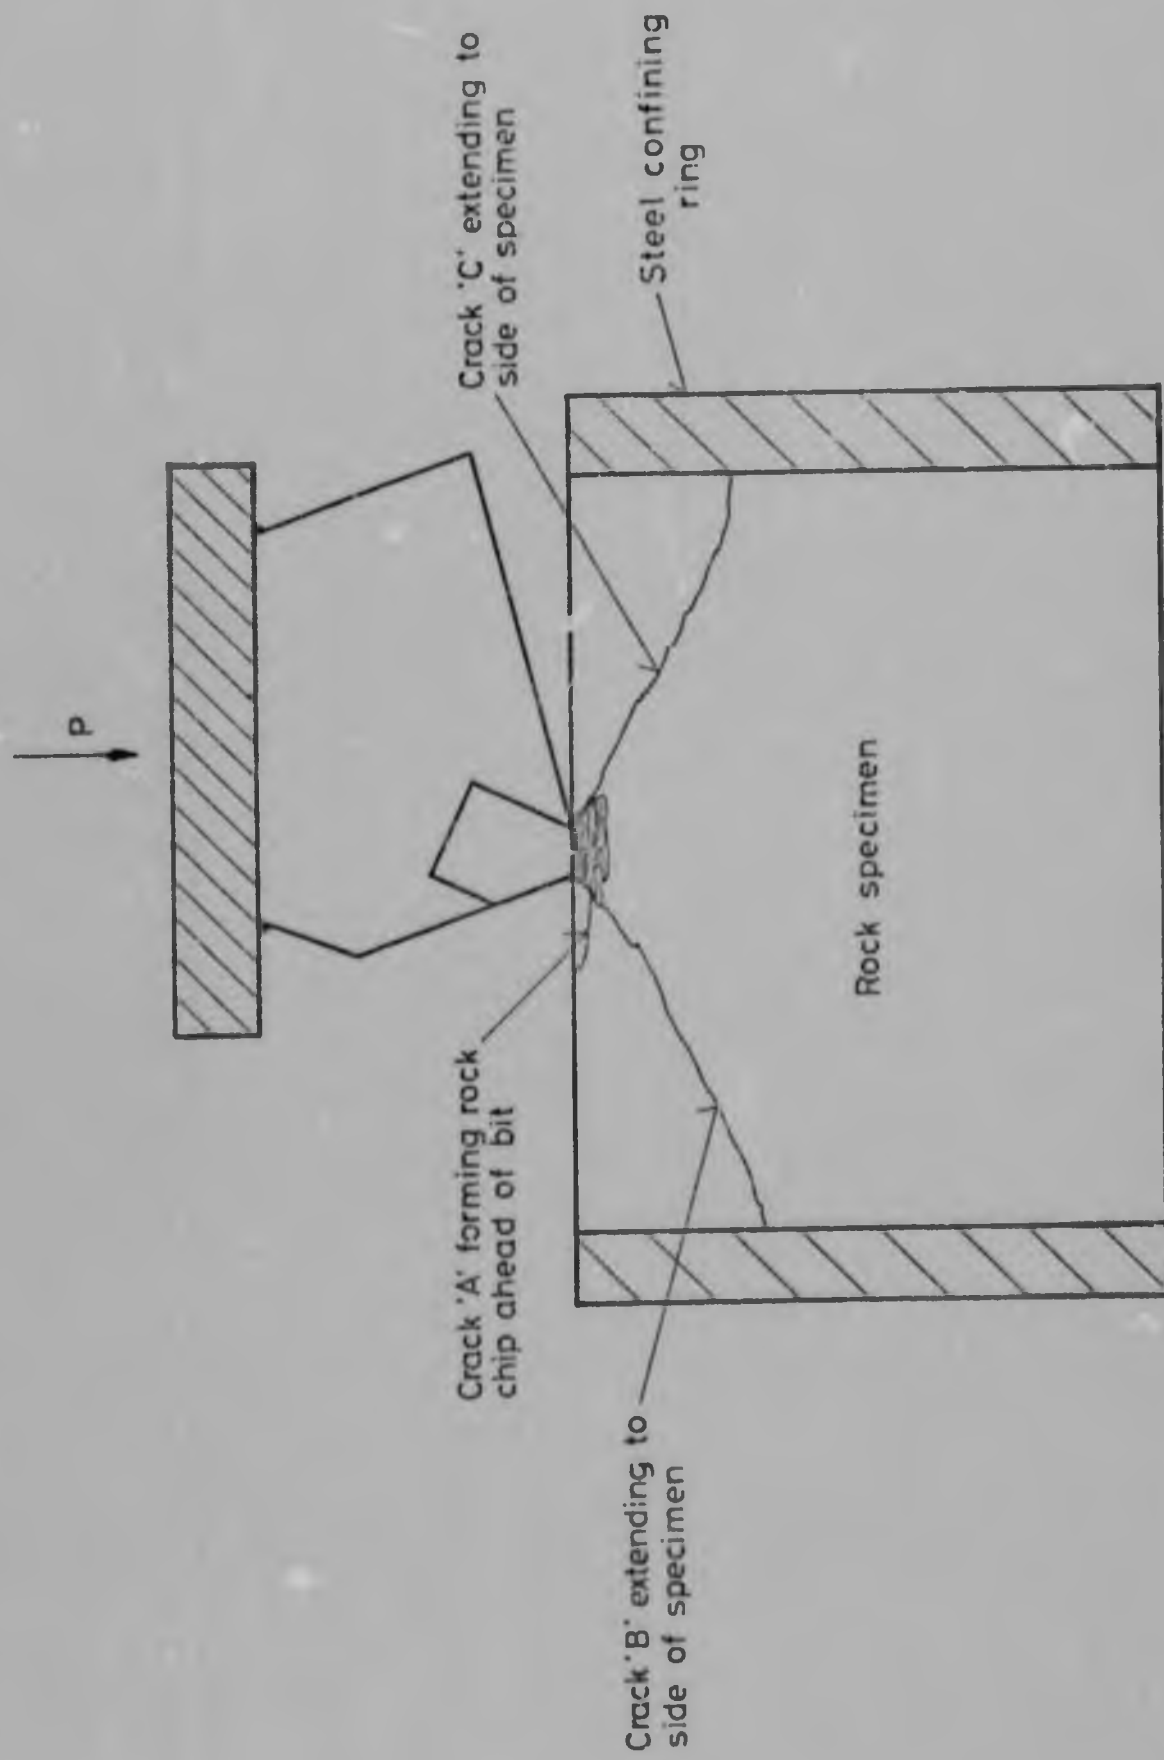
FIGURE 97 : Diagram illustrating cracks which developed as a result of the limited size of the specimen.

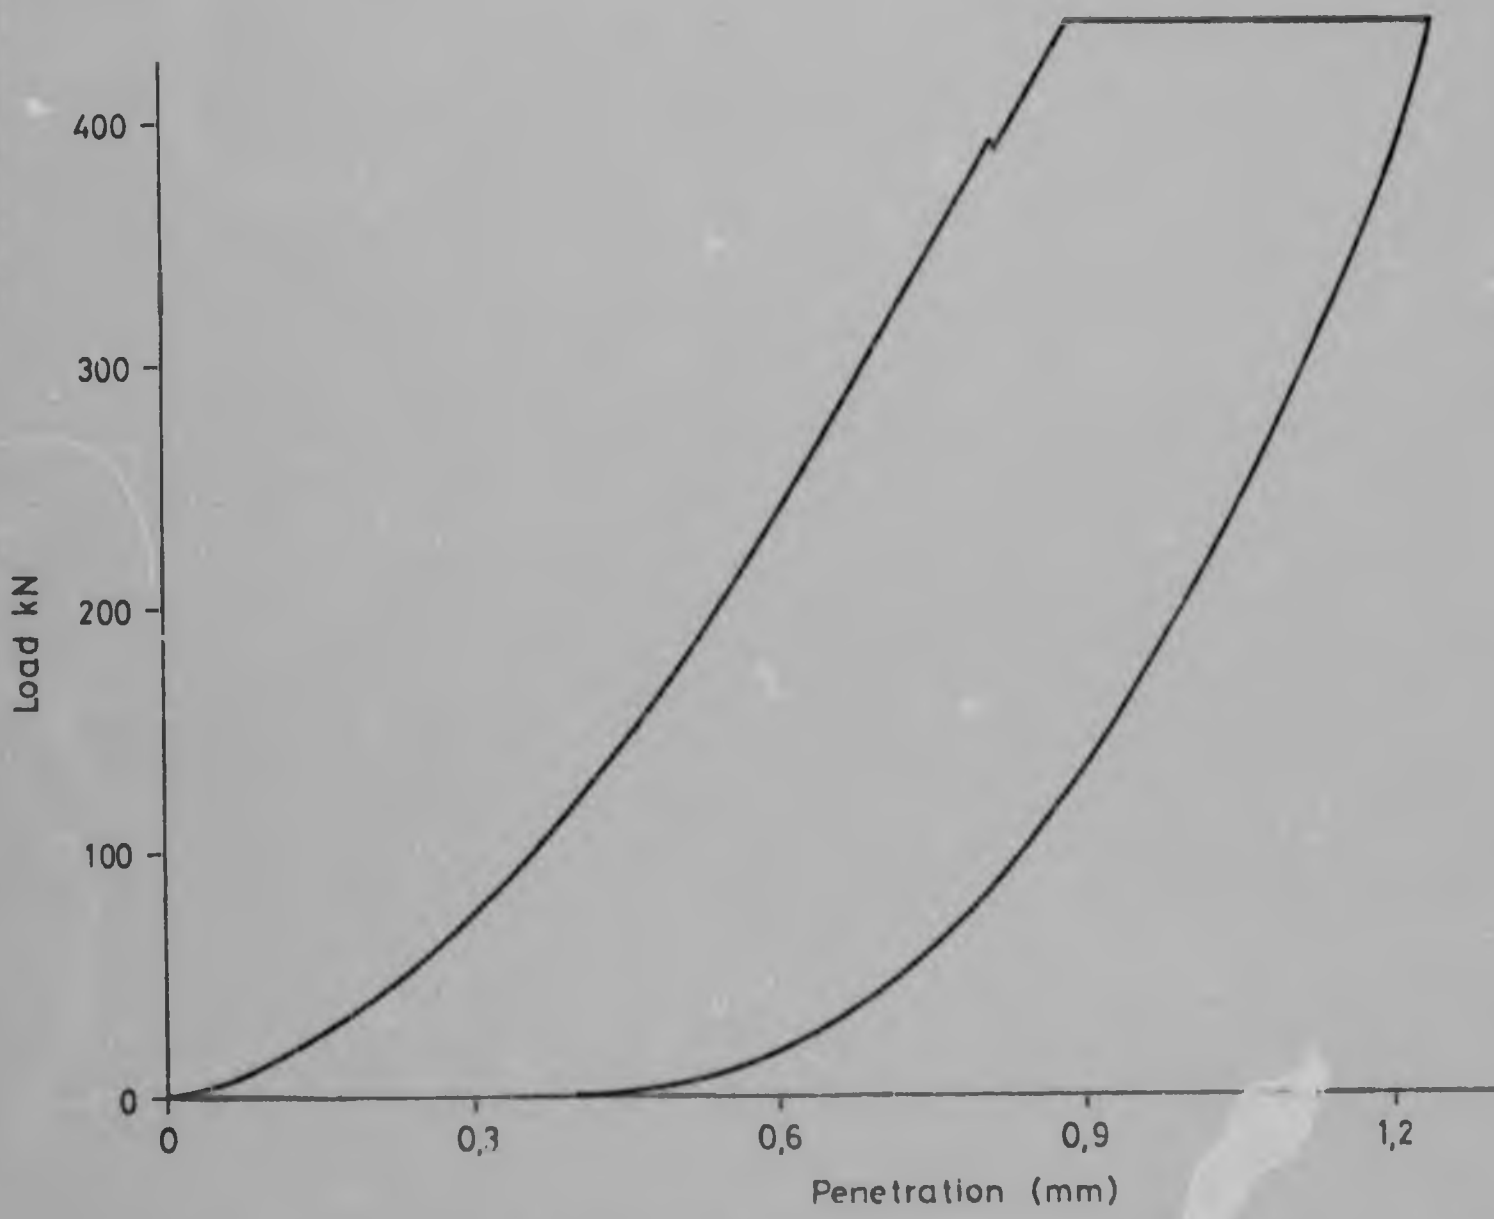
FIGURE 98: Indentation load plotted against bit penetration for first norite specimen.

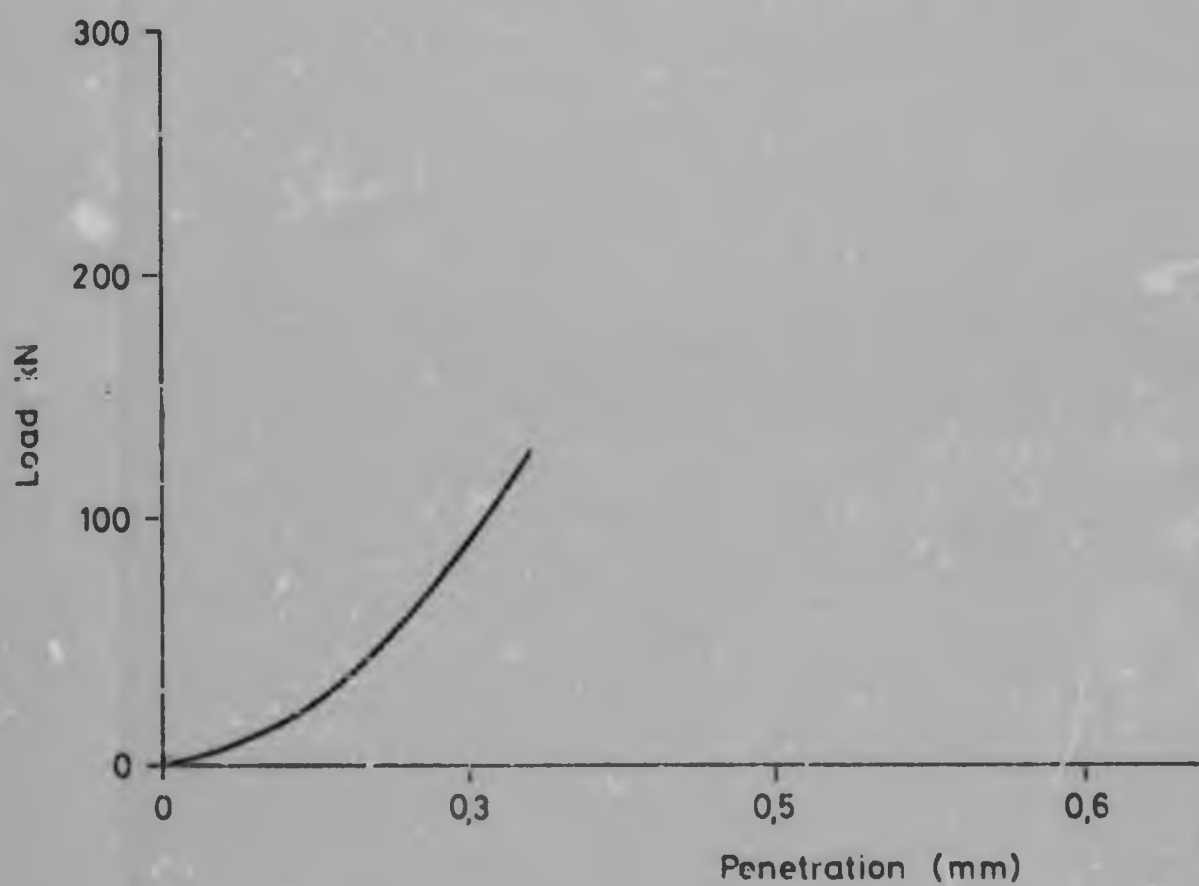
FIGURE 101 : Indentation load plotted against bit penetration for second quartzite specimen.

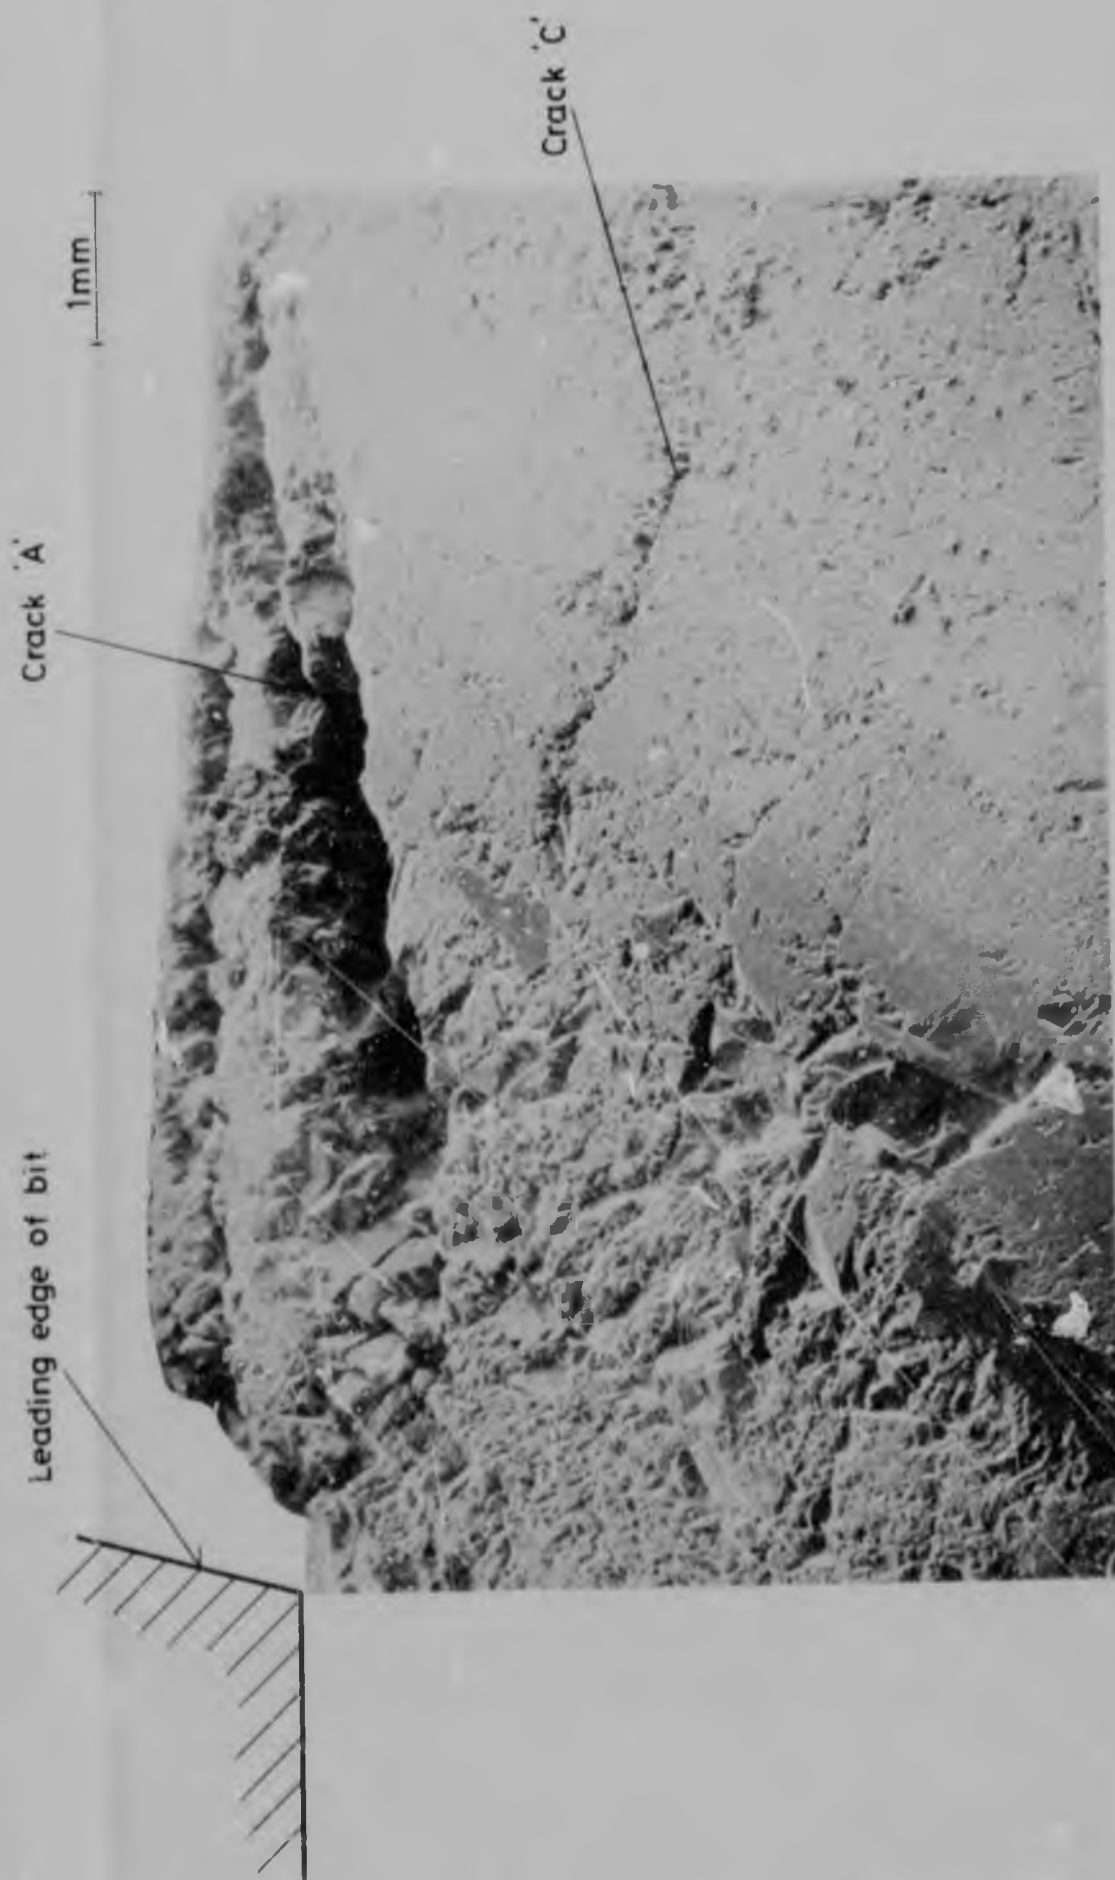
FIGURE 102 : Photo-micrograph of section through first norite specimen.

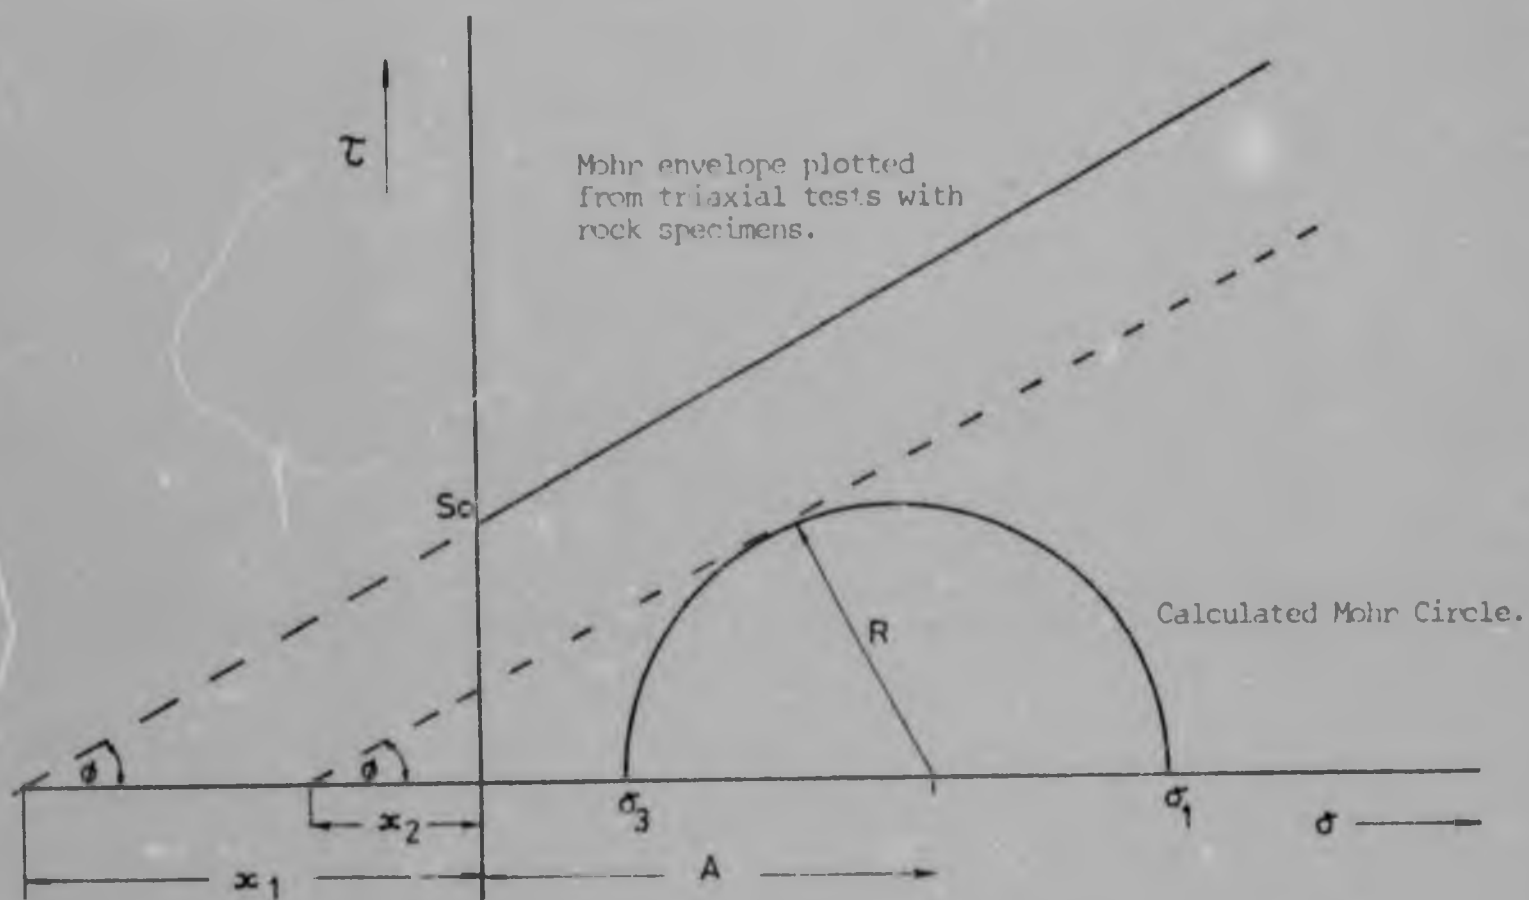
FIGURE 107 : Diagram illustrating the criterion used to determine the state of stress at points in the rock underneath an indenter.

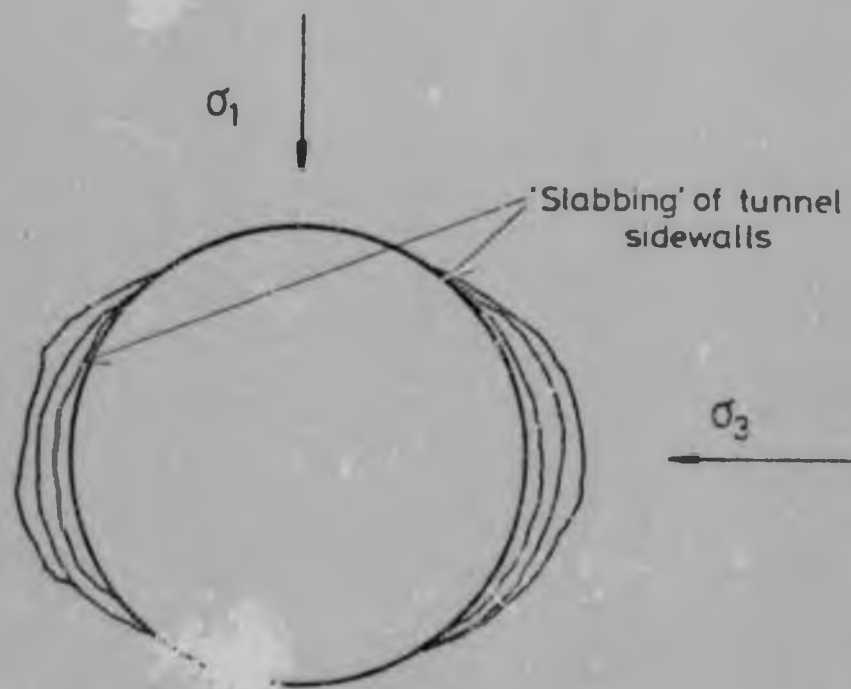
FIGURE 108 : Evidence of rock fracture parallel to the direction of the maximum principal stress illustrated by slabbing on the sidewalls of a tunnel.

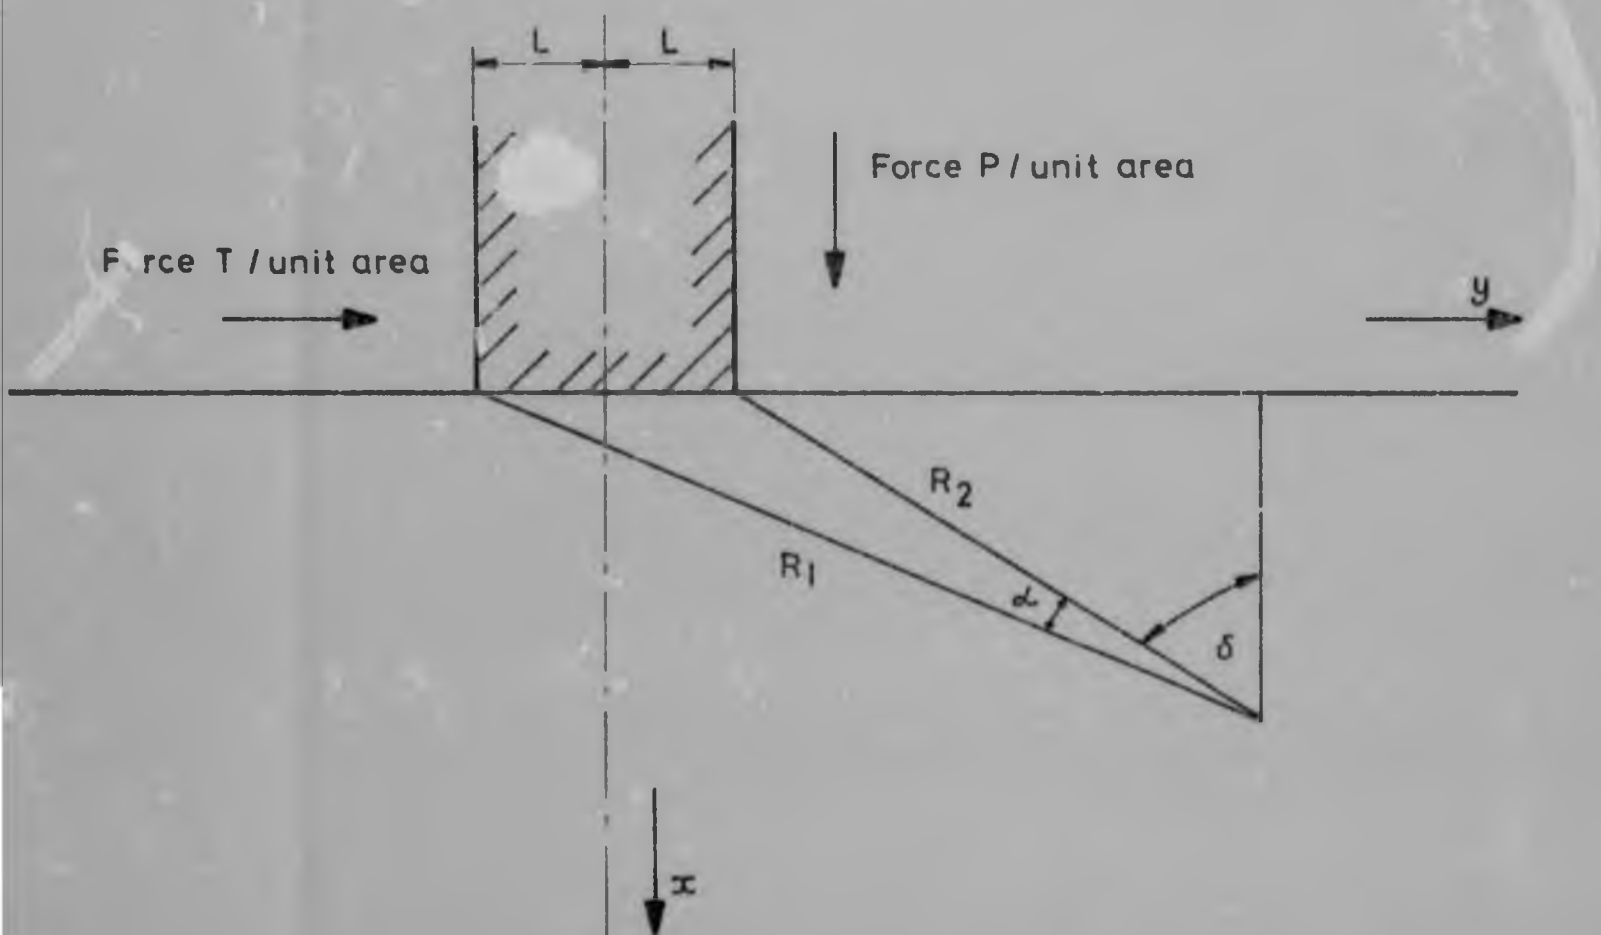
FIGURE 109 : Nomenclature for calculations of the stress induced in an elastic body when a punch is applied to the surface of the body.

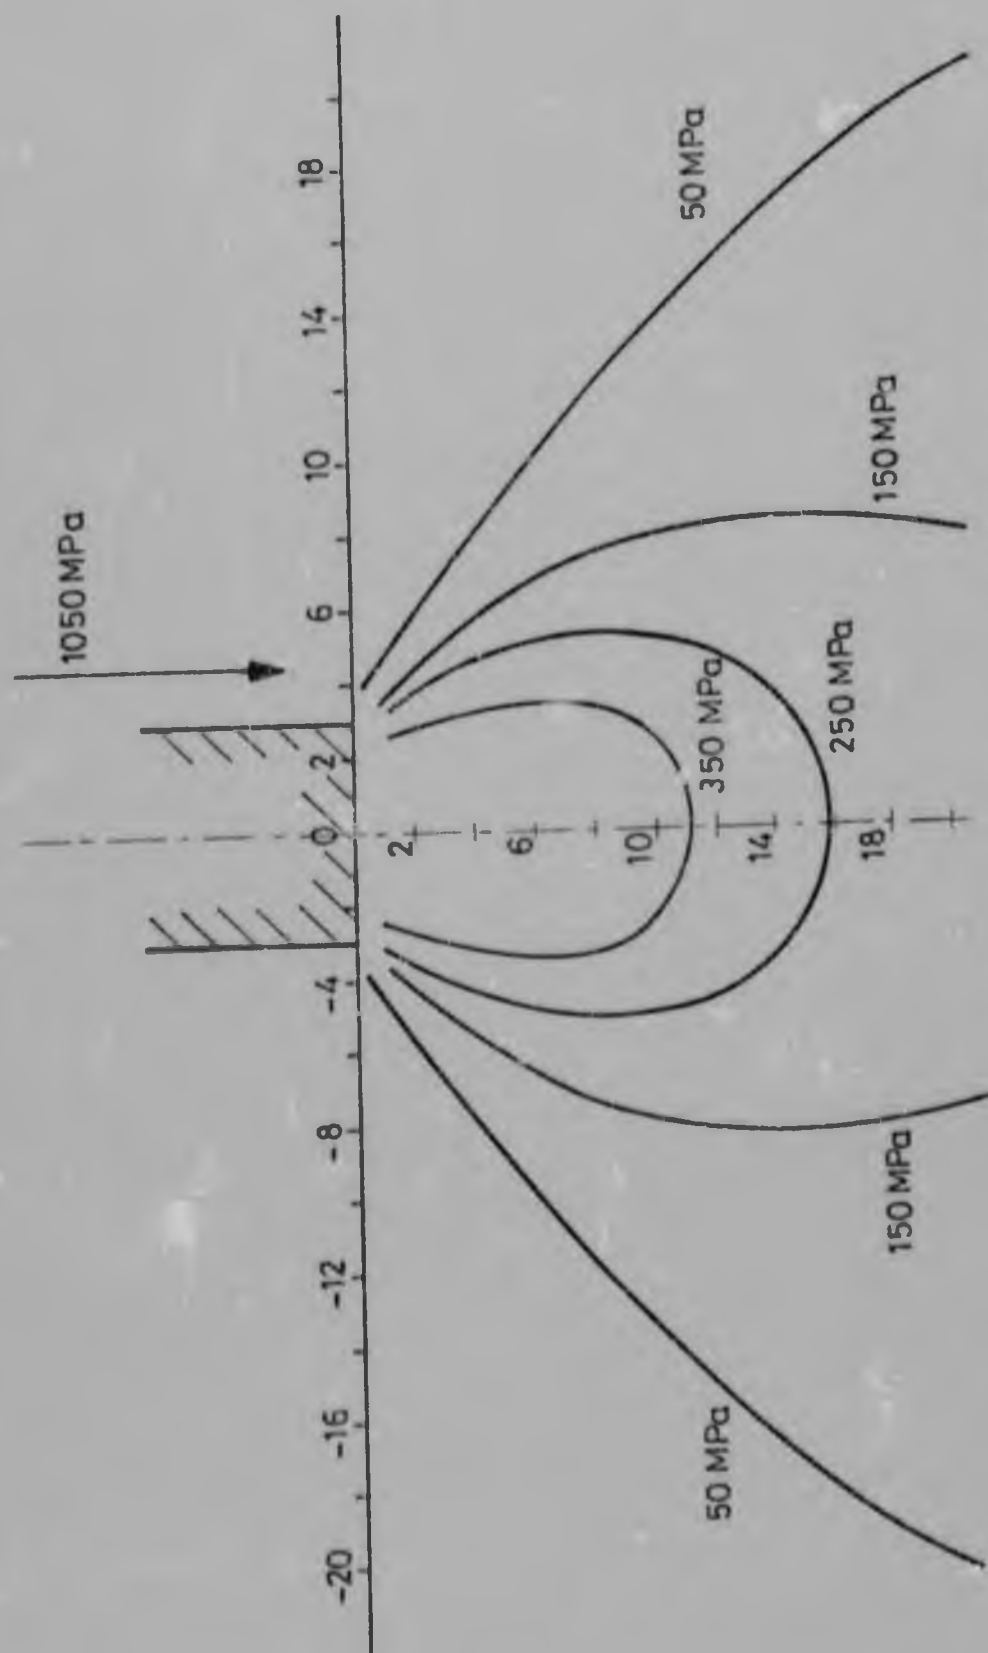
FIGURE 110 : Stress contours  $\sigma_{xx}$  when a normal pressure 1 050 MPa is applied to the surface of the body.
