A STUDY OF METHODS TO IMPROVE  
THE PERFORMANCE OF DRAG BITS USED  
TO CUT HARD ROCK.

A Thesis Submitted to the Faculty of Engineering  
University of the Witwatersrand, Johannesburg  
for the Degree of Doctor of Philosophy.

Johannesburg 1977

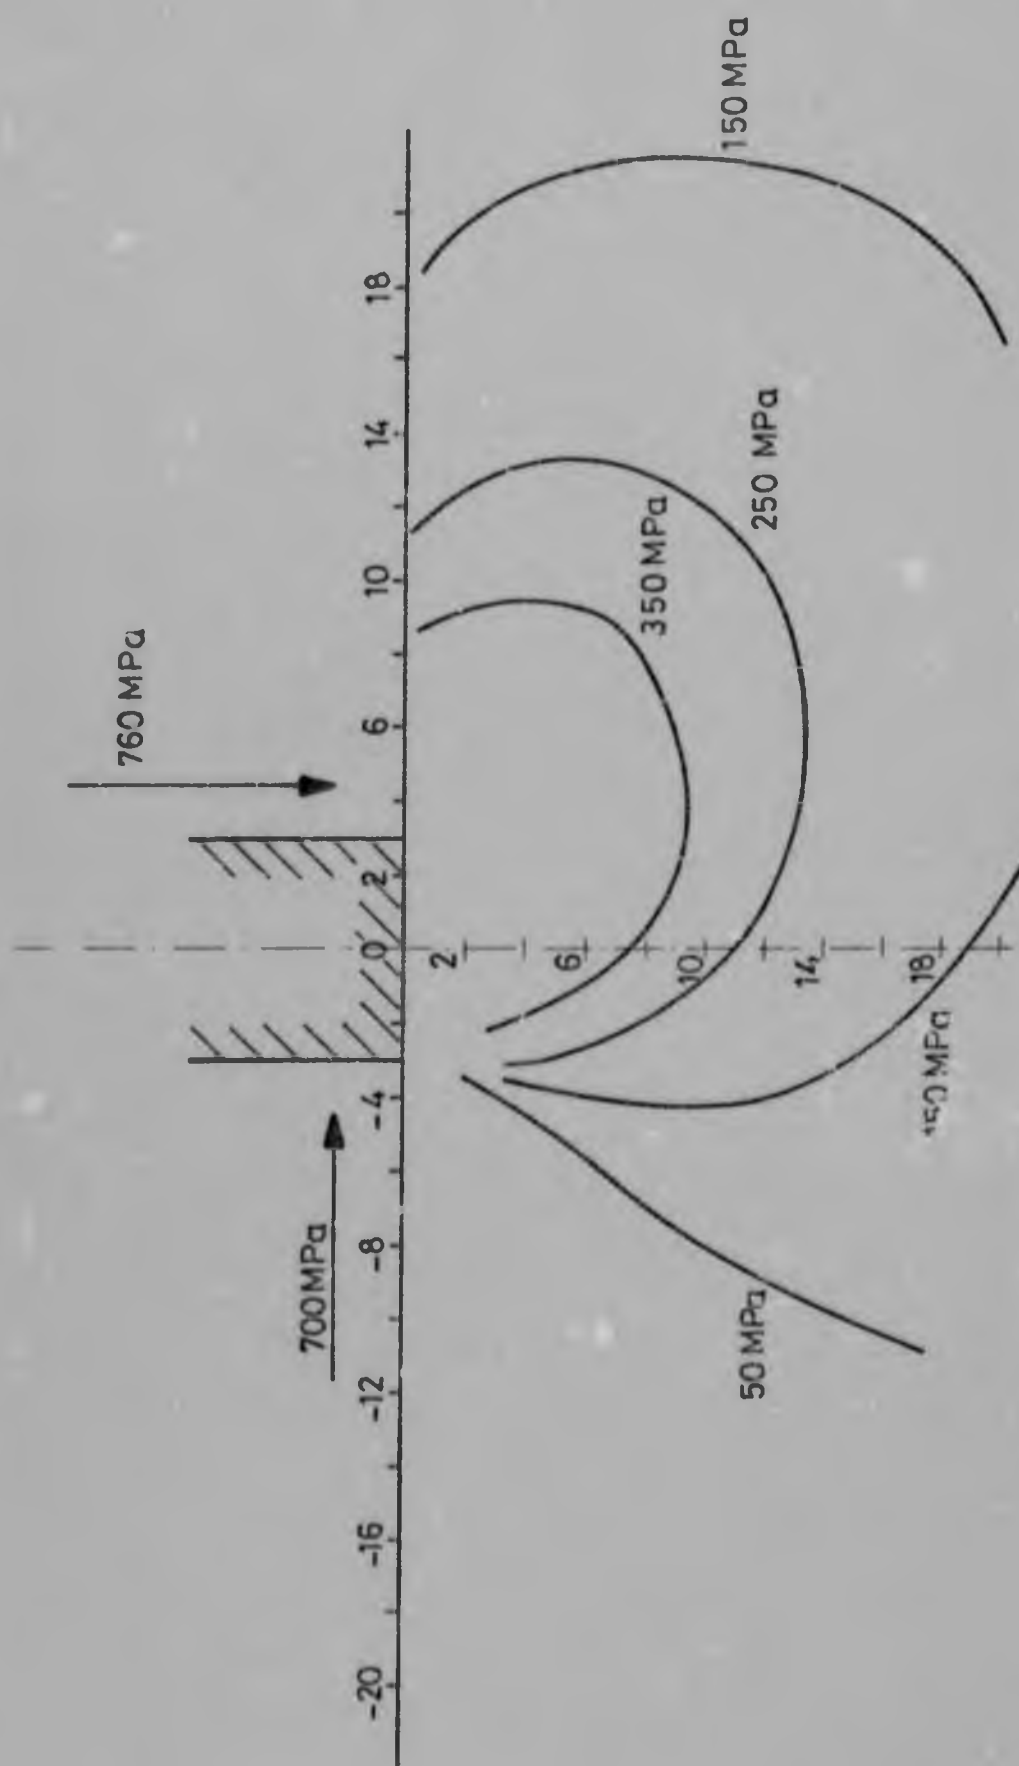
FIGURE 12 : Stress contours  $\sigma_1$  when both a normal pressure 760 MPa and a shear pressure 700 MPa are applied to the surface of the body.

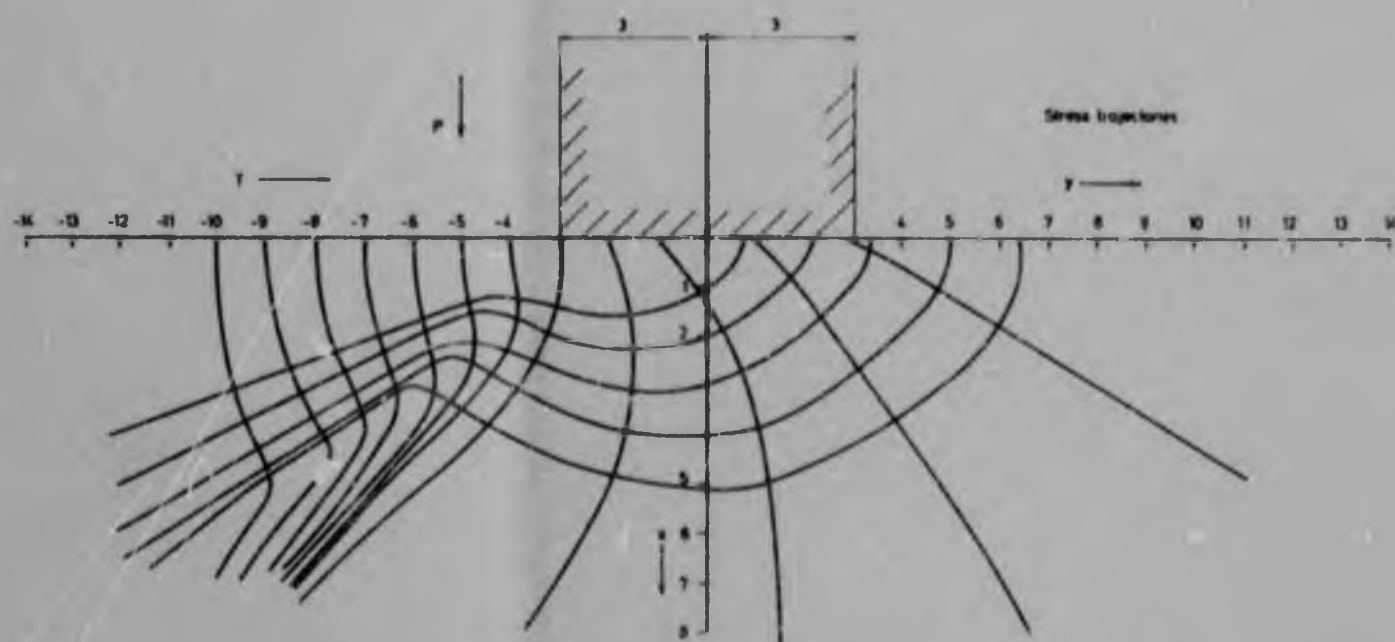
FIGURE 133 : Stress trajectories when both a normal pressure and a shear pressure are applied to the surface of the body.

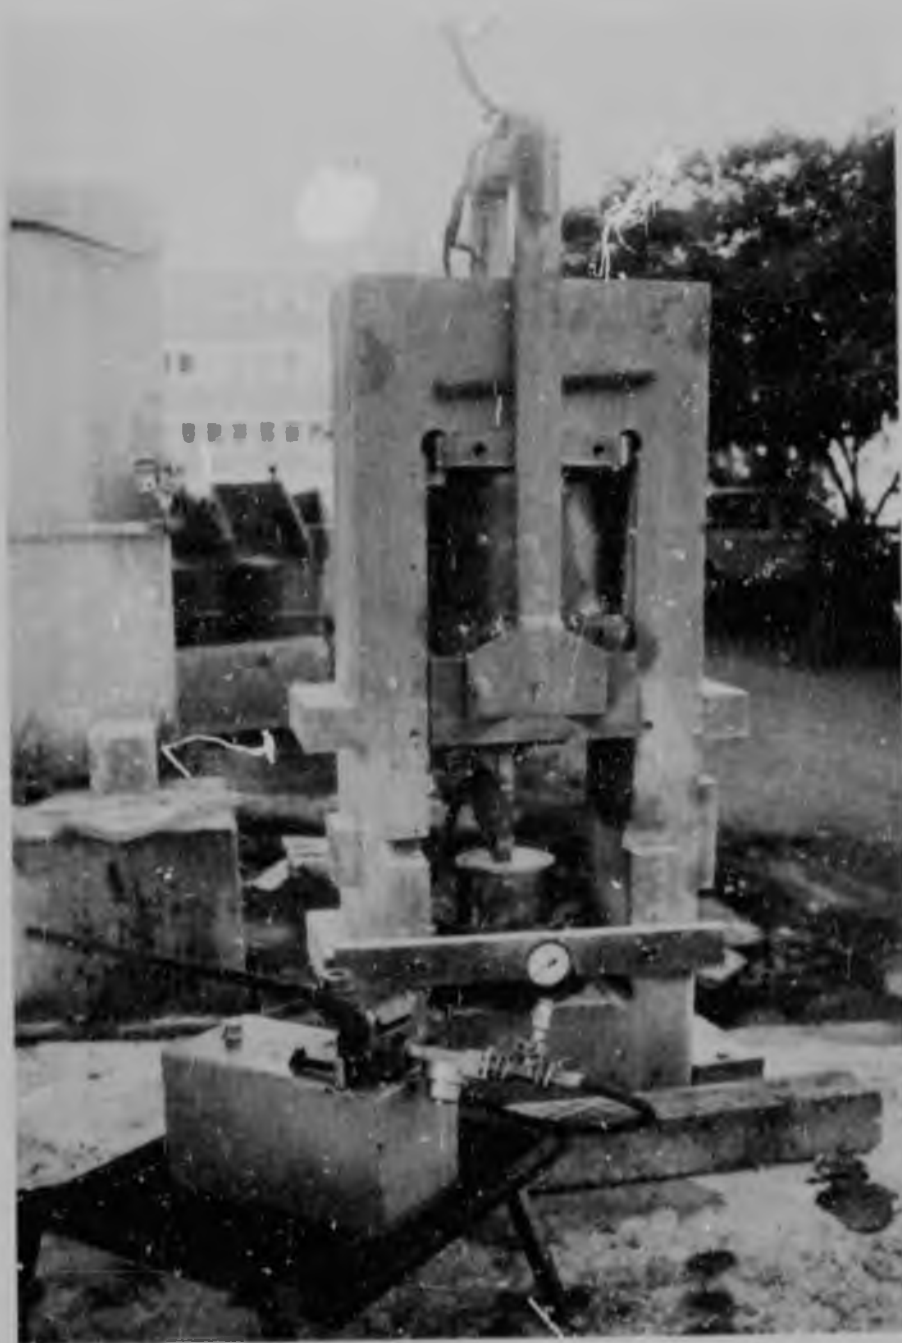
FIGURE 134 : Press used for indentation tests with high pressure water jets.

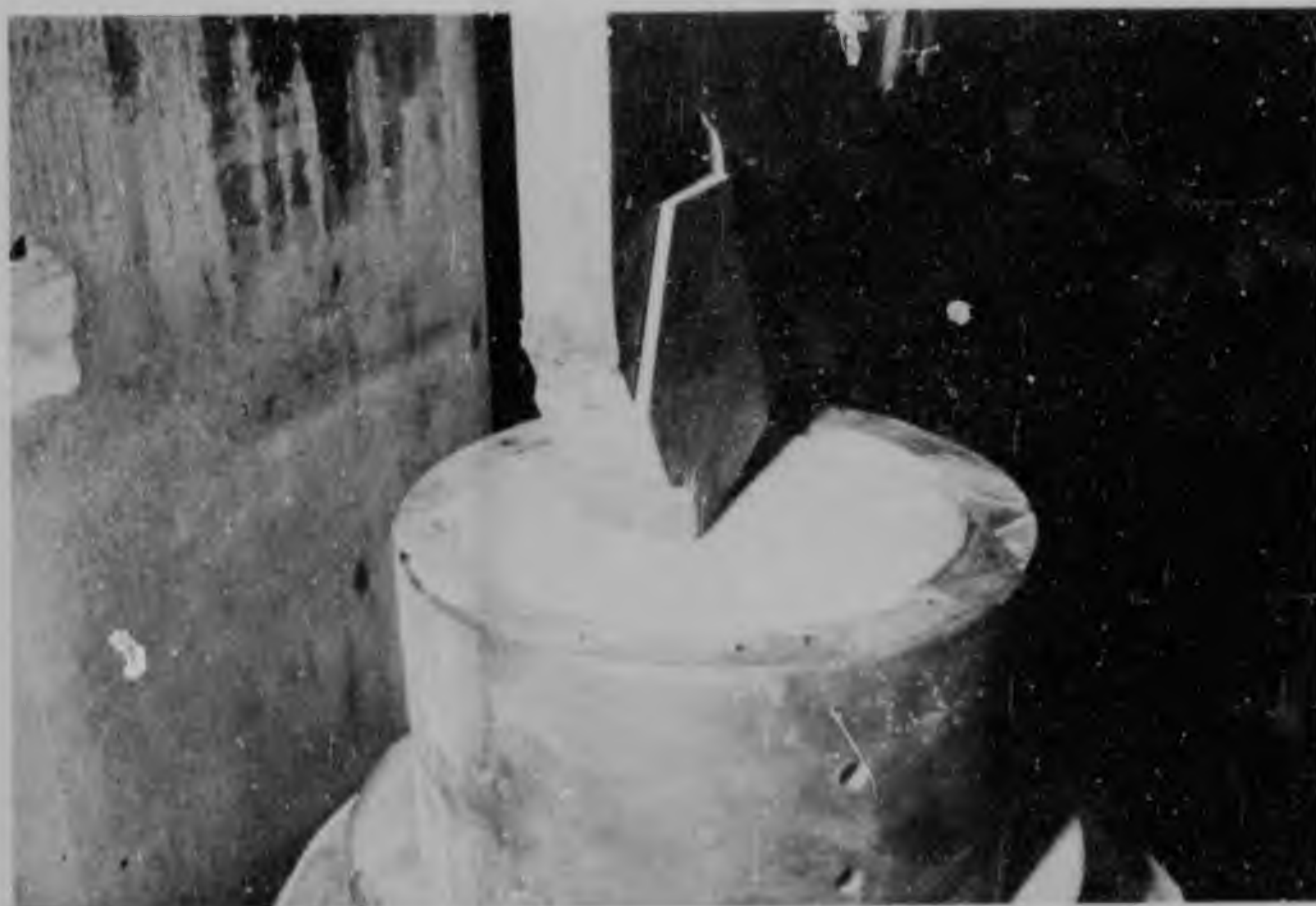
FIGURE 136 : Method of mounting bit and rock specimen in the press prior to conducting indentation tests assisted by water jets.

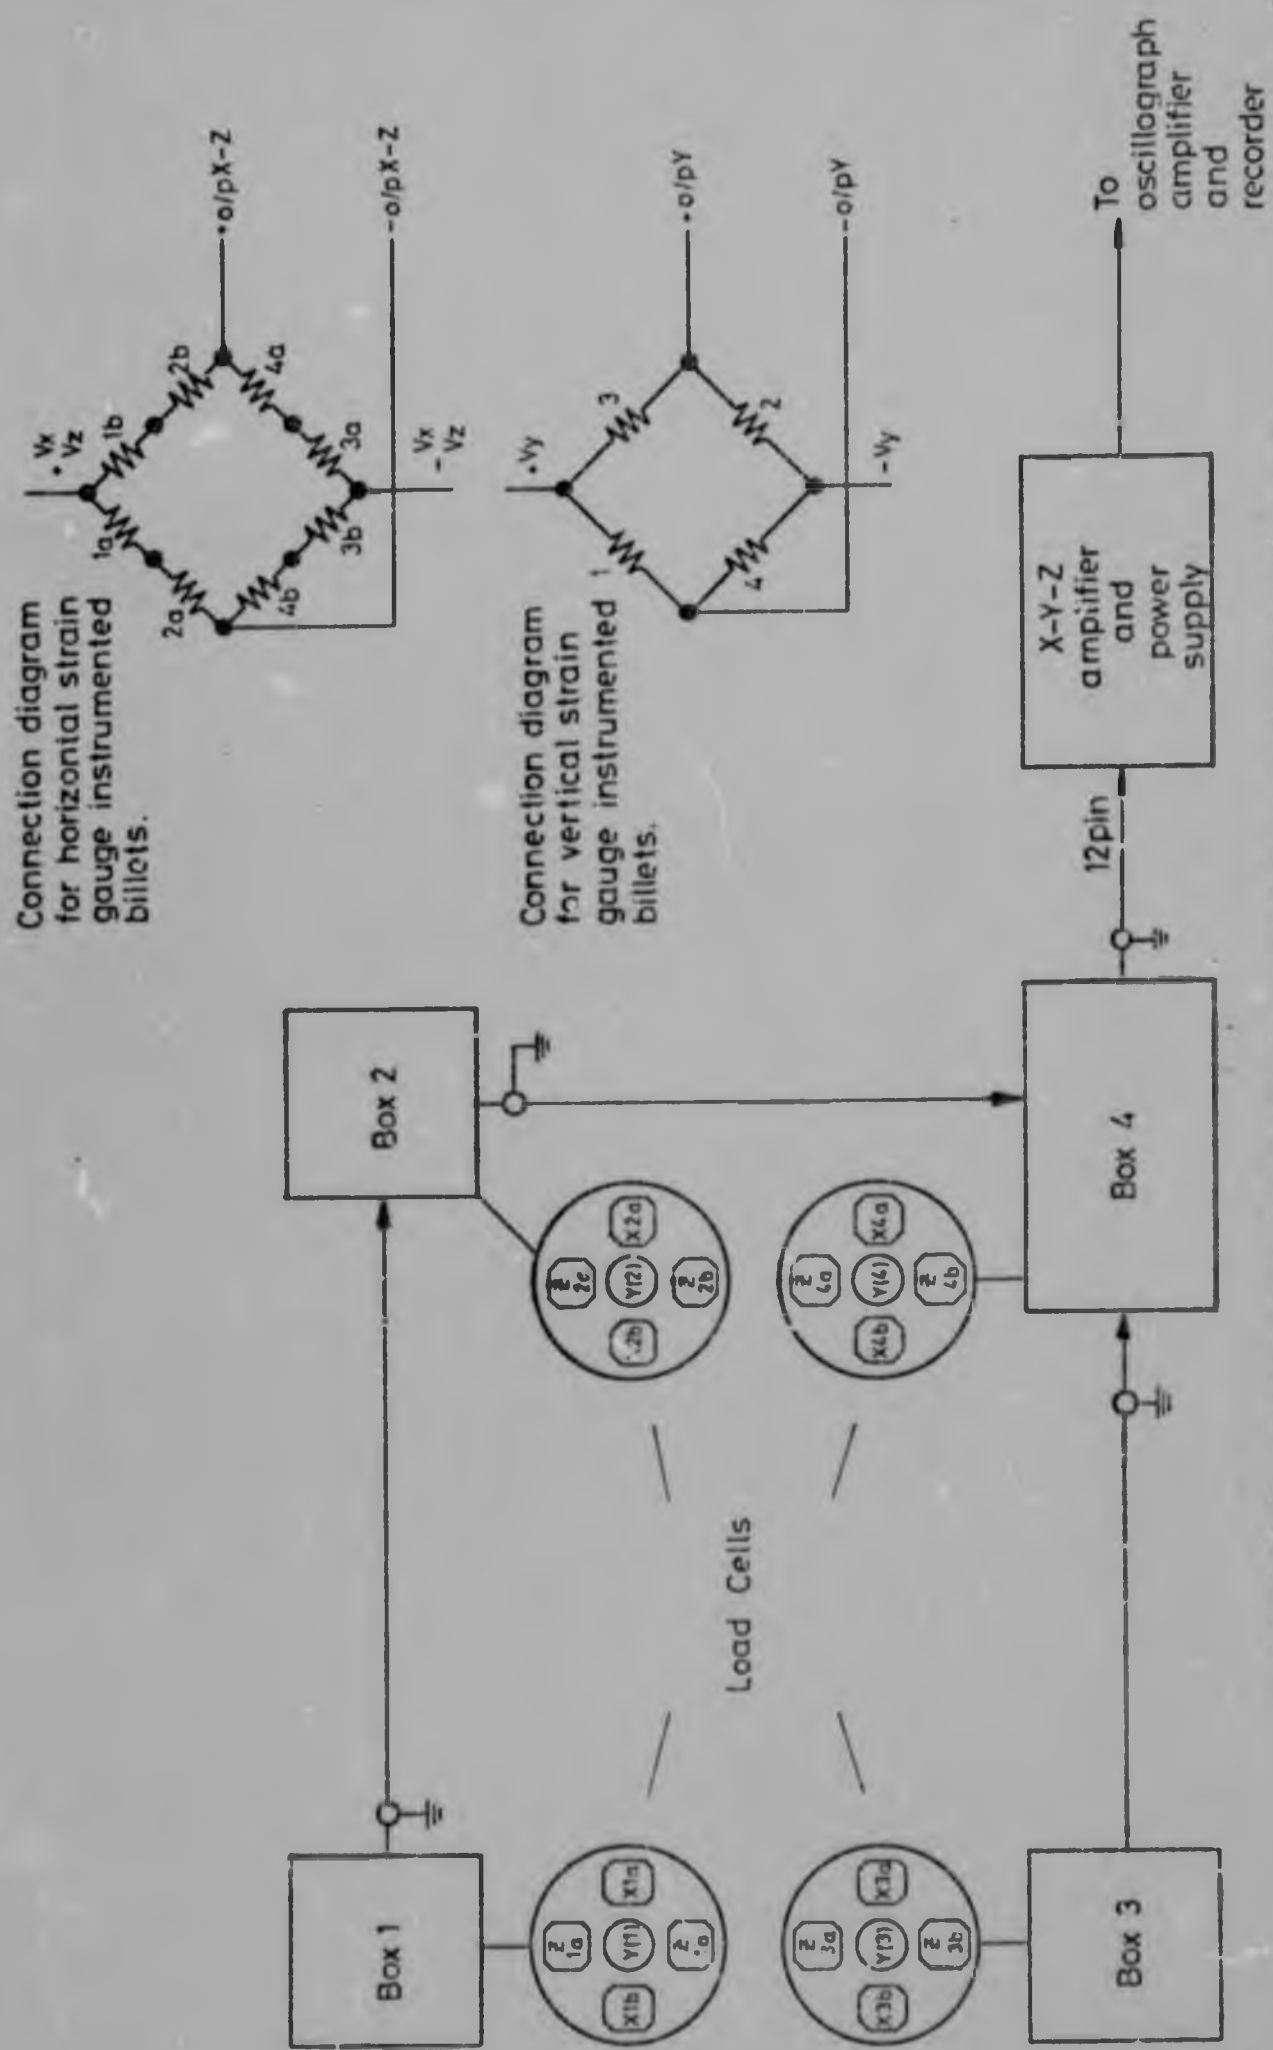
FIGURE 1.16 Instrumentation of the test frame used for experiments cutting rock.

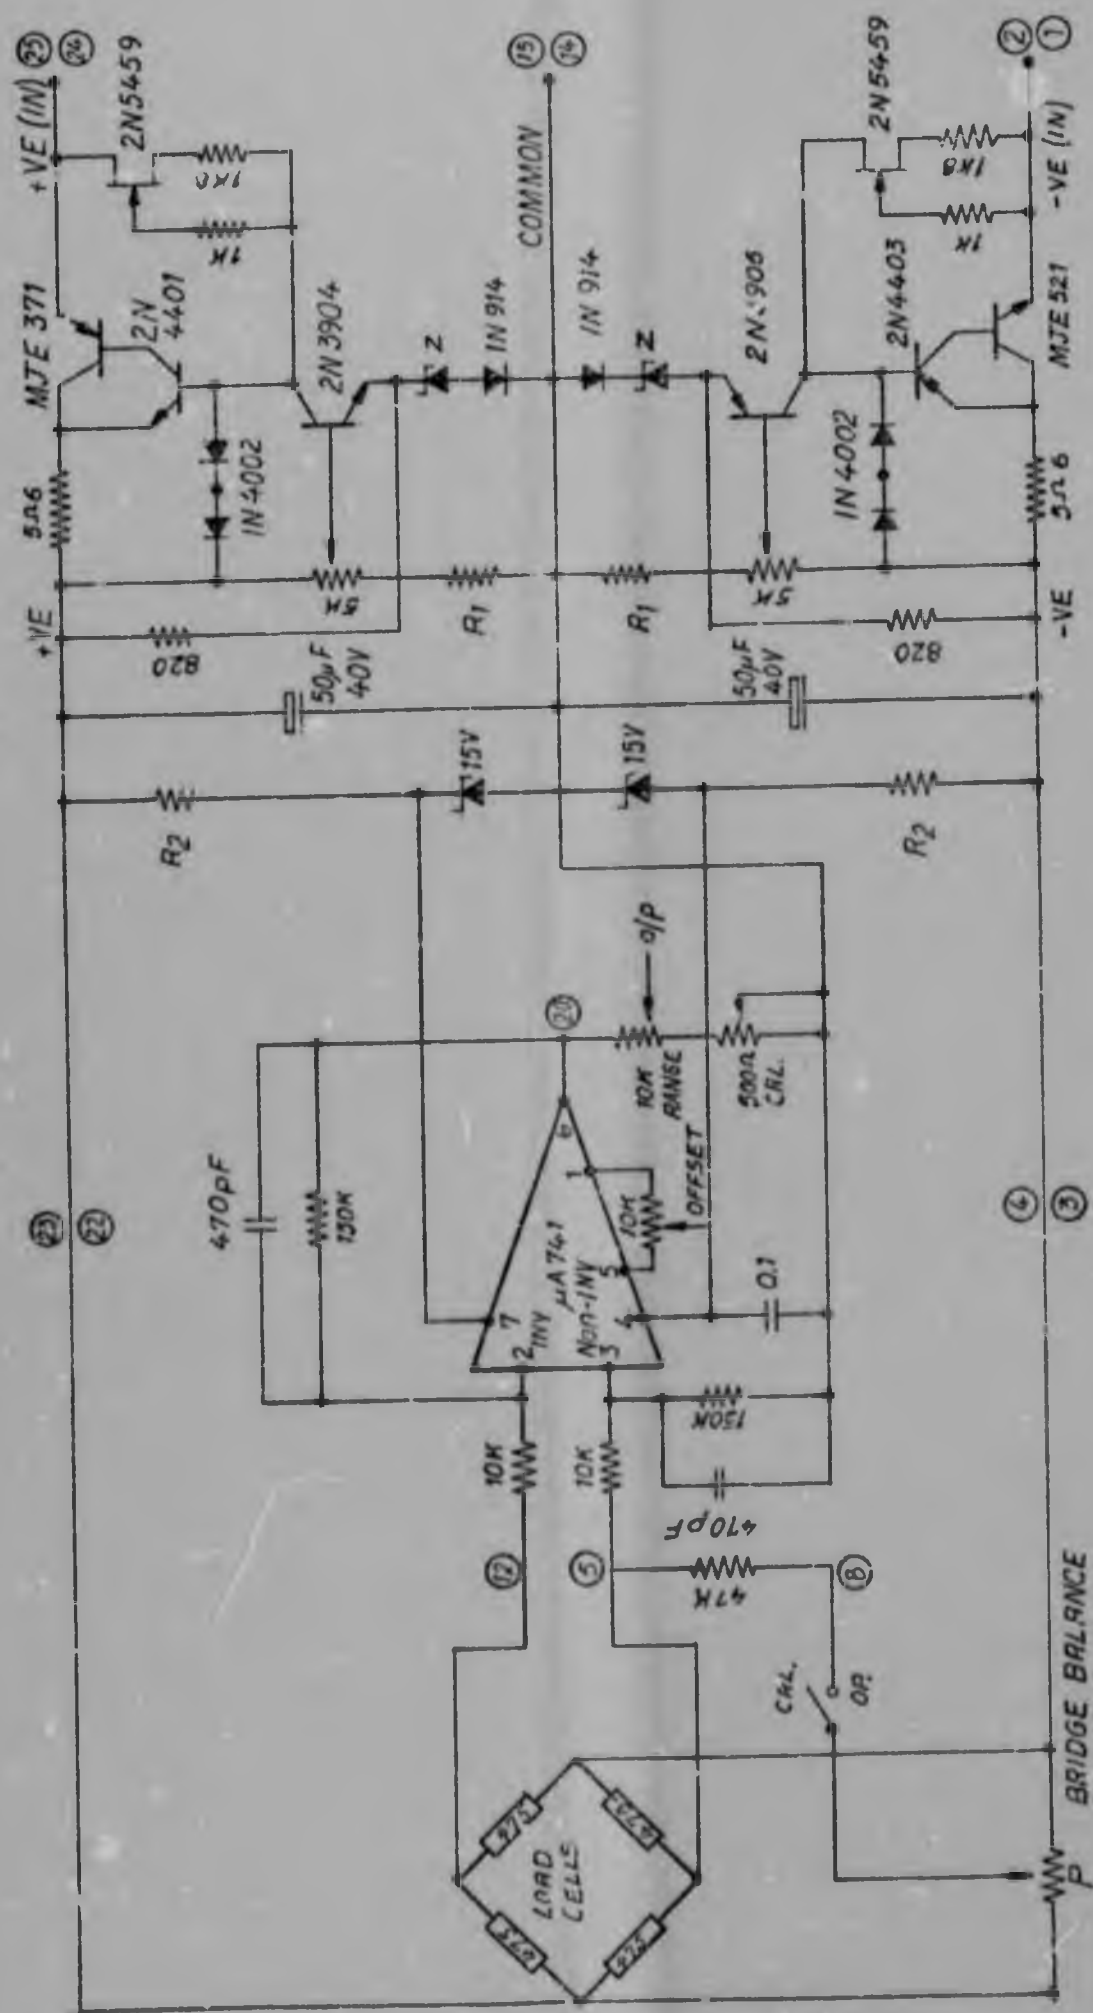
FIGURE 1.2 Pre-amplifier and bridge supply for test frame instrumentation.
