### 3 EXPERIMENTAL METHOD

#### 3.1 Test procedure

## **3.2 Experimental apparatus**

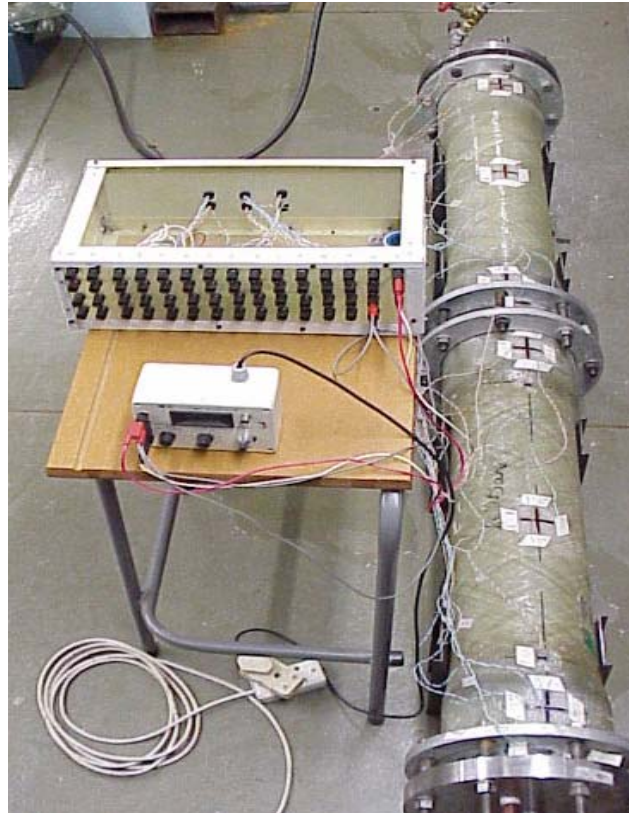
**Figure 3.1: Test set up**

A manual hydraulic pump was used to pressurize the system (Figure 3.1).

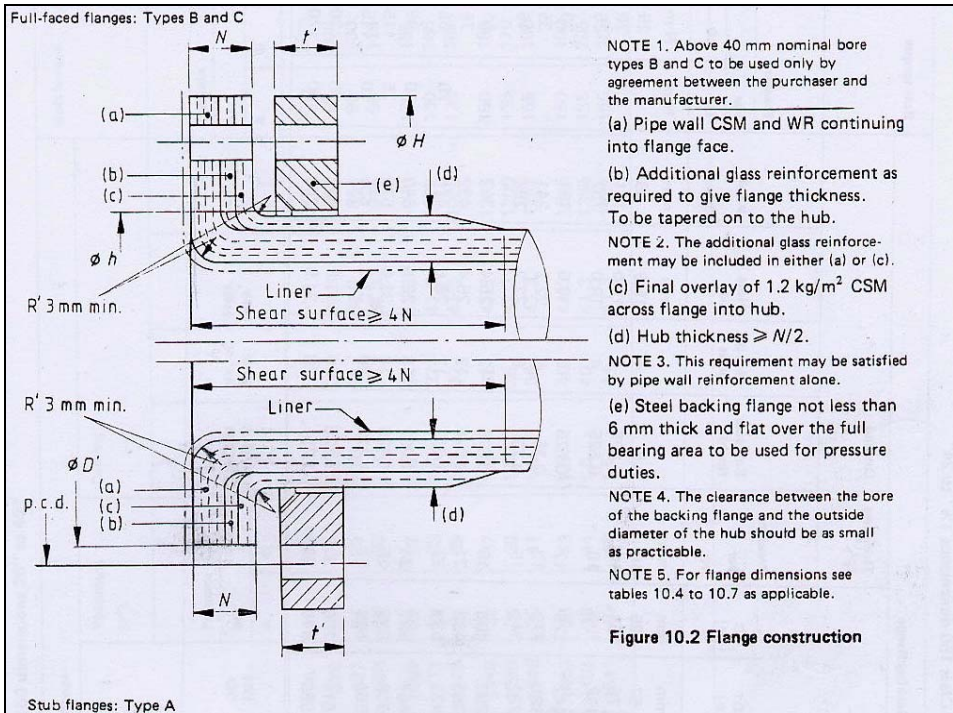
Figure 3.2: Pipe flange specifications<sup>(3)</sup>

The total thickness of the hub flange was calculated by adding up the thickness of individual chopped strand mat laminae. The thickness of the stub was determined taking into account the fact that the hub flange thickness must be less than  $N/2$ .  $N$  stands for the hub flange thickness (Figure 3.2). The resin material properties and catalyst specifications supplied by NCS Resins are listed in table B.1 and B.2. The

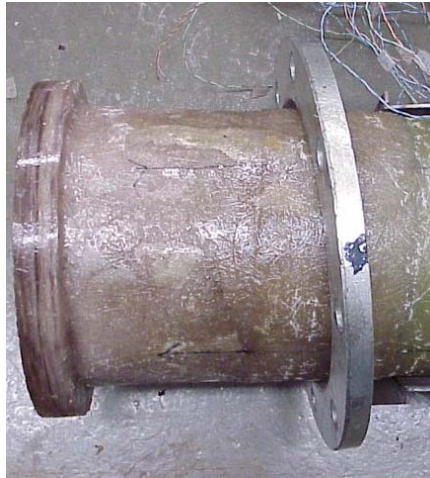
**Figure 3.3: 10 bar fabricated flange**

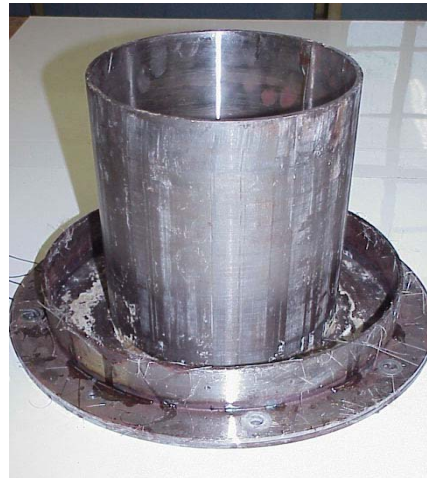
**Figure 3.4: Pipe flange mould**

The manufacturing procedure of flanges as presented below was done using the hand lay-up method<sup>(3)</sup>. First, a resin rich glass fibre corrosion resistant veil layer (C-veil) was laid into the gel-coated mould (Figure 3.4). Then reinforcement layers (chopped strand mat) impregnated with the conditioned resin were applied by hand. Rollers and brushes were used to compact and to consolidate the reinforcement. This ensured a uniform distribution of the materials and removed air bubbles from the structure. This process was done with caution in order to avoid breakage and random distribution of reinforcement especially at the flange radius. Note that poor and inconsistent fibre content at the heel and neck of the flange can detrimentally affect the reliability of the joint by introducing unfavourable localized residual thermal stresses at the curing stage<sup>(4, 6)</sup>. After completion, the flange was allowed to cure at room temperature for 24 hours, and the post-curing process was done at 80 °C for 24 hours. The flange was machined to get the required shape and size as specified at the design stage (Figure 3.3). All machined flanges were covered with a thin layer of pure resin to ensure a complete external corrosion barrier. The NCS 993 PA resin was conditioned and cured according to the recommendations provided by the supplier.

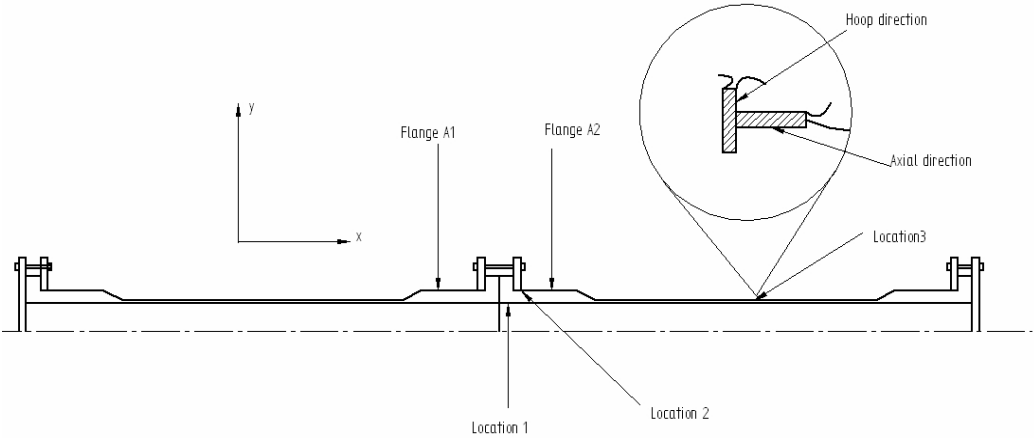
In practice, there was no way to attach the strain gauges exactly at the neck of the stub-flange where high stress concentrations were predicted. The strain gauges could not be allowed to bend at ninety degrees. In addition, the backing ring tended to crush the electrical leads during the joint assembly stage. Therefore, it was decided to position the strain gauges above the backing ring as shown in figure 3.5.

**Figure 3.5: Strain gauge locations**

The pressure test consisted of pressurising pipe flanges using tap water as the test medium. The test methodology was designed according to BS5480: 1990 and ASTM D F 37. BS 5480:1990 was used to define the requirements and the hydrostatic pressure test procedure, whereas ASTM D F 37 was used to evaluate the leak tightness of the pipe joint. Flange specimens fabricated at the RP/Composites Facility (University of the Witwatersrand, Johannesburg) and specimens supplied by Amitech were evaluated. The test specimens consisted of pipe pieces with stub flanges and steel backing rings on both sides (Figure 3.1). This configuration allowed simultaneous testing of two similar flanges. The end-sealing devices were steel stoppers. Test specimens were strain gauged according to figure 3.5. The specifications of the flange specimens are listed in table 3.1.

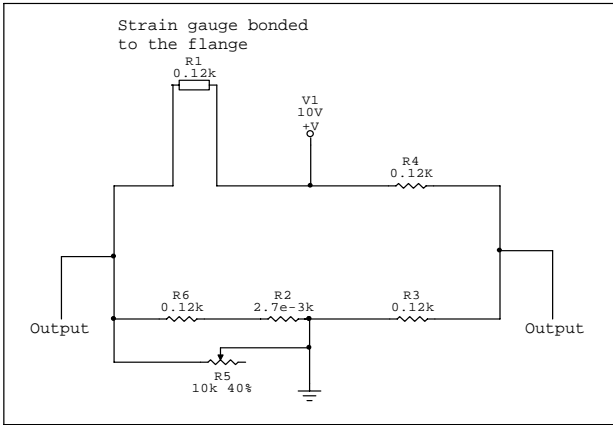
The principal of unbalanced bridges is that once strain gauges are bonded onto the specimen, the bridges are adjusted for zero readings under no load conditions. As the system is loaded, the bridges must be allowed to go to out of balance states. The output readings displayed for the out-of balance conditions are taken to represent the strain experienced by the test specimen. The strain meter was connected to an IEM strain gauge amplifier to obtain readable signals (Figure 3.8). The circuit diagram of the Wheatstone bridge made for this purpose is presented below.

Figure 3.6: Unbalanced Wheatstone bridge

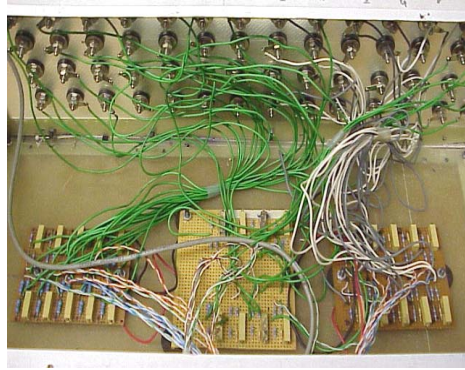
**Figure 3.7: Wheatstone bridge**

Strain measurement can be achieved by mean of balanced and unbalanced bridges. Although balanced bridge systems have the advantage of a wide strain range, which is obtained by means of adding or subtracting standard resistors to the circuit, significant time is required to balance the circuits. Unbalanced bridges do not suffer from this disadvantage (Figure 3.6). For this reason, an unbalanced bridge was used in this project. A strain meter fitted with twenty-eight input channels was used to record the strain variations (Figure 3.7).

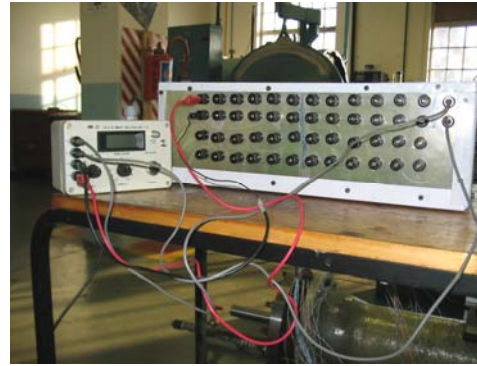
**Figure 3.8: IEM amplifier**

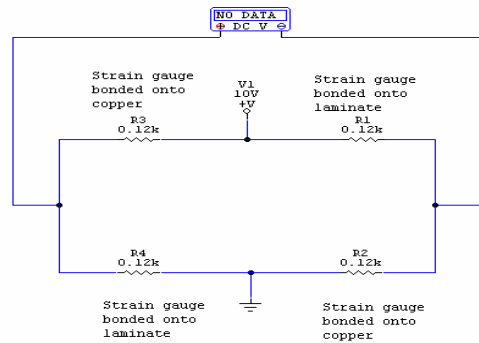
- Linear strain gauges connected to a full Wheatstone bridge were bonded onto the laminates and copper specimens (Figure 3.9). The IEM amplifier was adjusted to display zero volts for all bridges at the initial temperature (30.0°C).
- The temperature was increased slowly and gradually up to 60.0°C. The test specimens expanded due to thermal effects. Amplifier readings were recorded at five different temperatures ranging between 30.0 and 60.0°C.
- The strain gauge arrangement used for this purpose allowed the amplifier to display the global thermal strain experienced by both laminate and copper specimens. Therefore, the thermal strain experienced by the laminate specimen was expressed as

**Figure 3.9: Full bridge circuits**

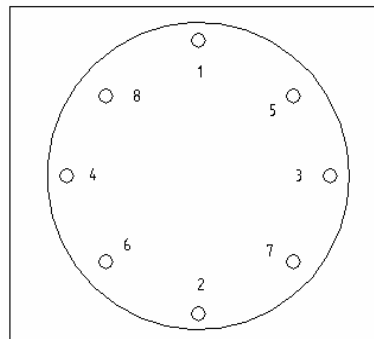
**Step 1:** Each bolt was tightened progressively and continuously to 30%, and then to 60 % of its full required torque.

**Step 2:** At least one final full torque was applied to all the bolts in a clockwise direction to ensure the same required bolt load and a uniform distribution of flange pressure upon the gasket.

**Figure 3.10: Bolt tightening sequence**

- Using acetone, all traces of greases were removed from the seating surfaces of the gasket, and fine sand paper was used to clean the bottom faces of the stub-flange;
- Bolts and nuts were lubricated to minimize the effects of thread friction, thereby ensuring that the torque energy stretches the bolts in tension efficiently;
- Consistent flange pressure and correct initial bolt load magnitude were ensured by using a calibrated torque wrench in multiple steps, and by following the sequence shown in figure 3.10.
