Polishing Porcelain

A Note on New Rotary Abrasive Tools

C.F. Valcke

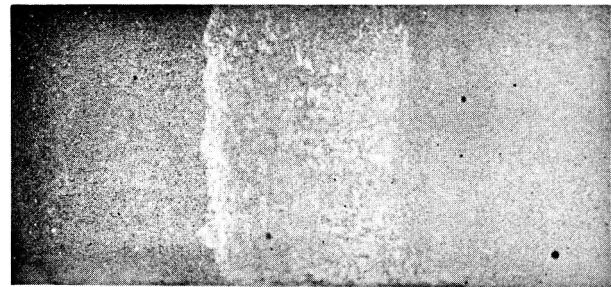
Fig. 1. Surface of porcelain specimen (2 cm x 1 cm).
 Left - glazed area
 Centre - ground area
 Right - polished area (note porosity).

of the porcelain was then ground over two-thirds of its area, using a coarse cylindrical abrasive point and subsequently half of the ground area was polished with the abrasive wheels. Thus the prepared specimen had a surface showing, at one end, the original glaze, at the other end, the polished area, and, in the centre, a ground area (fig 1). The surface of the specimen was then examined with a Taylor-Hobson Talysurf Model 3 surface roughness measuring machine which makes it possible to make a quantitative assessment of the surface roughness.

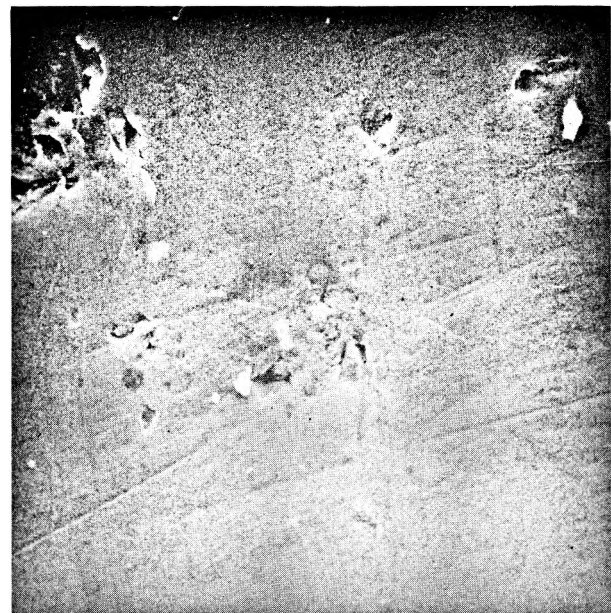
Fig. 2. Electron micrograph, polished commercial denture tooth, showing porosity. Area shown 100 x 100 micrometres.

Scanning electron micrographs of the ground and polished teeth showed a smooth surface with a few linear scratches and occasional defects due to porosity of the porcelain (fig 2). These micrographs were considered relatively uninformative. On the other hand the porcelain specimen which was examined with the surface roughness measuring machine showed that no appreciable surface defects were evident in either the glazed or polished areas (figs 3 and 5). In contrast to this the trace of the central (ground) area showed marked surface irregularities, some were of the order of four micrometres (fig 4). In figs 3, 4 and 5 the horizontal magnification is 100 x and the vertical magnification 1000 x. The distance between the straight horizontal lines therefore represents two micrometres.

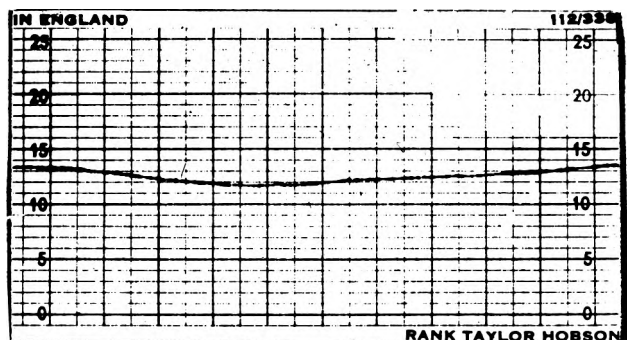
Fig. 3. Trace of glazed area in fig 1 produced by surface roughness measuring machine.

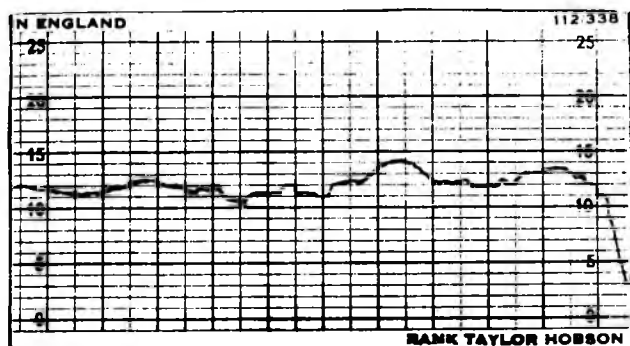
Fig. 4. Trace of ground area in fig 1 produced by surface roughness measuring machine.

and breadth of surface irregularities, but not their depth. It is for this reason that the scanning electron micrographs were considered relatively uninformative. In contrast to this the machine used for surface roughness measuring of the specimen demonstrated the depth of the irregularities in the ground area and showed that the finish in the polished area was comparable to the original glaze.

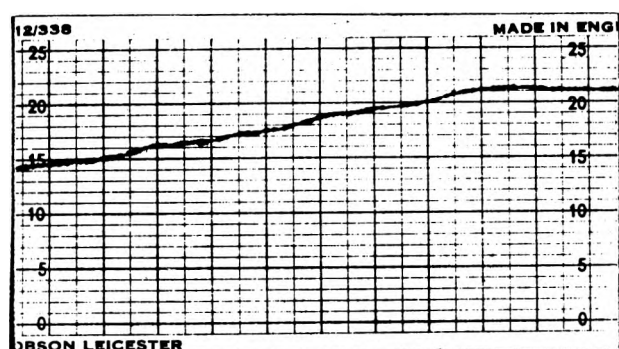
Fig. 5. Trace of polished area in fig 1 produced by surface roughness measuring machine.
