## On the Sixth Mechanism of Lightning Injury

On the sixth mechanism of lightning injury

A thesis submitted to the Faculty of Engineering and the Built Environment, University of the Witwatersrand, Johannesburg, in fulfilment of the requirements for the Degree of Doctor of Philosophy.

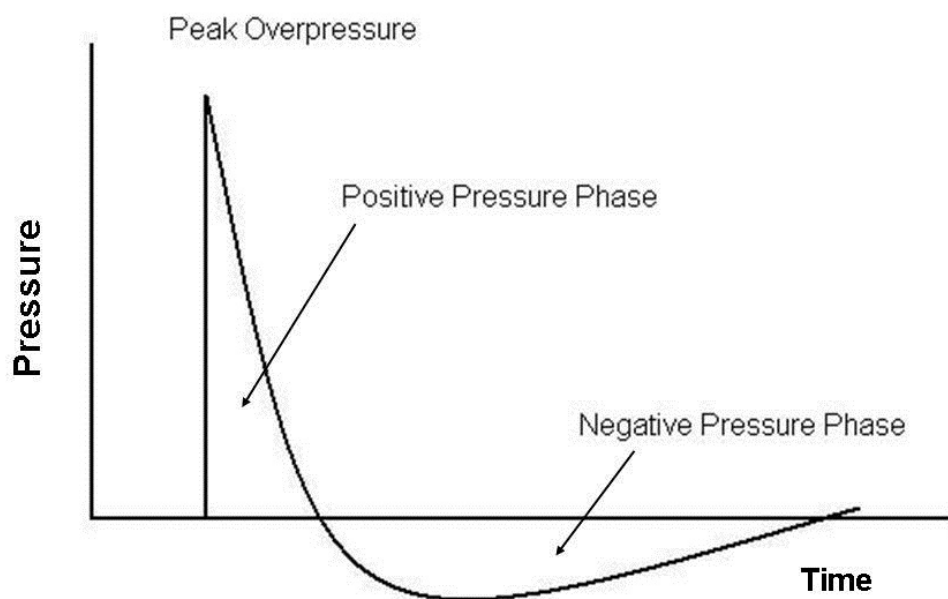
**Figure 1.7:** The idealized blast waveform, adapted from the work of Nabil M Elsayed and James L Atkins (2008).

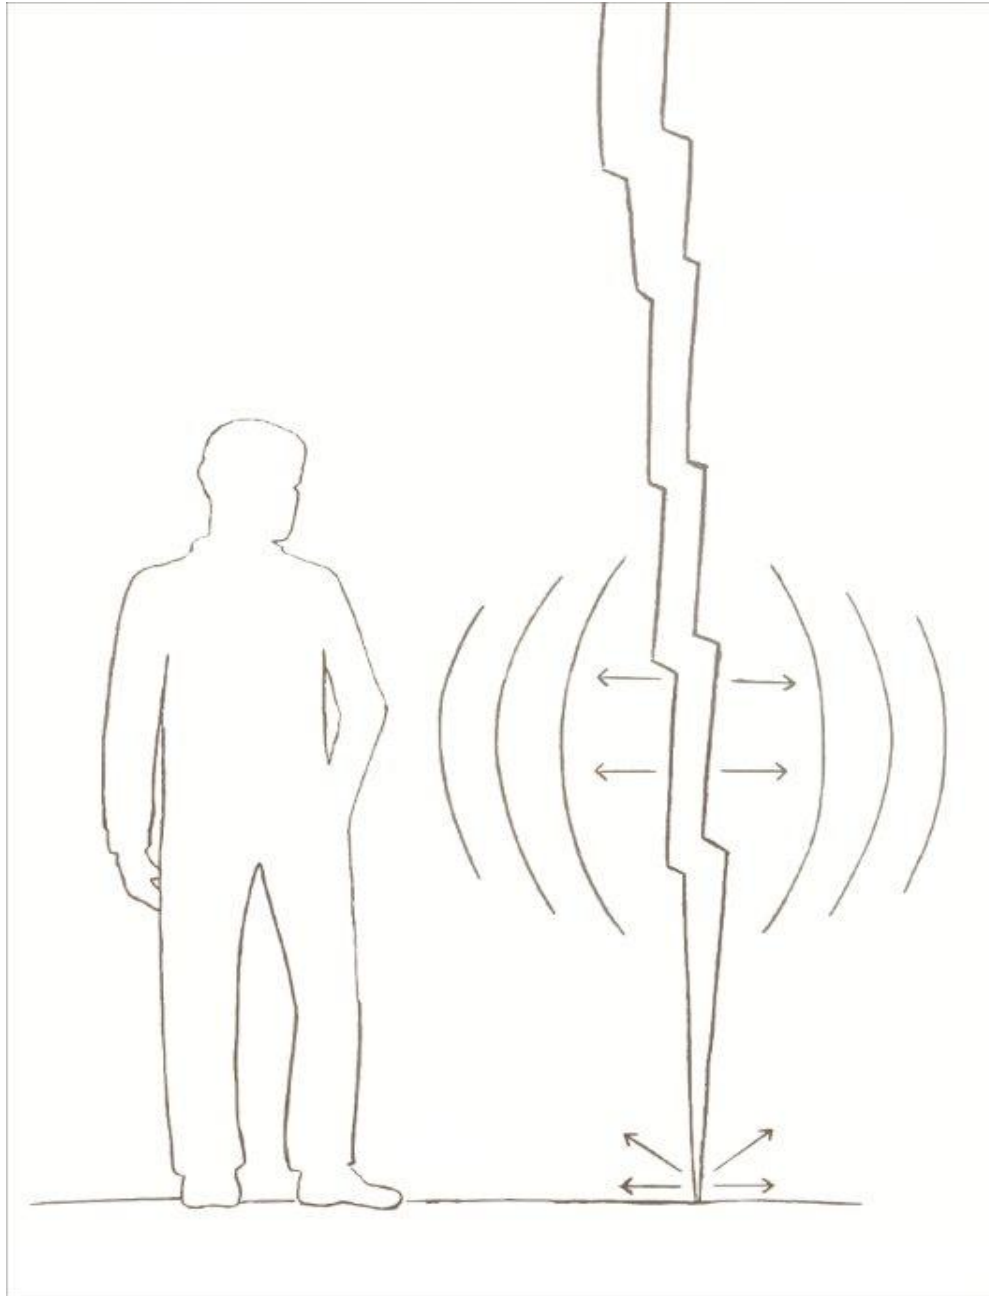
**Figure 1.8:** The sixth mechanism of lightning injury: Lightning explosive barotrauma, imagined as a 'pressure-shock wave' immediately surrounding lightning's luminous channel.

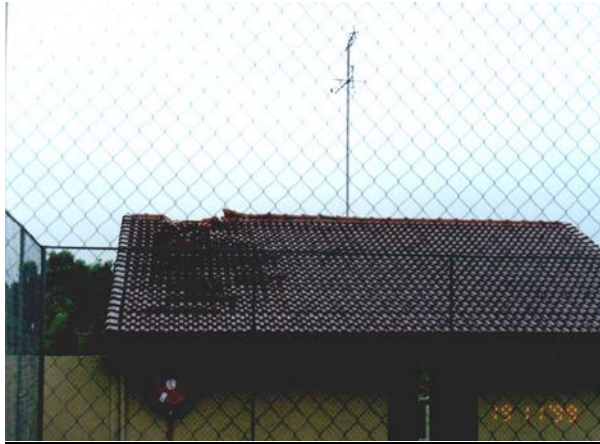
**Figure 2.3:** Structural damage to a club house due to direct lightning strike (McKechnie and Jandrell, 2008).

The case studies reported by McKechnie and Jandrell are important to this thesis and form the basis of the argument for the sixth mechanism. Their reports describe the popping of nail-supported drywall away from horizontal and vertical wooden studs inside houses and broken glass windows (McKechnie, 2008).

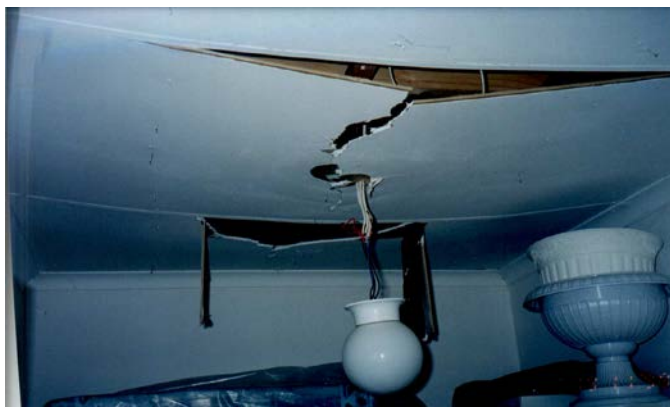
**Figure 2.4:** Signs of a roof having collapsed. Structural damage caused to a club house building as a result of direct lightning strike (McKechnie and Jandrell, 2008).

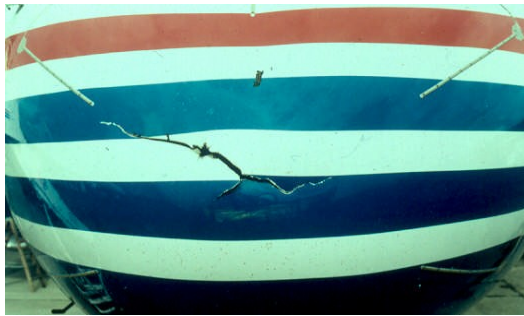
**Figure 2.5:** *Photograph: Aircraft nose radome punctured by lightning (American Airlines photo).*

The 'punctured' radomes however are important to this thesis and also form the basis of the argument for the sixth mechanism.

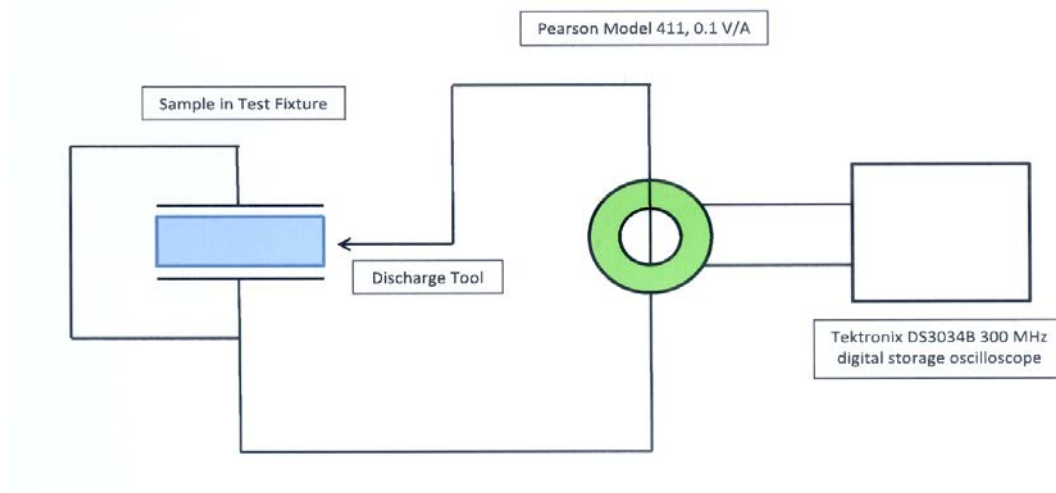
**Figure 2.6:** Schematic diagram of Hickman's experiment.

Solid dielectric breakdown phenomena have been studied for over a decade (Hickman, 1999-2012). Hickman's production runs represent the closest experiment to the '2012 sixth mechanism experiment', in that both use currents passing through solid, block-like structures. Further details on Hickman's experiments may be found on their website (Hickman, 2013). Please refer figure 2.6.

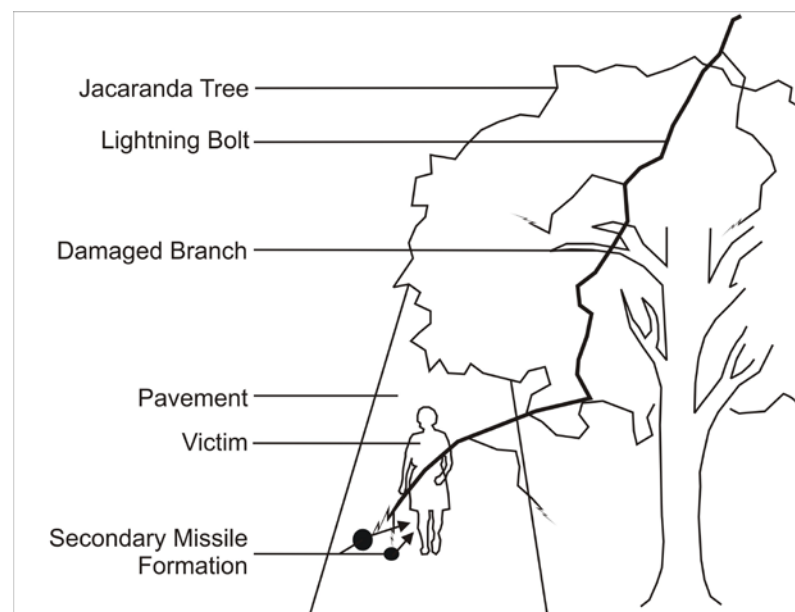
**Figure 3.1:** Diagrammatic representation of the lightning strike event as described. Note the lightning ‘splashing’ and/or ‘flashing’ off the tree (third mechanism), striking the victim and then striking the concrete pavement. The concrete pavement ‘exploded’ (sixth mechanism).

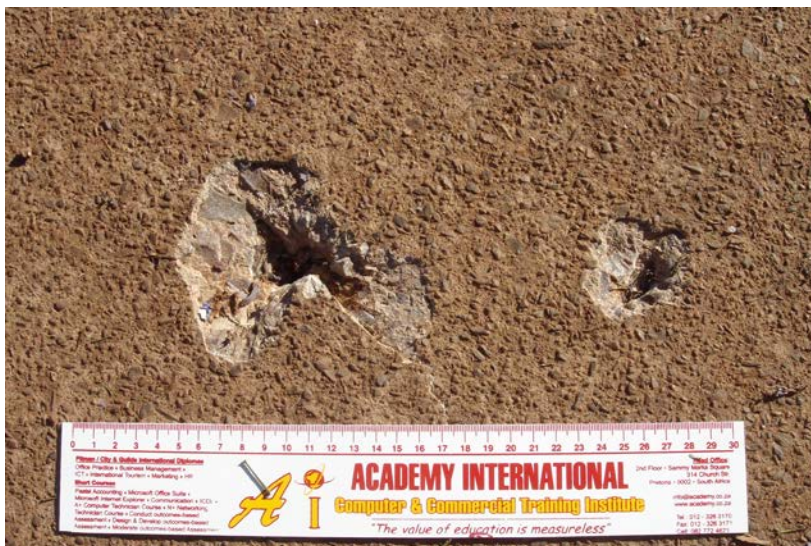
**Figure 3.3:** Blast / explosion effects from the lightning noted on the concrete pavement on the right side of the victim.

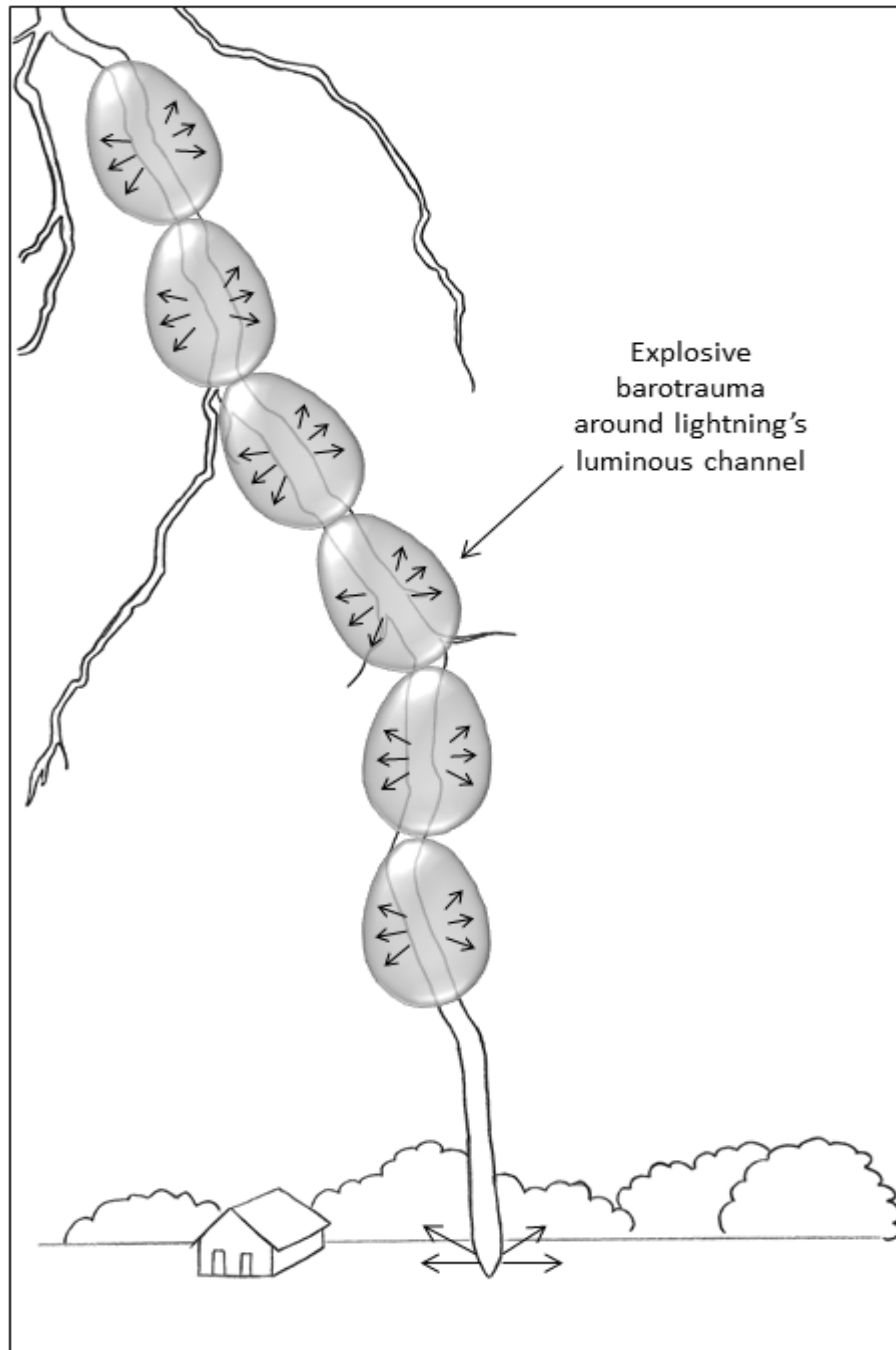
**Figure 4.1:** Proposed appearance of the sixth mechanism of lightning injury. Please keep in mind that the lightning channel is three-dimensional.

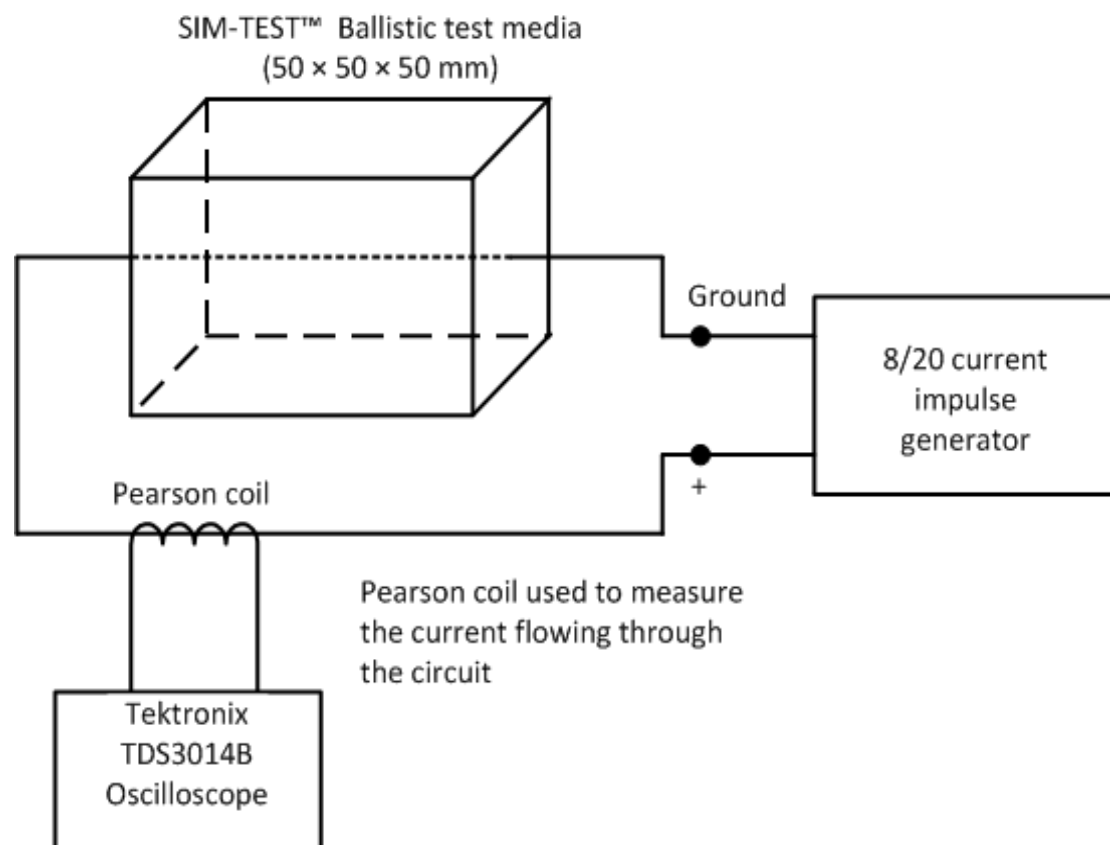
**Figure 4.4:** The 2012 ‘sixth mechanism gel experiment’: Physical layout of current impulse generator and test object (the gelatine block).

The aim of the experiment was to determine the shape and nature of the 'pressure shock-wave' surrounding the long electrical spark. The wire made sure that the long electrical spark did not flash over the gelatine blocks. What is important to realise is that, all things being equal, (the wire and the gelatine blocks for example – with all their associated contaminants), the only things being tested for in this experiment were current, voltage and size and shape of the cavity.

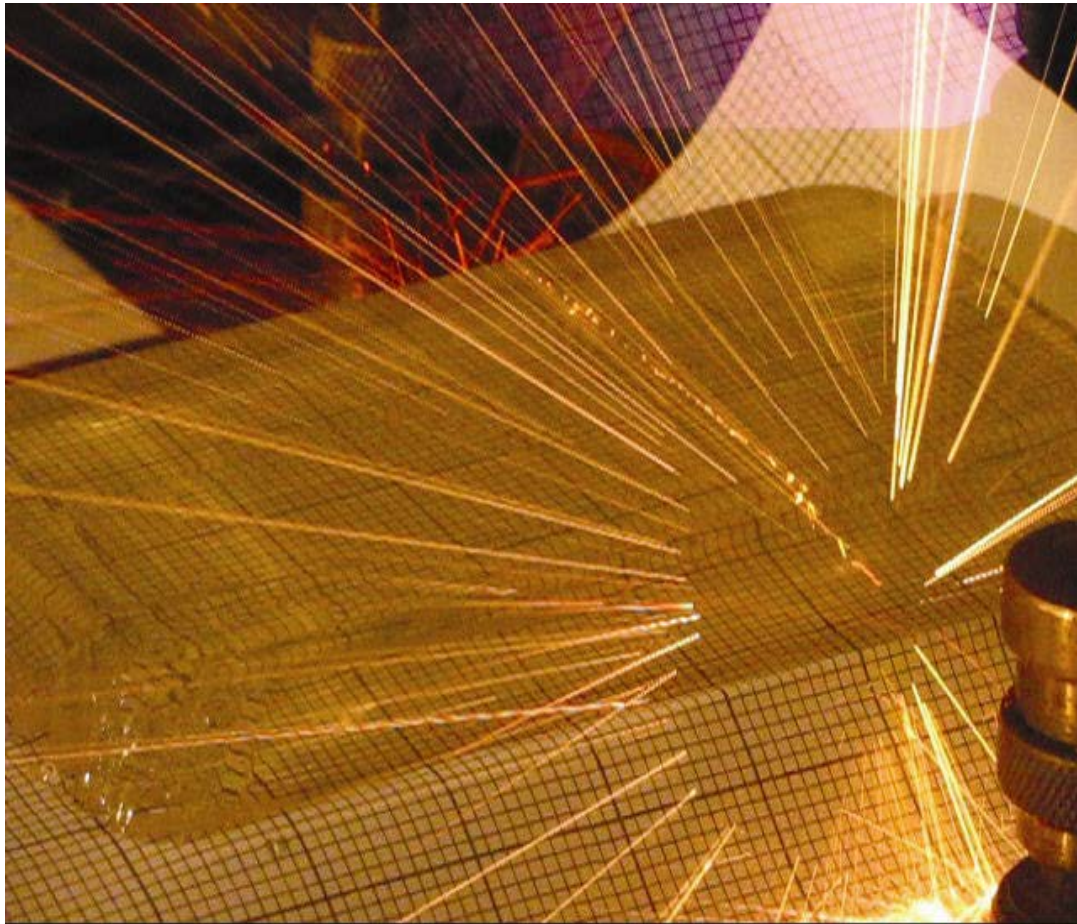
**Figure 4.6:** High-speed camera footage showing the moment of impulse generation. Note the radial explosion from the wire. The propagation mode of the blast wave through the jelly was visibly noted. Current impulse generated through gel showing radial explosion.

Gelatine proved an excellent medium to study the behaviour of the shock wave in that it was transparent and allowed for optical measurements. High-speed photography was performed in second-phase experimentation and the propagation mode of the blast wave was visibly noted. Since gelatine is made of natural substances, (water and proteins), disposal was also not a problem.

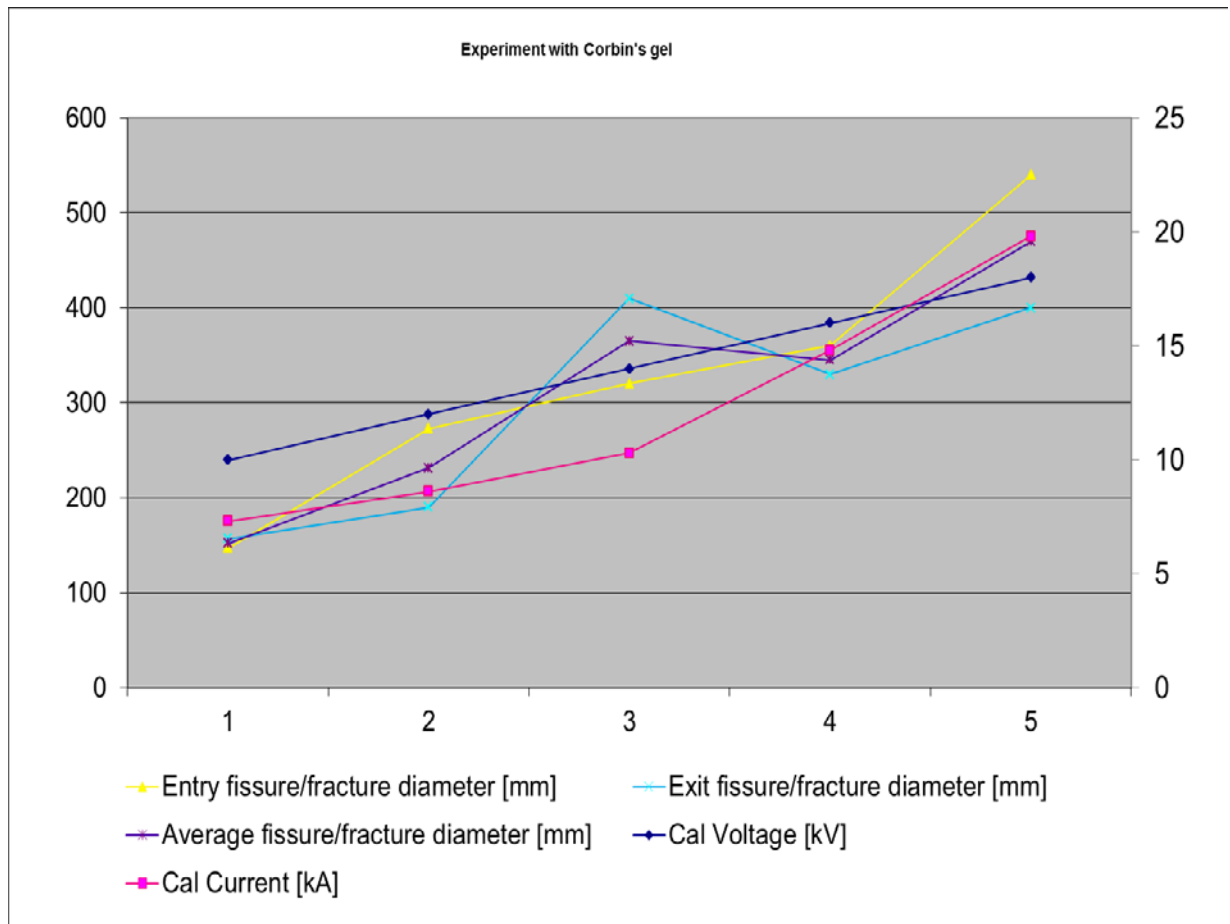
**Figure 4.10:** Initial testing with Corbin's gel. The x axis plots the current (kA) whereas the y axis plots the fissure/fracture diameters in millimetres. Due to the fact that this represents a 2-D chart with values from a data series which vary widely, and which contain mixed-type of data, a further analysis using a secondary axis in the chart was employed. This method enabled the author to plot one data series (kA) on a secondary vertical axis. A correlation between kA and the entry and exit fissure/fracture diameters exists. It appears from the graph that kA and the fissure/fracture diameters are directly proportional to one another. Please note that the findings were based on objective, descriptive appearance of the so-called 'wound profiles'.

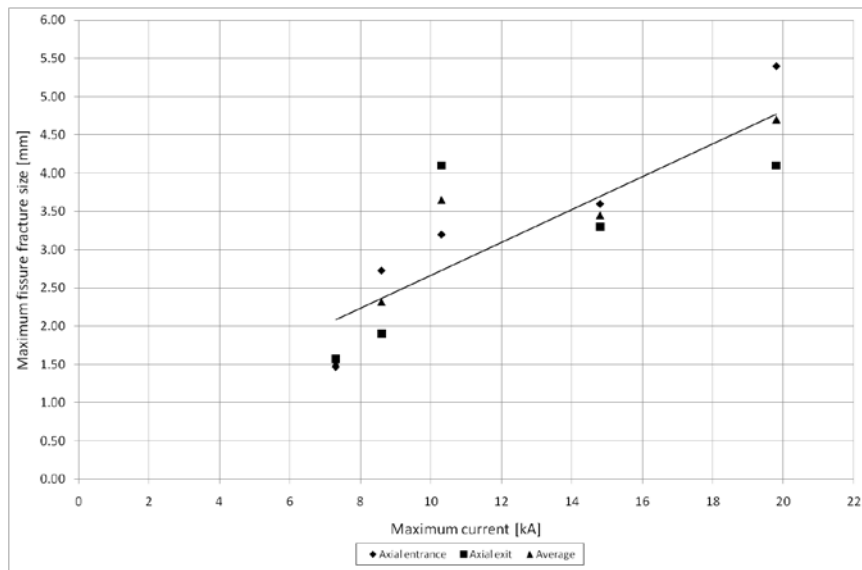
**Figure 4.13:** Graph demonstrating incremental fissure/fracture cracks in Corbin's gel. As the current increased through the wire, the size of the temporary cavity also increased in a directly proportional manner

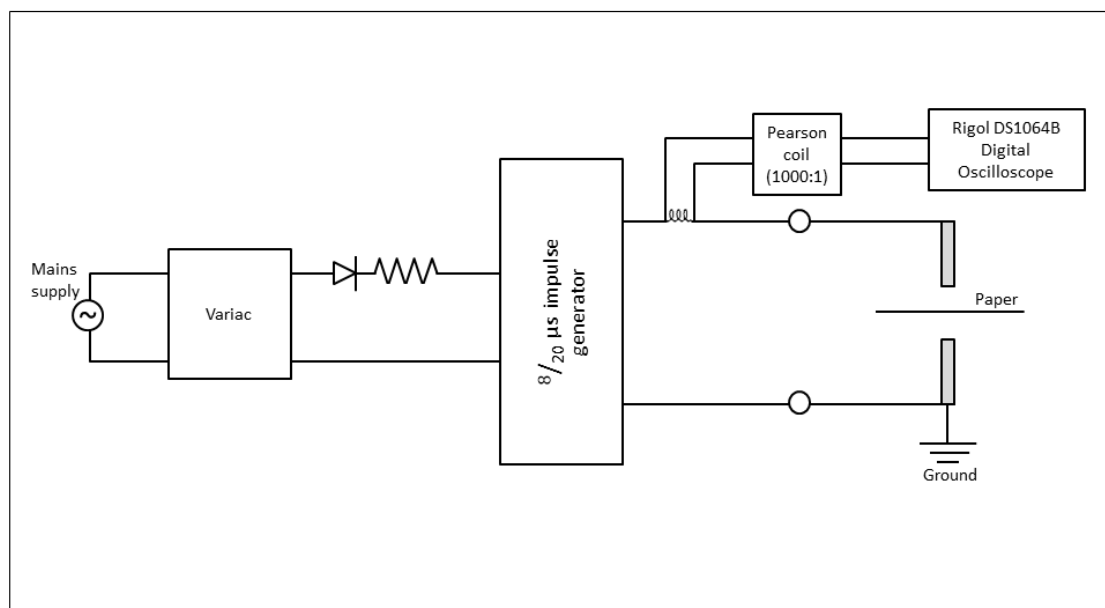
**Figure 4.14:** The 2014 'sixth mechanism paper experiment': Physical layout of current impulse generator and test object (graph paper)

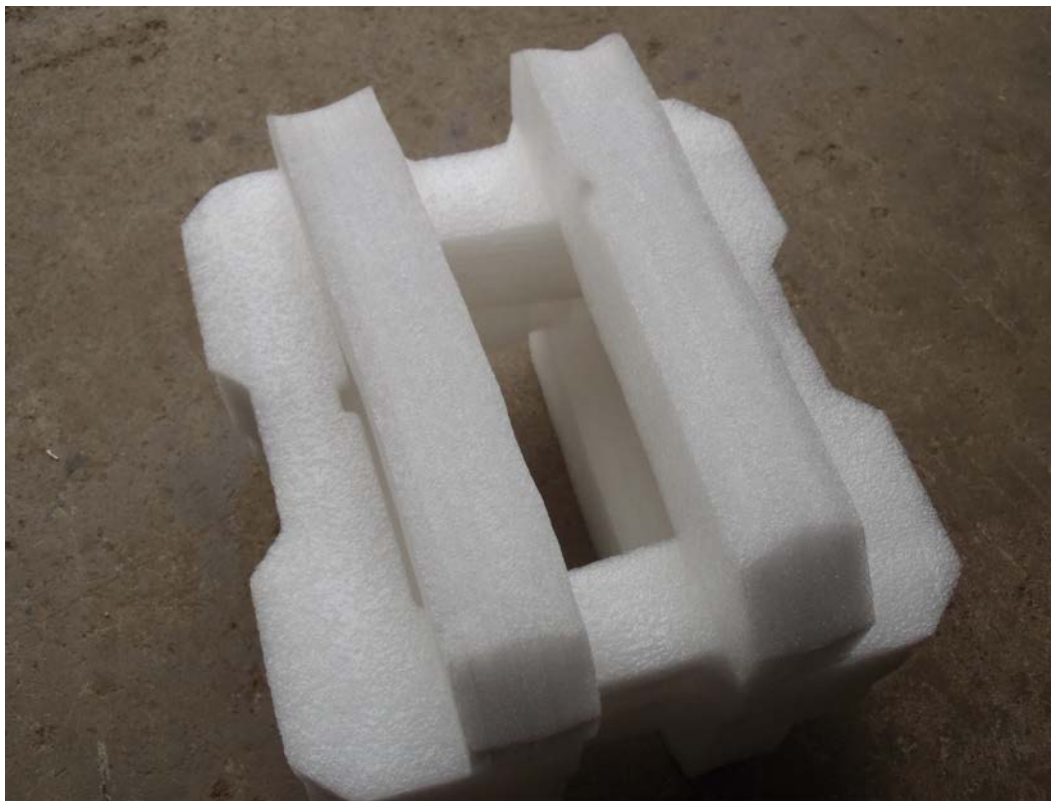
**Figure 4.16:** The polystyrene 'clamp' designed to clamp the graph paper and not cause any undue forces on the graph paper, thereby enabling the tearing and tattering to take place without any undue influence.

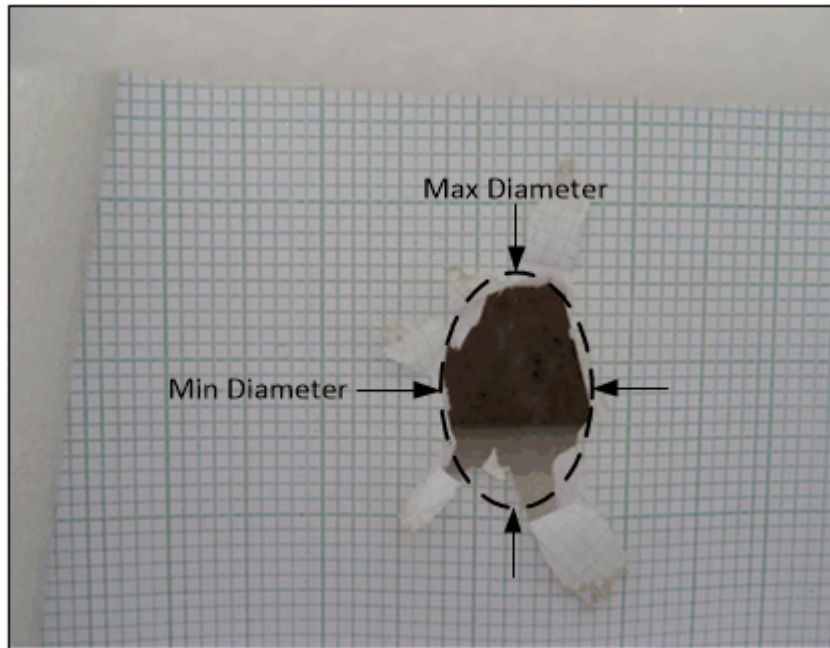
**Figure 4.17:** Tearing and tattering of dry graph paper to a maximum diameter of 29 mm. 15 kV. 24 kA.

Figure 4.17 and Figure 4.18 show what happened to the graph paper after having been subjected to an impulse. The majority of knowledge related to lightning parameters has been derived by 'scaling up' the equivalent information obtained during experimentation with the use of long linear electrical discharges generated under laboratory conditions (Uman, 1970).

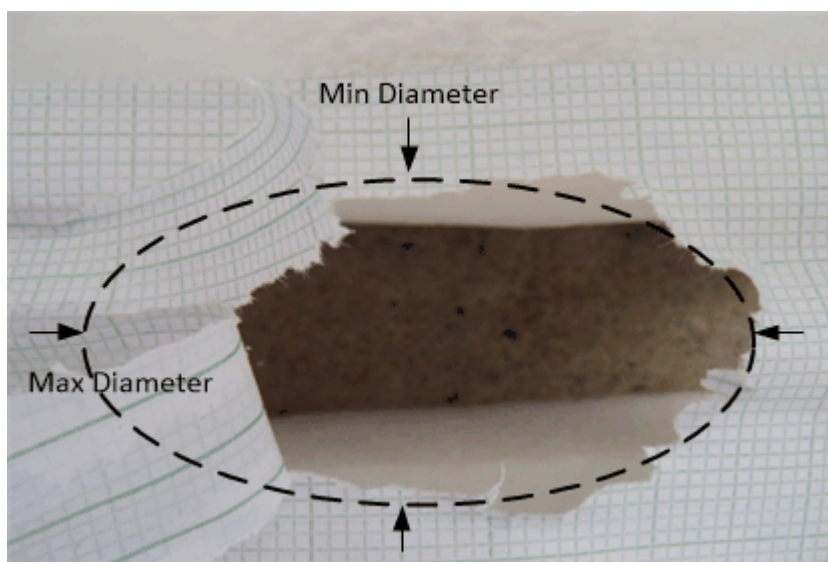
**Figure 4.18:** Tearing and tattering of saline-soaked graph paper to a maximum diameter of 80 mm. 20 kV. 32,8 kA.

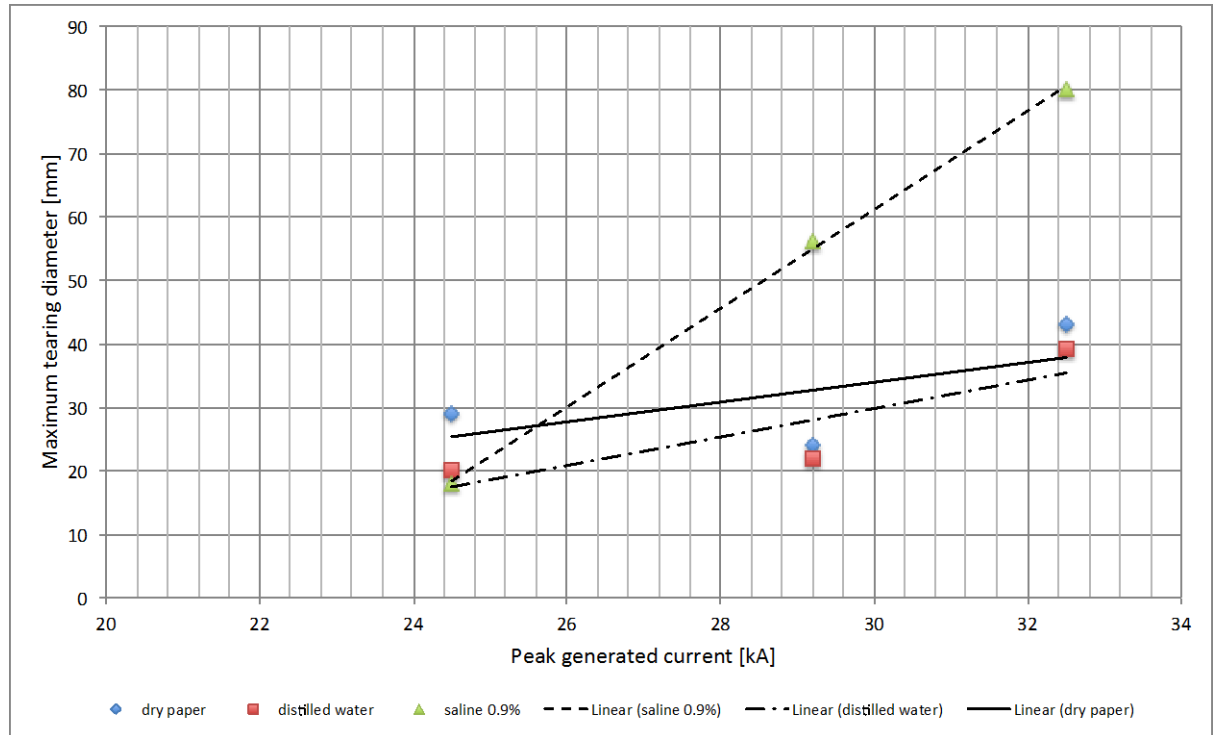
**Figure 4.19:** Trend lines showing significantly higher tearing of the paper soaked in 0.9% saline solution.

The graph illustrated in Figure 4.19 shows the maximum tearing diameters against the peak generated currents for dry, distilled and saline-soaked graph papers.

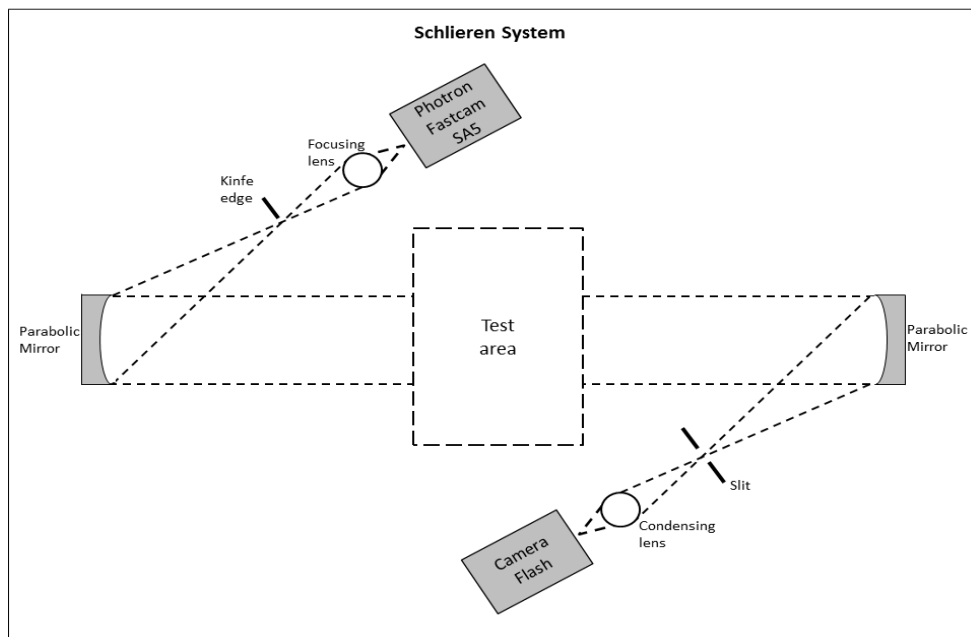
**Figure 6.1:** Proposed Z-configuration Schlieren test to photograph the lightning blast wave around a spark.
